R20TS0545EJ0100

CS+ Code Generator for RL78 (CS+ for CC),
 CS+ Code Generator for RL78 (CS+ for CA,CX),
 e² studio Code Generator Plug-in,
 AP4 Coding Assistance Tool for RL78

Overview

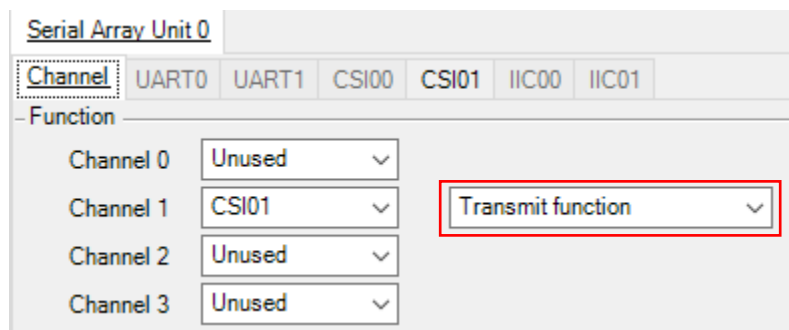
When [Transmit function] is selected in the channel settings, incorrect callback functions might be enabled in CSI or UART, resulting in generation of unintended callback functions.

This problem occurs when [Transmit function] is selected in serial array unit [CSI01] or [UART1] with interrupt [INTP2] selected.

After setting the channels of the serial array unit, do not change the function indicated by the red frame below unless it becomes necessary to do so. If you do need to change it, make the change, then set the channel settings back to "Unused", and set the channels again.

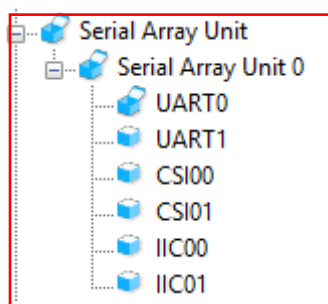
If you open an item in the [Serial Array Unit] folder again after setting CSI or UART, the pin function assignment of the serial array unit is canceled, and the pin conflict judgment does not function correctly.

If you open the item in the [Serial Array Unit] folder in the peripheral function tree, the pin function assignment is canceled.

After setting CSI or UART, do not open any item in the [Serial Array Unit] folder.

If you open an item in the [Serial Array Unit] folder and the pin function assignment is deleted, set the channel settings back to “Unused”, then set the serial array unit again.
