Errata Sheet

SLG46108

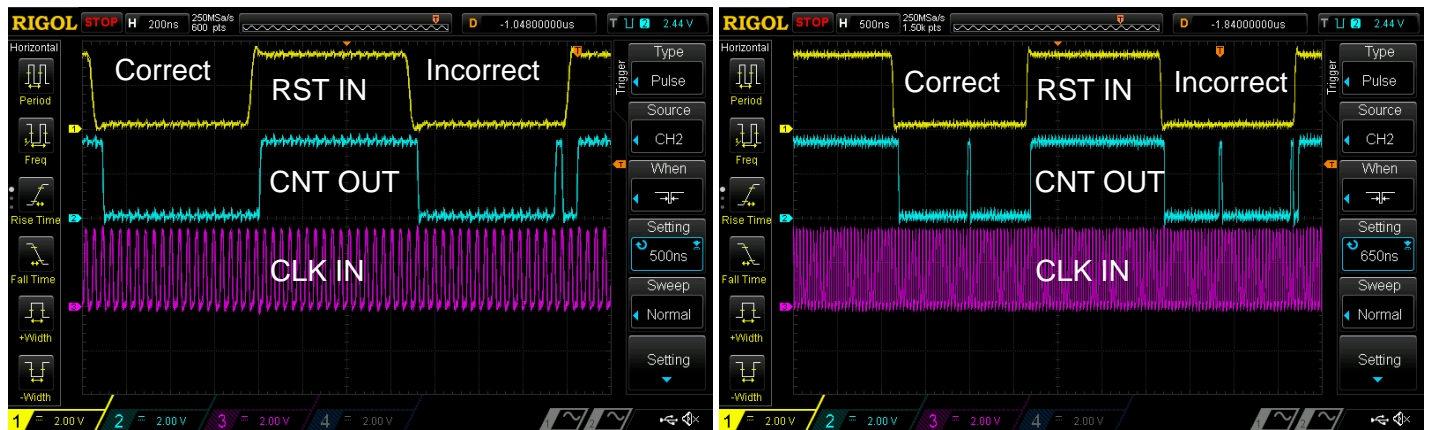
ISSUE 1: Incorrect Counter Operation after the Reset

If the Counter Reset is asserted at the same time as a rising clock edge, it is possible that the Counter Data will be reset incorrectly and the counter output may appear faster than expected, it doesn't depend on Edge select option. This phenomenon appears more often as the clock frequency increases.

- Synchronize the RESET input of the Counter with its CLK using 2 DFF cells as shown in the image below.

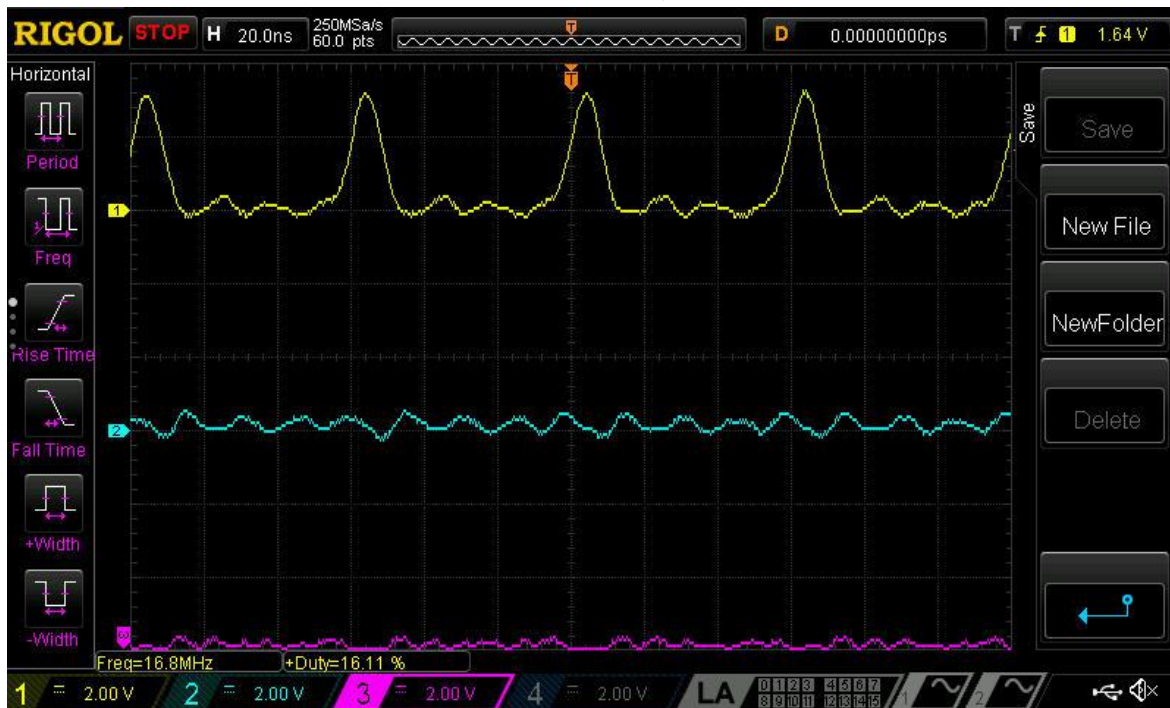
1. Period is 60 ns. Pulse width is 10 ns, DC = 16.7 % (correct functionality).

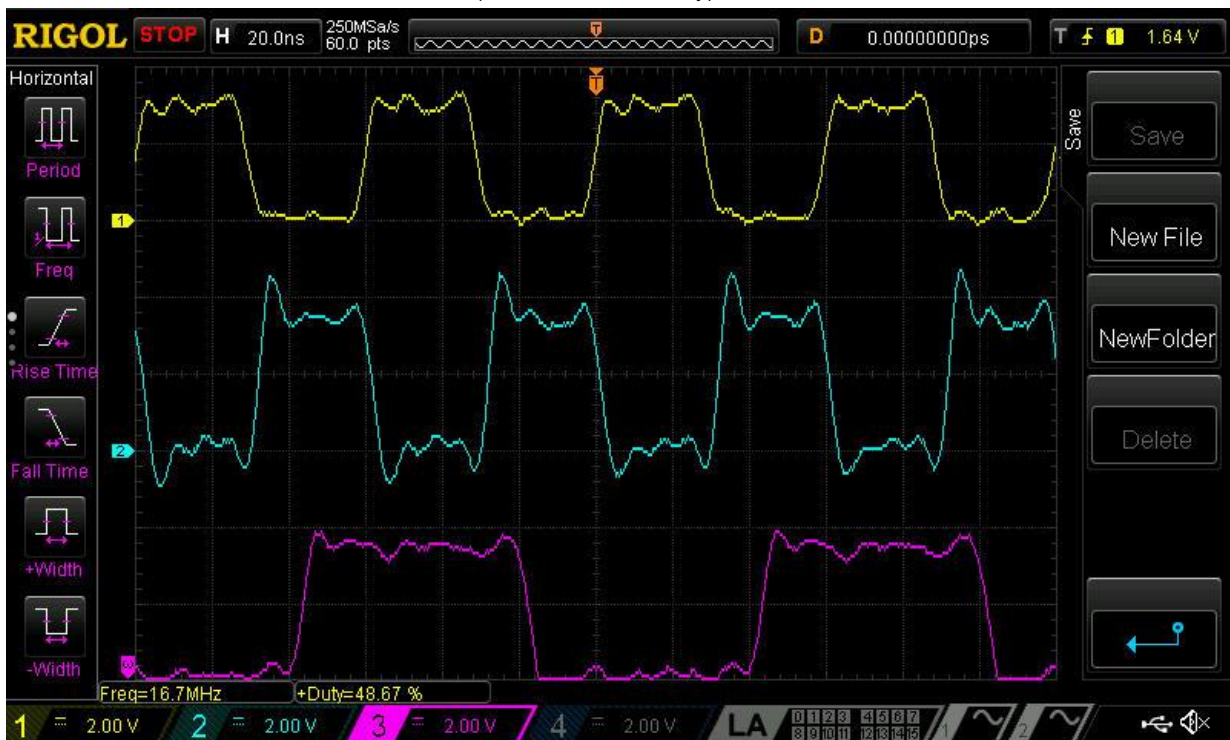
- Period is 60 ns. Pulse width is 30 ns, DC = 50 % (incorrect functionality).

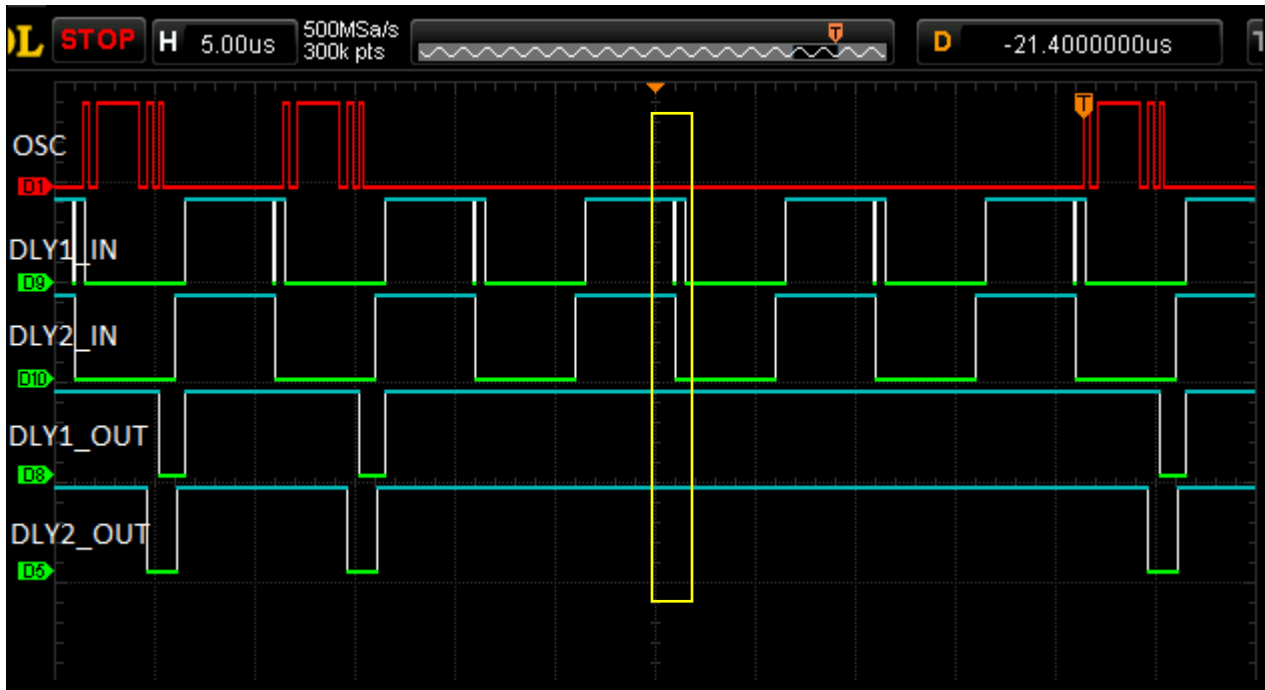
Figure 3: Errata Capture (Zoom Out)

Figure 3 shows a series of DLY output events are missing, where the OSC is correspondingly not triggering when it was supposed to. Figure 4 is a zoom in of the boxed region from Figure 3. The total glitch/chatter time was measured in this case at 152 ns. By using the composite OR of the two delay channels, we can asynchronously strobe with tiny frequency variations, and so tune the timing to induce this errata. Note that the error is not persistent – the system is recovered when all DLYs are returned to inactive state, such as when input of falling edge DLY goes high, thus canceling delay, or after DLY out finishes.

1. Use signal conditioning circuits to prevent glitch on DLY inputs < 200 ns. Examples:
 - a. ACMP with Hysteresis
 - b. External RC in front of Digital Input with Schmitt Trigger
 - c. Filter cell.
2. Set OSC power mode to Force Power On mode instead of Auto Power On.
3. Use different oscillator, such as 25 MHz Ring OSC, which does not have Auto Power On issue.
