Errata

SLG46117

CE-GP-012

This document contains the known errata for SLG46117 and the recommended workarounds.

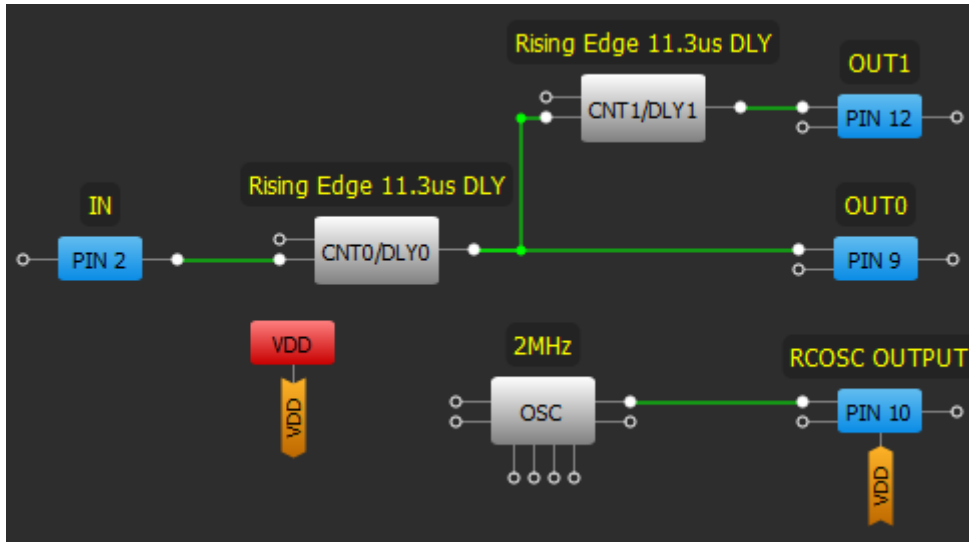
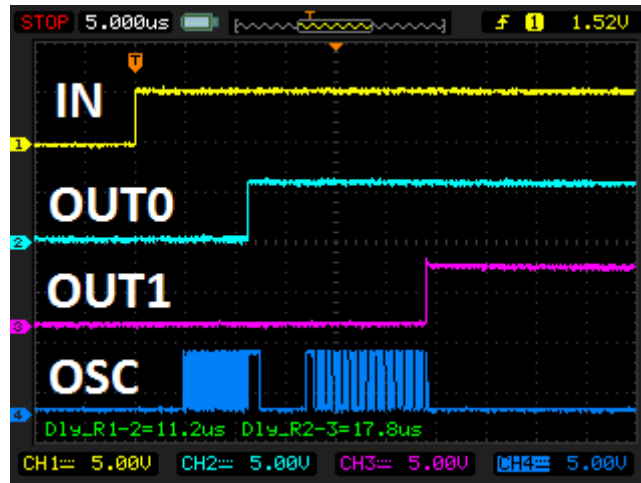
The same situation occurs while using two connected delays (all edge detect types except for a pair “Rising edge DLY – Falling edge DLY”).

In the following example, Delay0 and Delay1 are configured in the same way. However, Delay1 time is 17.8us instead of expected 11.3us (Delay0 time).

- using two delays in series (except for a pair “Rising edge DLY – Falling edge DLY”) use one Filter cell or P DLY between delay blocks. Using LUTs won’t help in this case.

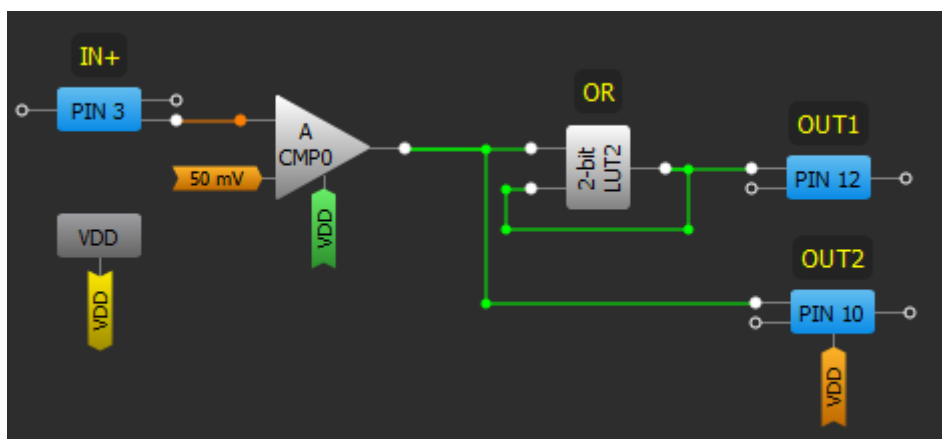
In some cases, ACMP may have short high-level glitches on its output (even if IN+ voltage is less than IN- voltage) after GreenPAK chip being powered up. Such cases may appear when using ACMP with Low Bandwidth mode enabled and Power Up is connected directly to the V_{DD} .

In order to detect such glitches, scheme with additional LUT was used. This LUT detects high level on ACMP output and stays high until chip powers down.

ACMP IN+ is connected to the Ground.

Use POR block, connected to the ACMP's Power Up pin. However, in this case ACMP will start working with low level output and will be able to go high only after POR goes high + ACMP power on time.

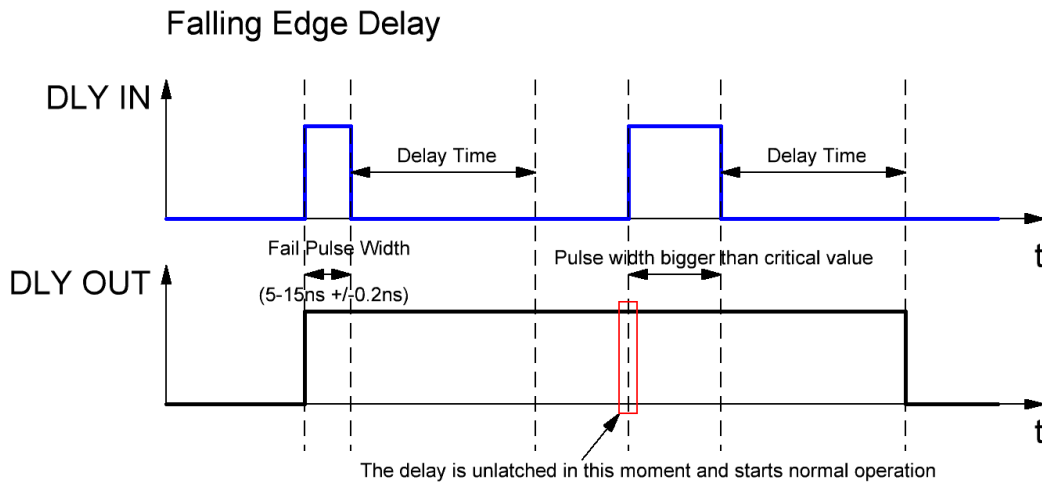
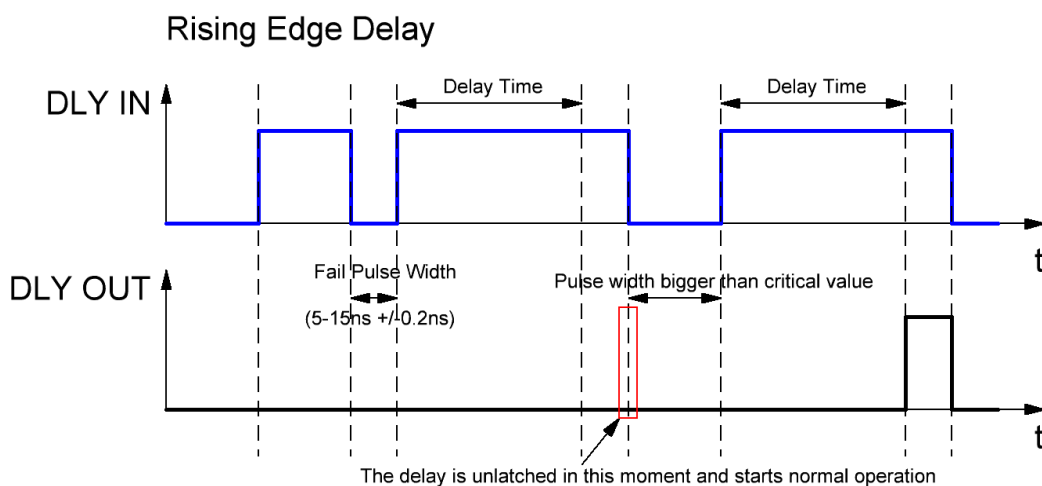
The delay output could be latched despite the input change when a short pulse is input. For example, if the delay cell is configured as a falling edge delay, the short pulse (see NOTE) appears on its input the delay cell output will switch from LOW to HIGH but may not switch from HIGH to LOW even after the delay time has passed.

NOTE: The pulse width varies from chip to chip and with different V_{DD} voltage. It is in range of 5-15ns and in the window $\pm 0.2ns$, so it should be very precise for issue happen.

Use P DLY/FILTER block configured as a both edge delay or FILTER.

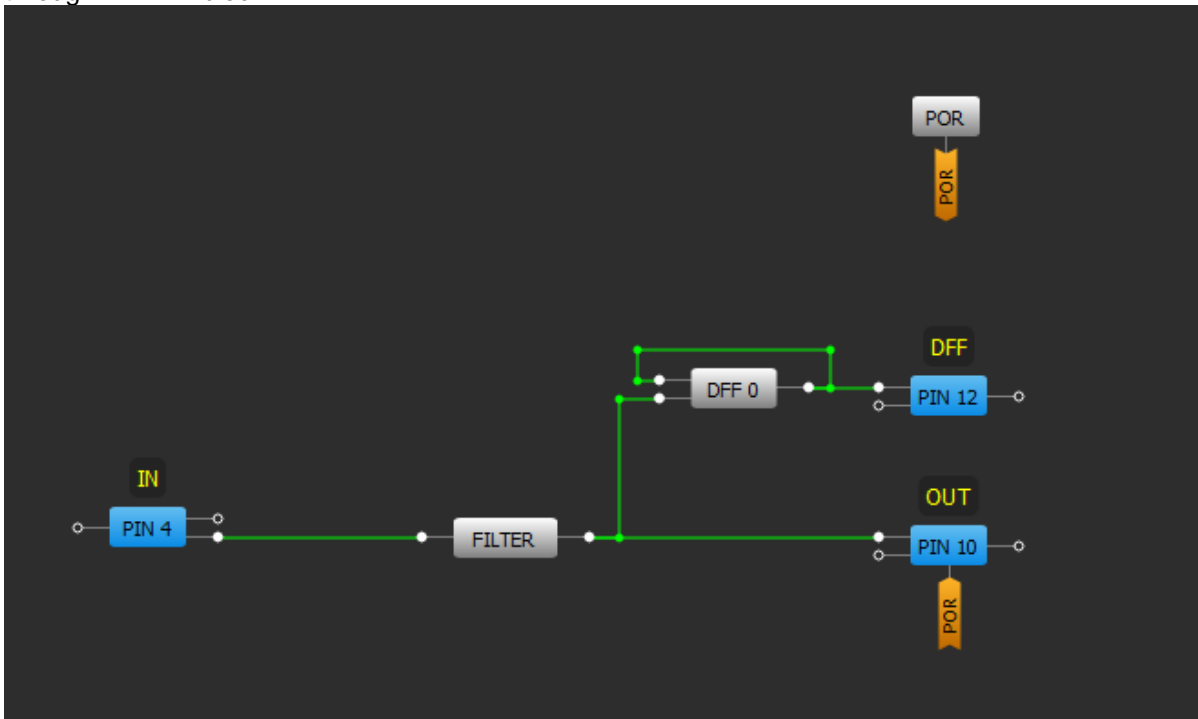
If clock type high frequency input comes in, the FILTER cell may not filter out it. There are several factors like input frequency, duty cycle and LOW duration in such signal that may lead to its passing through FILTER block.

Channel 1 (yellow/top line) – PIN#4 (IN)
 Channel 2 (light blue/2nd line) – PIN#10 (OUT)
 Channel 3 (magenta /3rd line) – PIN#12 (DFF)

Currently there is no workaround for this issue. Filter block is good at filtering short spontaneous glitches. It is intended to be used in series connection before the delay cell to avoid its latching (see issue #5).

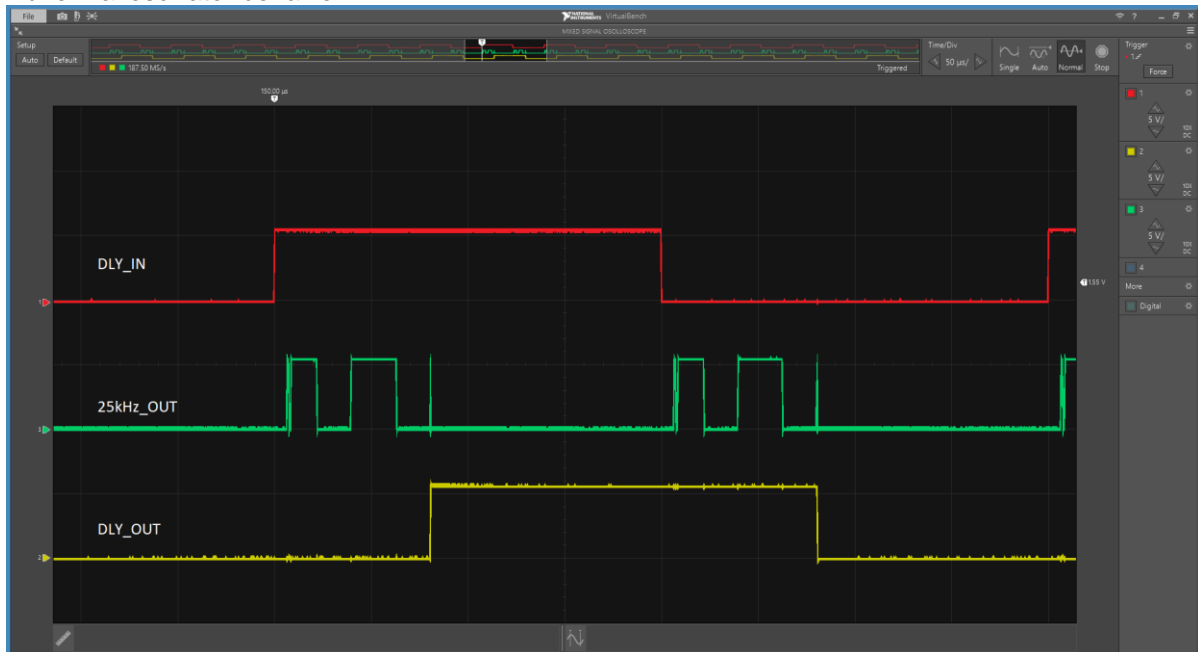
Abnormal oscillator behavior.

- Avoid V_{DD} higher than 4 V
- Force ON OSC
