Errata

SLG46120

CE-GP-014

This document contains the known errata for SLG46120 and the recommended workarounds.

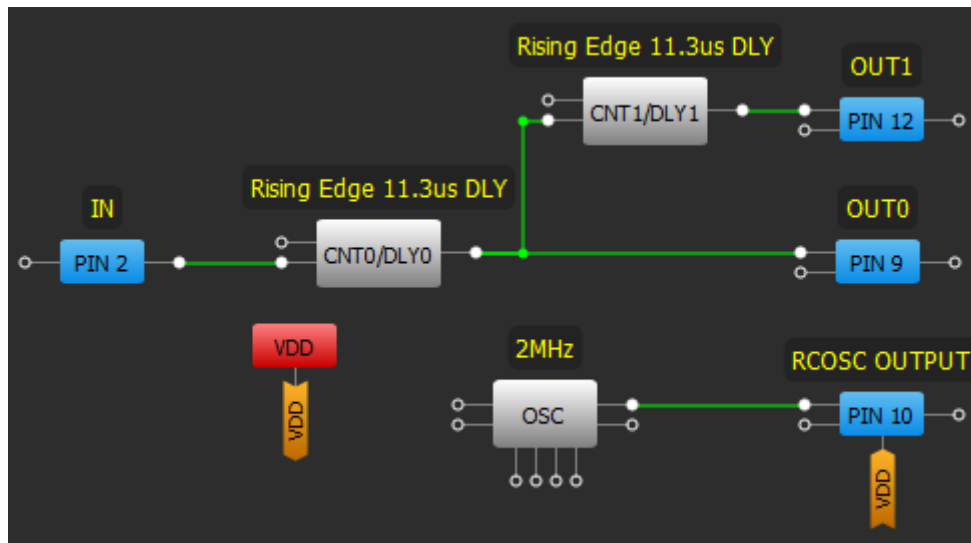
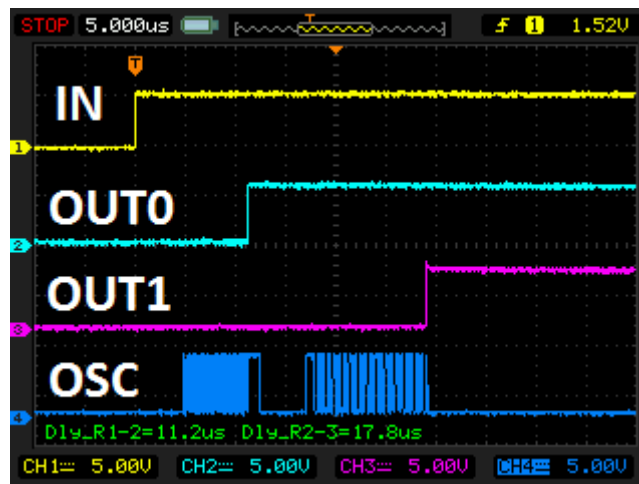
The same situation occurs while using two connected delays (all edge detects types except for a pair “Rising edge DLY – Falling edge DLY”).

In the following example, Delay0 and Delay1 are configured in the same way. However, Delay1 time is 17.8us instead of expected 11.3us (Delay0 time).

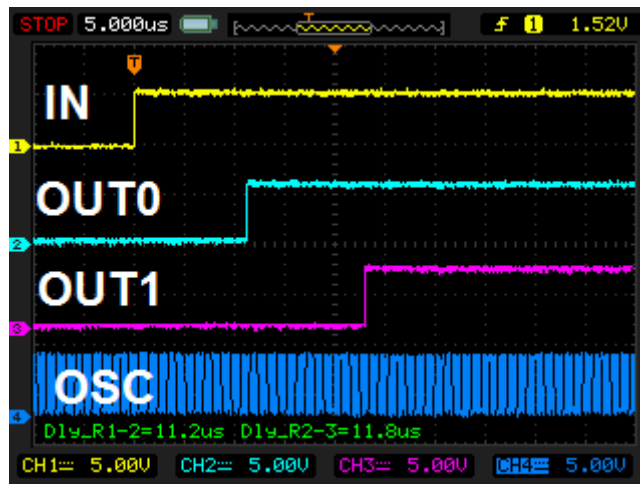
If there are some inner blocks which use RC OSC at the moment or RC OSC is forced power on when such error appears, RC OSC will be operational and delay value will be proper.

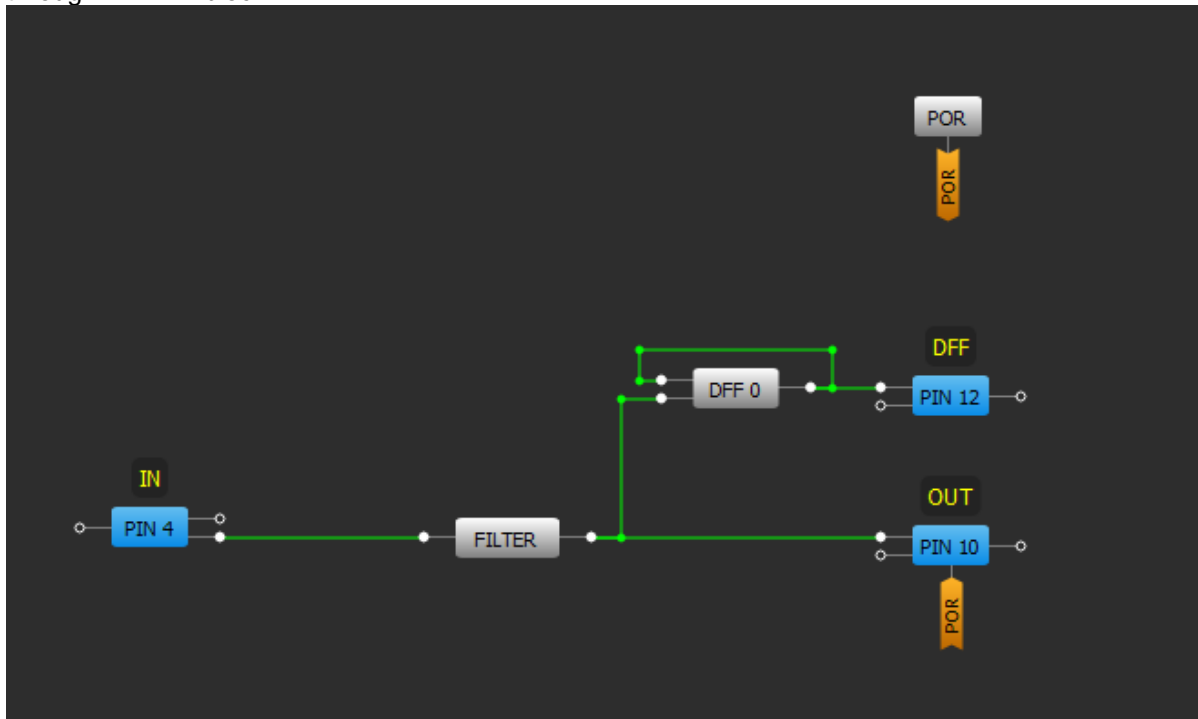
Channel 1 (yellow/top line) – PIN#4 (IN)
 Channel 2 (light blue/2nd line) – PIN#10 (OUT)
 Channel 3 (magenta /3rd line) – PIN#12 (DFF)

If clock type high frequency input comes in, the FILTER cell may not filter out it. There are several factors like input frequency, duty cycle and LOW duration in such signal that may lead to its passing through FILTER block.

Currently there is no workaround for this issue. Filter block is good at filtering short spontaneous glitches. It is intended to be used in series connection before the delay cell to avoid its latching (see issue #5).

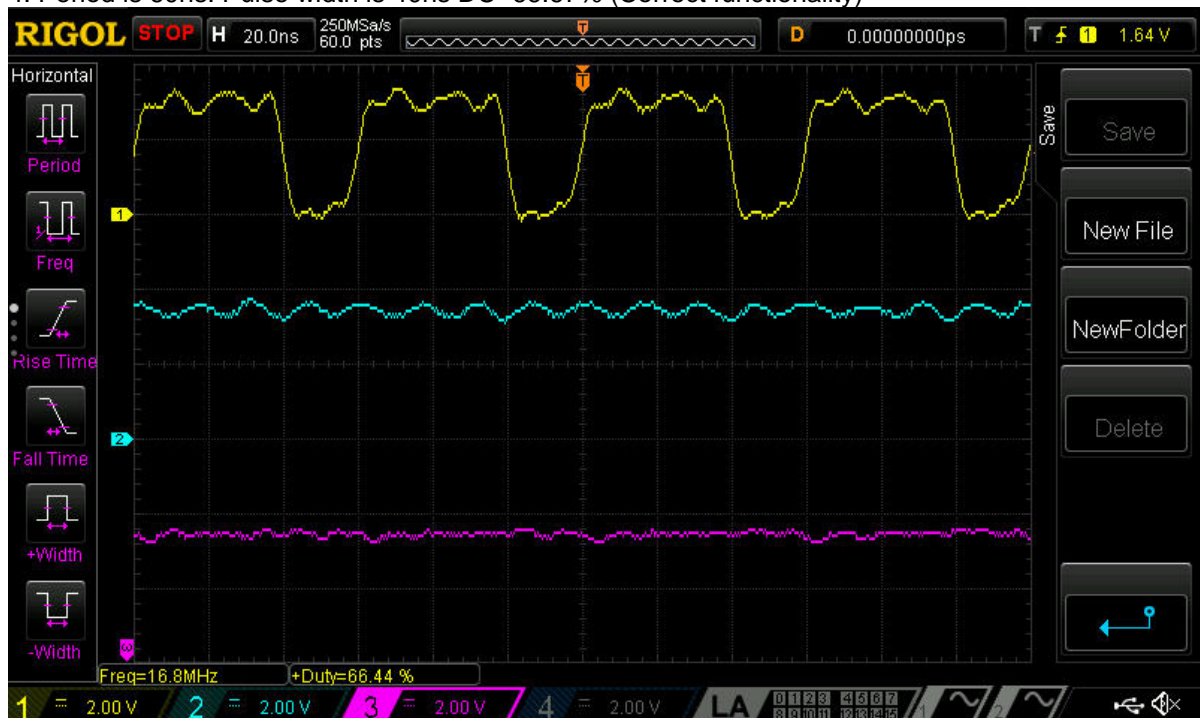
4. Period is 60ns. Pulse width is 40ns DC=66.67% (Correct functionality)

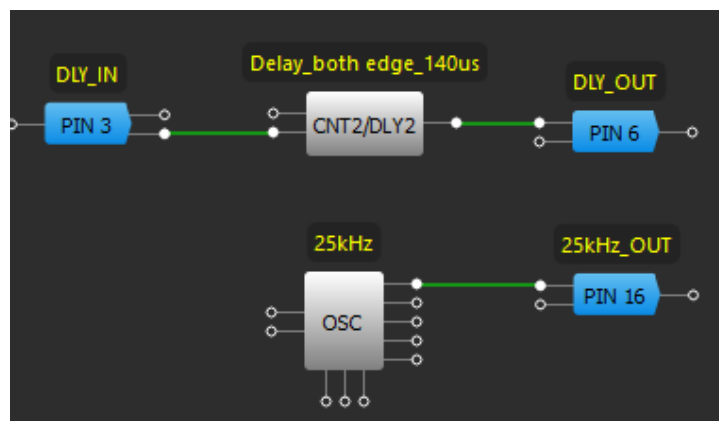
The first period of the RC OSC can be very short when OSC configured as 25 kHz with Auto Power On in the designs. This can be occurred when V_{DD} is above 4.0 V. Critical for CNT/DLY with a low counter data (less than 10) or if it is necessary to use the frequency of the OSC to clock external elements.

- Avoid V_{DD} higher than 4 V
- Force ON OSC

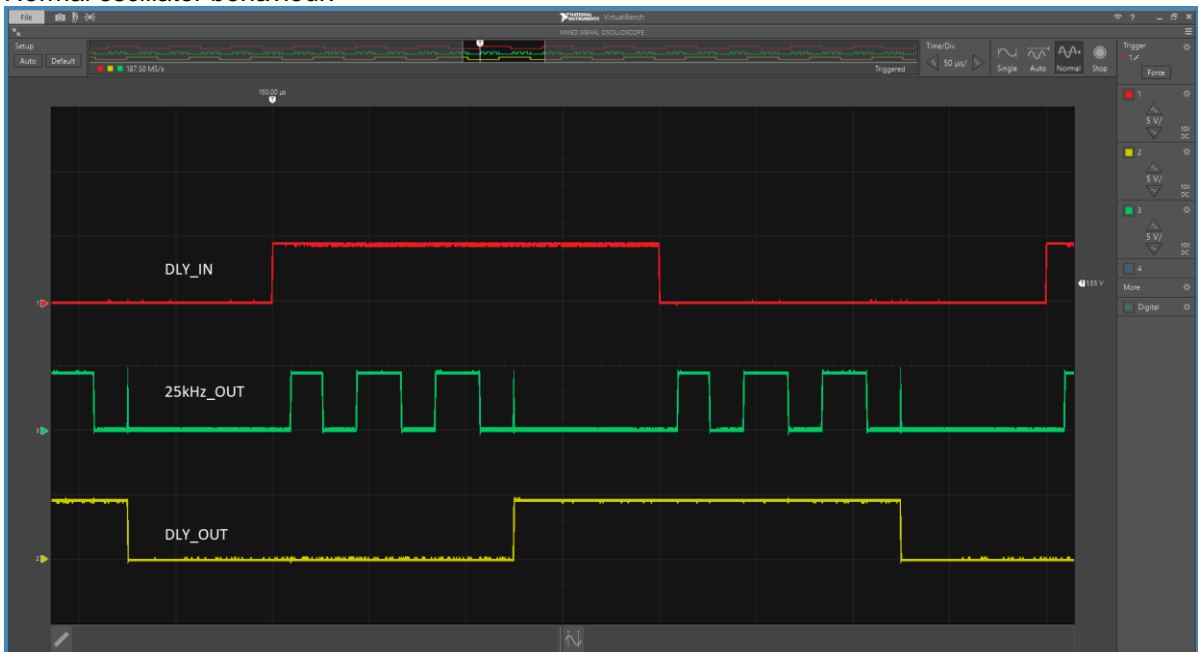
Normal oscillator behaviour.

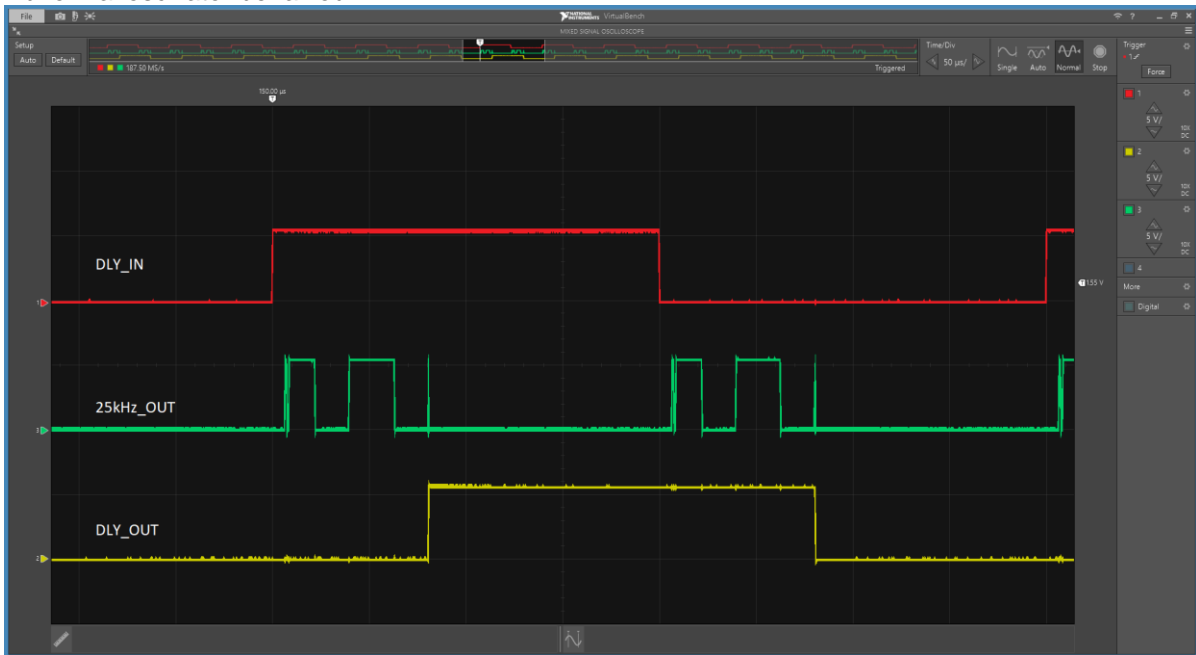
Abnormal oscillator behaviour.
