# Errata

## SLG46517

### CE-GP-001

*This document contains the known errata for SLG46517 and the recommended workarounds.*

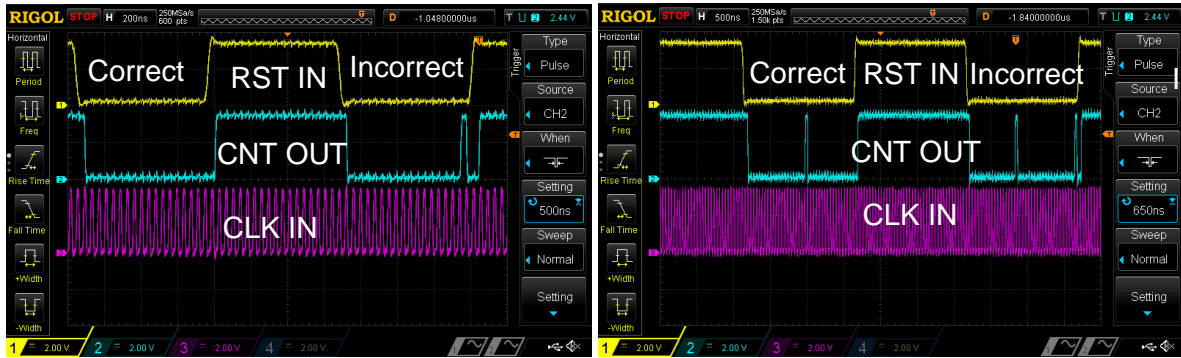
Figure 1

If the Counter Reset is asserted at the same time as a rising clock edge, it is possible that the Counter Data will be reset incorrectly and the counter output may appear faster than expected. This phenomenon appears more often as the clock frequency increases.

Synchronize RESET input of the Counter with its CLK using 2 DFF cells as shown on Figure 3.

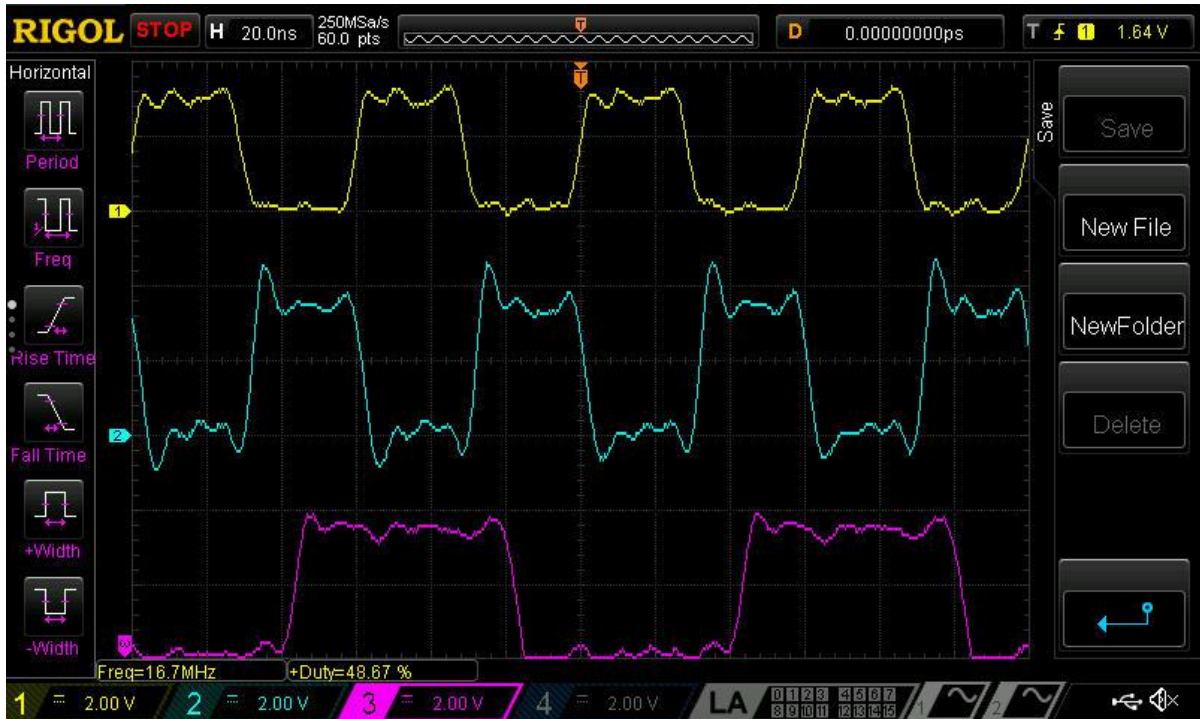
Figure 7

3. Period is 60ns. Pulse width is 30ns DC=50% (Incorrect functionality)

Currently there is no workaround for this issue. Filter block is good at filtering short spontaneous glitches. It is intended to be used in series connection before the delay cell to avoid its latching.

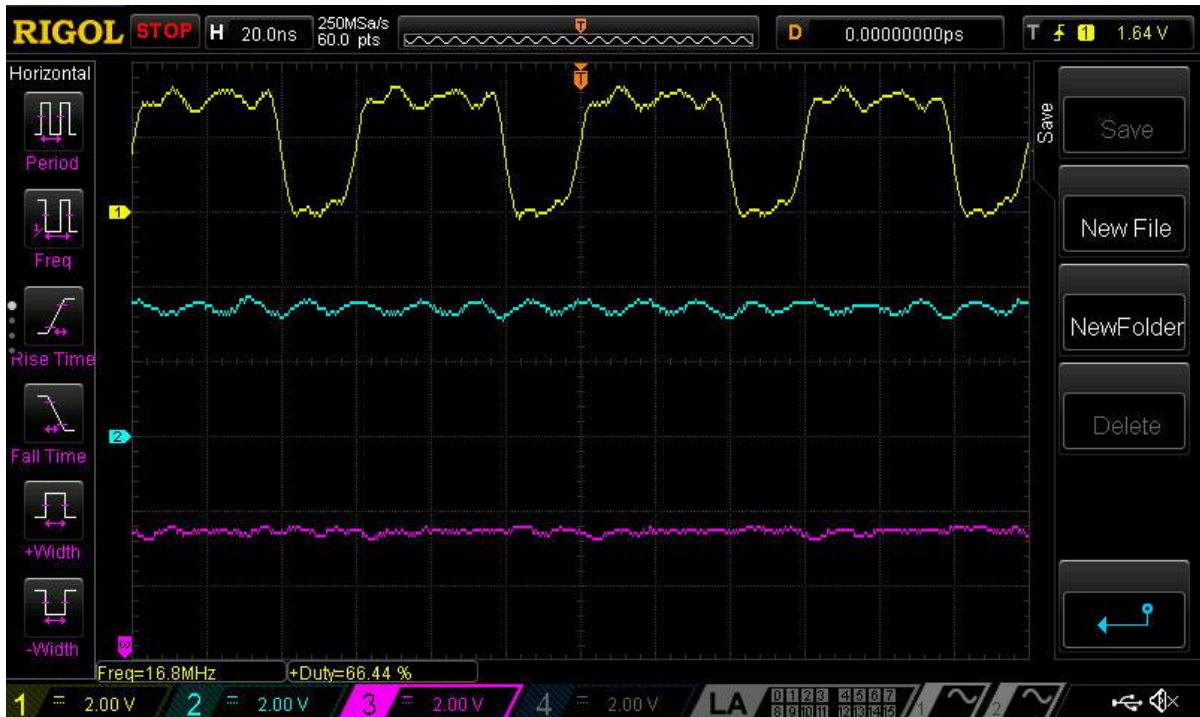
Figure 8

4. Period is 60ns. Pulse width is 40ns DC=66.67% (Correct functionality)

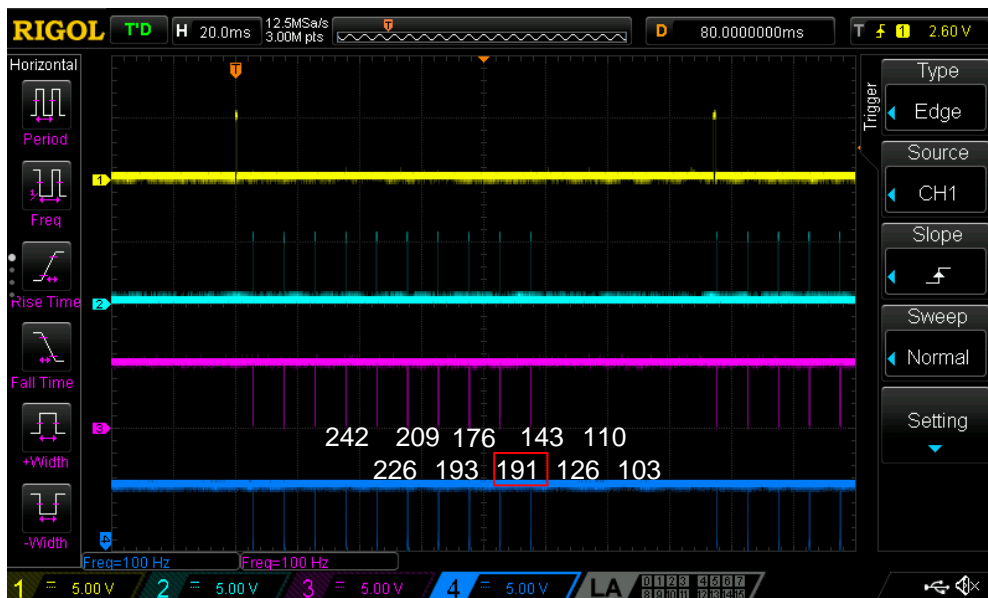
Figure 9

Asynchronous interaction between the CNT/DLY clock input and the I2C latch signal (generated by an I2C read command of the CNT/DLY block's count value) can result in an incorrect I2C data read. The CNT/DLY block will count accurately, but the count value transferred into the block's I2C read register might be loaded incompletely if the I2C latch signal and the clock input occur at about the same time.

The example data capture below shows ten periodic I2C reads of CNT2/DLY2 configured to count down at about 16 clocks per read. The sixth read sample erroneously shows a value greater than that of the fifth. The seventh sample reads as if the previous I2C error never occurred - the difference from the fifth sample (176) to the seventh (143) is 33 clocks or 16 clocks + 17 clocks as expected.

If the possibility of incorrect I2C data reads can't be accommodated for by external software checks, one can guarantee proper operation by stopping the CNT/DLY block's clock during I2C reads

through one of the following methods: by disabling the oscillator block, by reconfiguring the CNT/DLY block's clock source, or by gating an external clock using a LUT (Look-up Table) in the signal matrix. After disabling the CNT/DLY block's clock, the count registers can be read without error. Please note that this workaround will add the I2C read and processing time to the counter's overall clock period.

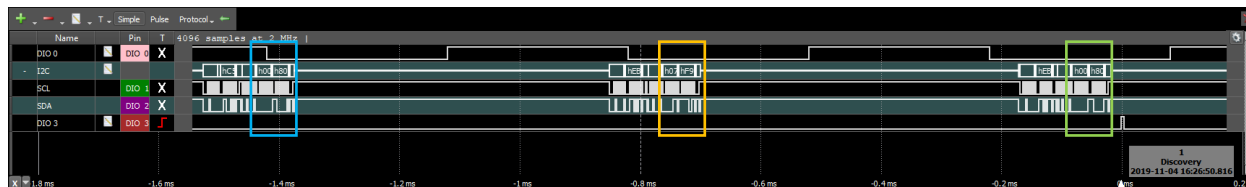
Figure 12: Counter Behavior

For the following condition, the Counter Data register contents are unexpectedly loaded into the counter’s DFF chain. This behavior occurs when there is a falling edge on the counter block’s clock input during the data return portion of an I2C read of the Counter Data registers. Figure 10 shows this falling edge boxed in light blue followed by two I2C reads of the Current Count Value registers.

As you can see by the MCU data log below, the Current Count Value gradually increases from 0xF904 to 0xF907 but is unexpectedly reset to 0x8000. Please note that the colored HEX values in the MCU Log correspond to the boxed I2C read commands shown in the waveform above. As previously described, this reset occurs because there is a falling edge on the counter’s clock input while the GreenPAK device is responding to an I2C read request to 0xC5 and 0xC6. (Note that 0xC5/0xC6 are the Counter Data registers and 0xEB/0xEC are the Current Count Value registers for CNT0.)

The reason that the counter isn’t set to 0x8000 on the I2C read immediately following the Counter Data query is because the counter requires two rising edges on its clock input to load the data from the Counter Data registers into the DFF chain. Note that all rising edges during  $T_{stop}$  will be gated internally by the “Stop and Restart” feature.

For systems that require I2C write access to the Counter Data registers while the counter is clocking, enable the "Stop and Restart Bit." (Case 2)

I2C Read of Counter Data: Avoid reading Counter Data via I2C while the counter is being clocked.

Within the MCU, we recommend saving the Counter Data register configuration as a software variable so that the Counter Data register doesn't need to be read during counter operation.

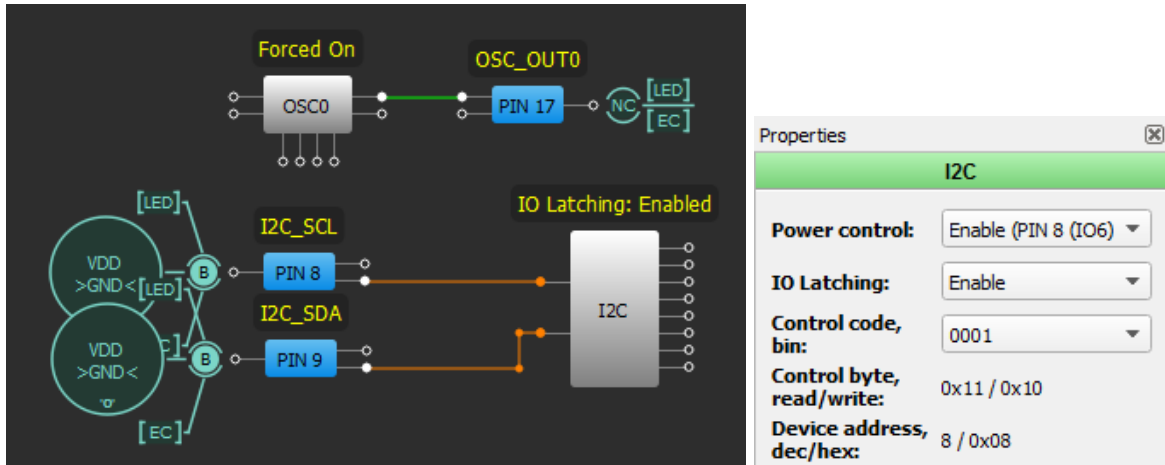
Figure 11

The GreenPAK device does not check for a matching I2C Slave address condition before triggering 'IO Latching'. A Start bit on the I2C bus will trigger IO Latching. A Start bit is when I2C\_SDA goes low first followed by I2C\_SCL going low after.

In the example below, we will be monitoring the OSC output, which is measured by a scope on Channel 3 via PIN17 ("OSC\_OUT0"). The I2C bus will be forced low to create a START bit.

Disable IO Latching in programmed OTP. This register is I2C-write locked during normal operation and therefore should be disabled in configuration file.  
Do not share I2C bus with other devices and make sure the I2C bus is not powered down while the GreenPAK is still powered through VDD.

If the above cannot be satisfied, then consider using the SLG4658x devices, where this errata has been fixed.

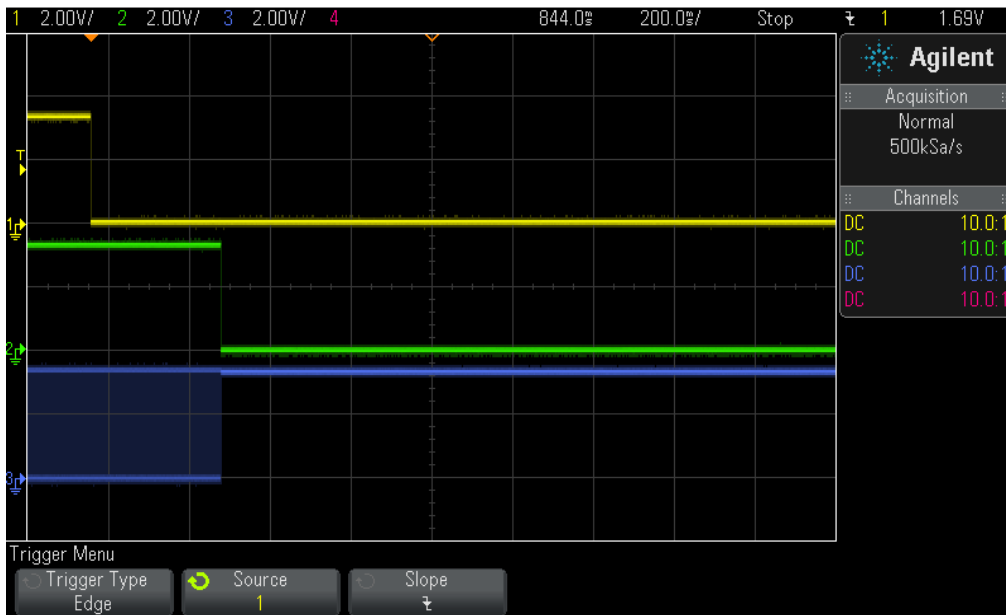
Figure 12

By toggling I2C\_SDA low and then I2C\_SCL low, the GreenPAK registers this as a start bit and latches all General Purpose Outputs such as PIN#17(“OSC\_OUT0”). In the Figure 12, notice that PIN#17 (OSC\_OUT0) stops toggling.
