## SLG4653x Errata

### CE-GP-002

*This document contains the known errata for SLG46533, SLG46534, SLG46535, SLG46536, SLG46537, SLG46538 and the recommended workarounds.*

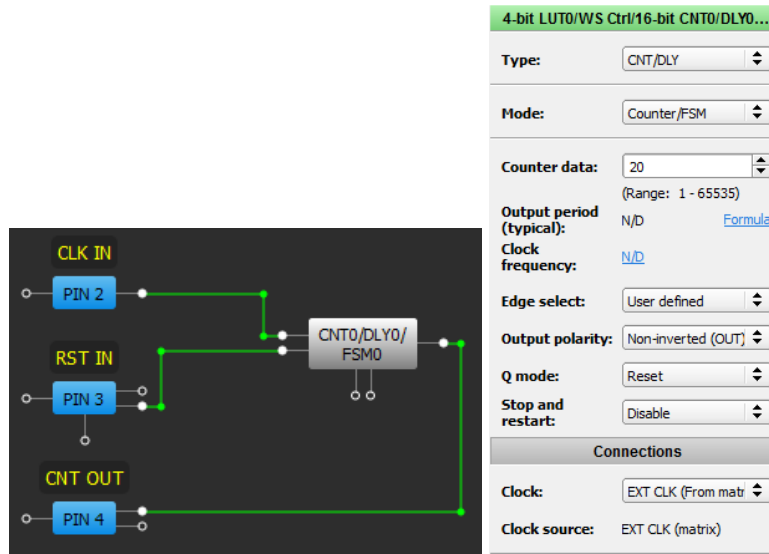
Figure 1

If the Counter Reset is asserted at the same time as a rising clock edge, it is possible that the Counter Data will be reset incorrectly and the counter output may appear faster than expected. This phenomenon appears more often as the clock frequency increases.

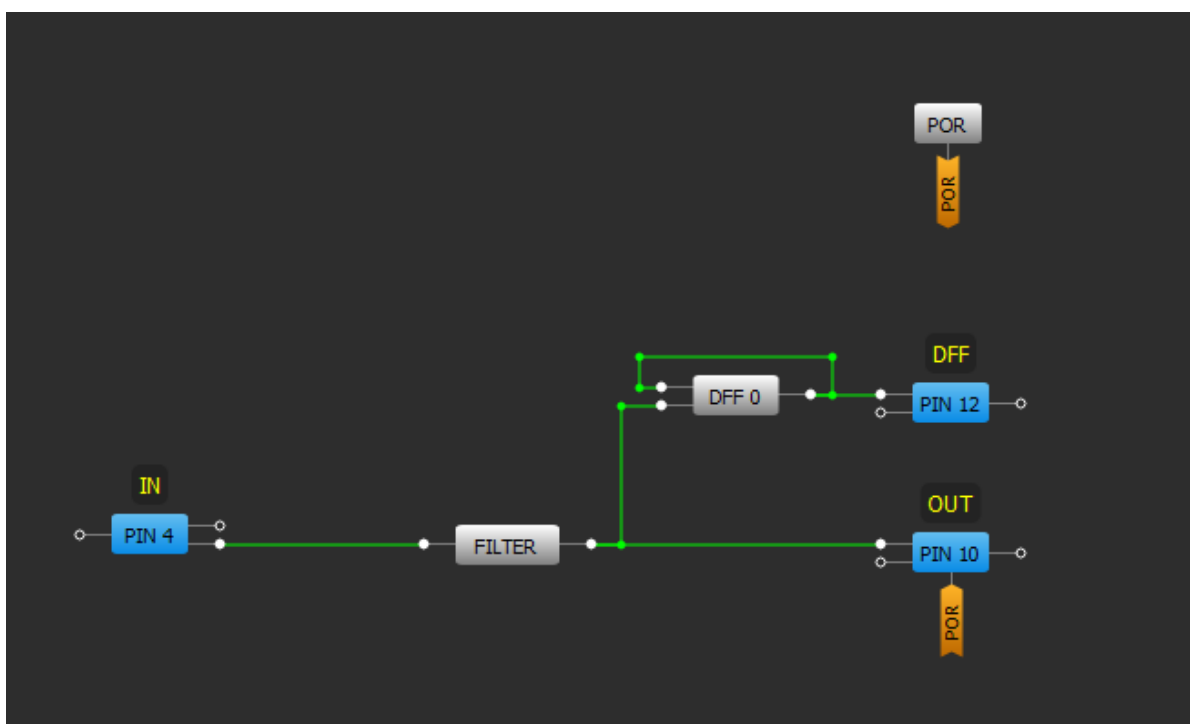
Figure 4

If clock type high frequency input comes in, the FILTER cell may not filter out it. There are several factors like input frequency, duty cycle, and LOW duration in such signal that may lead to its passing through FILTER block.

Currently there is no workaround for this issue. Filter block is good at filtering short spontaneous glitches. It is intended to be used in series connection before the delay cell to avoid its latching.

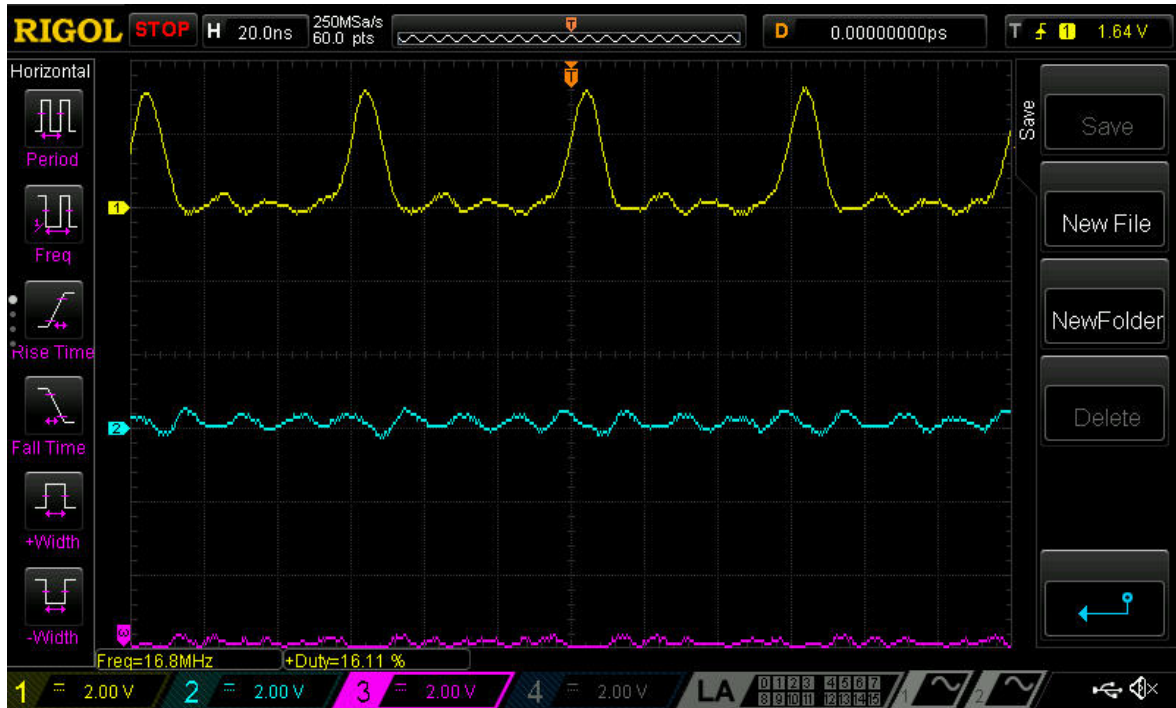
Figure 5

- 1. Period is 60 ns. Pulse width is 10 ns, DC = 16.7 % (correct functionality).

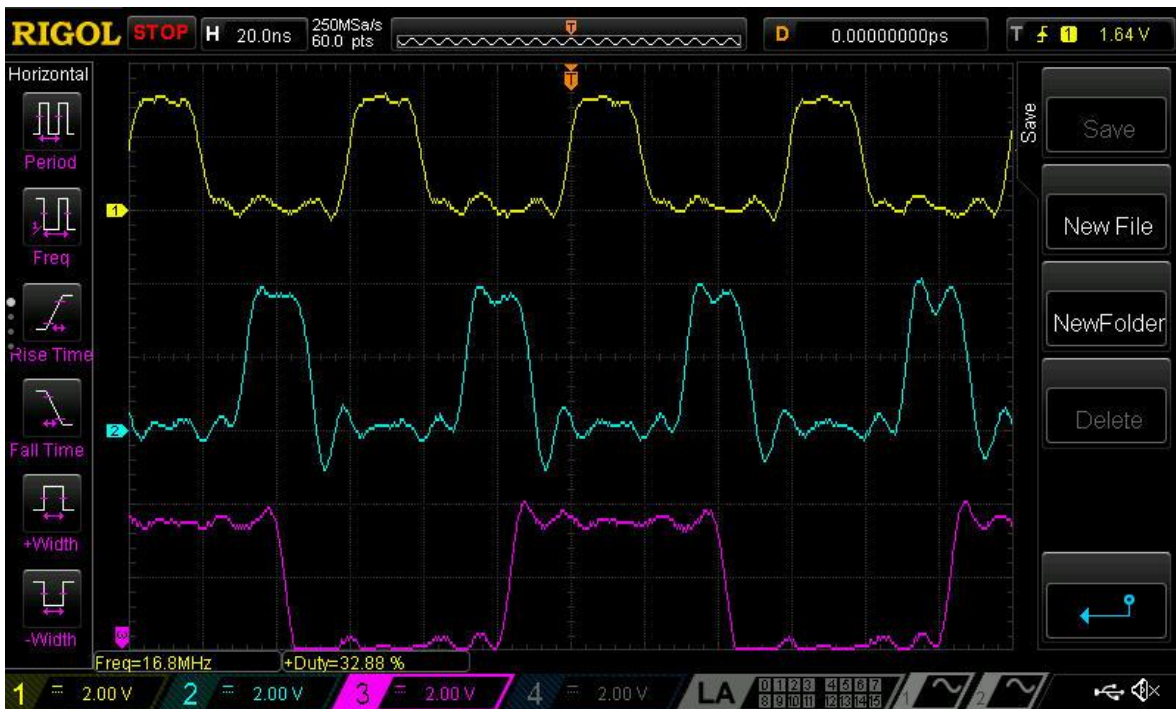
Figure 6

- 2. Period is 60 ns. Pulse width is 20 ns, DC = 33.3 % (incorrect functionality).

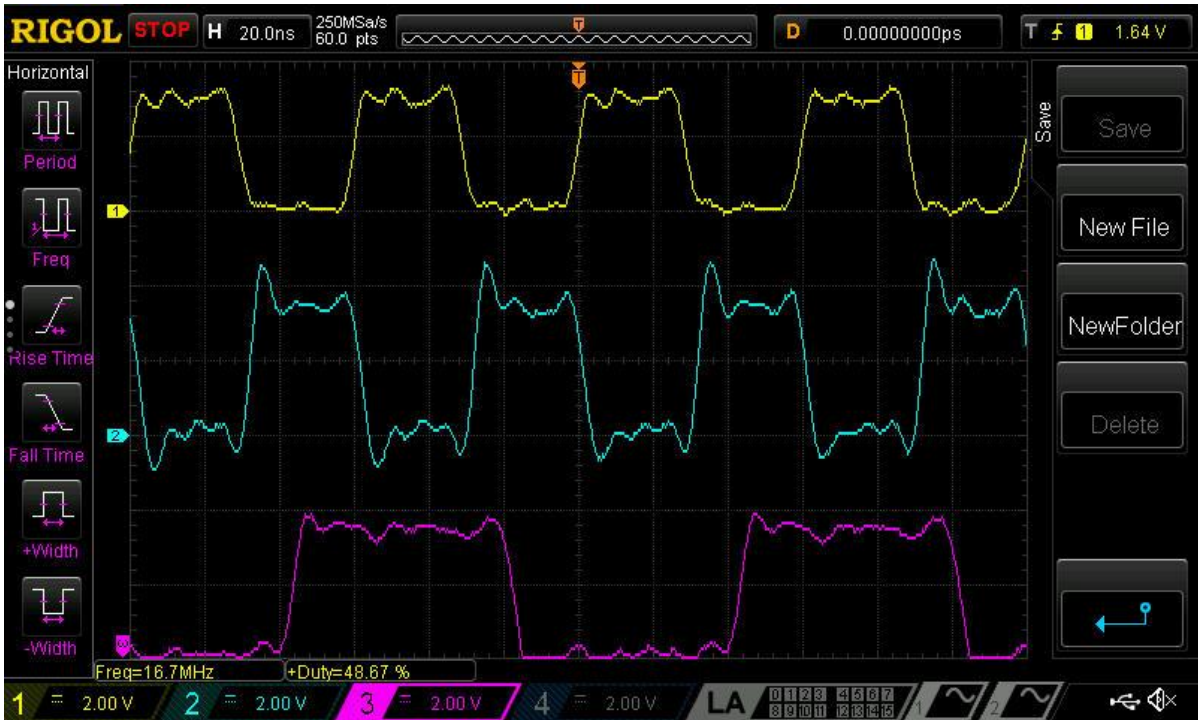
Figure 7

3. Period is 60 ns. Pulse width is 30 ns, DC = 50 % (incorrect functionality).

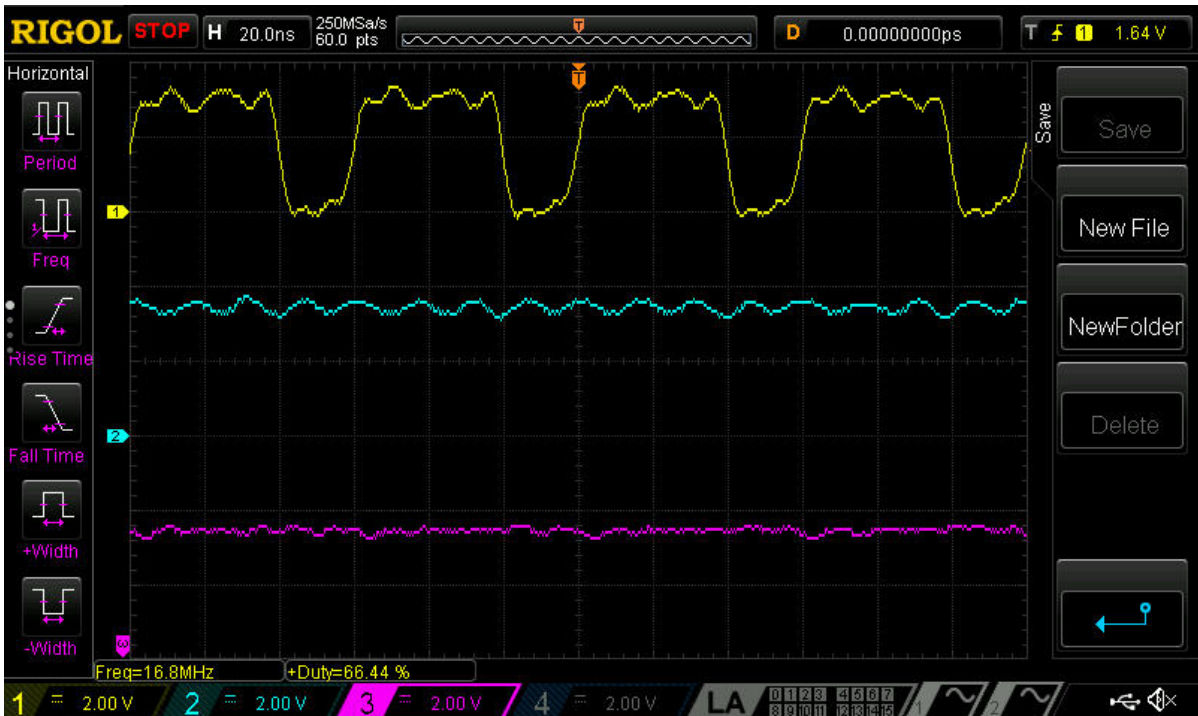
Figure 8

4. Period is 60 ns. Pulse width is 40 ns, DC = 66.67 % (correct functionality).

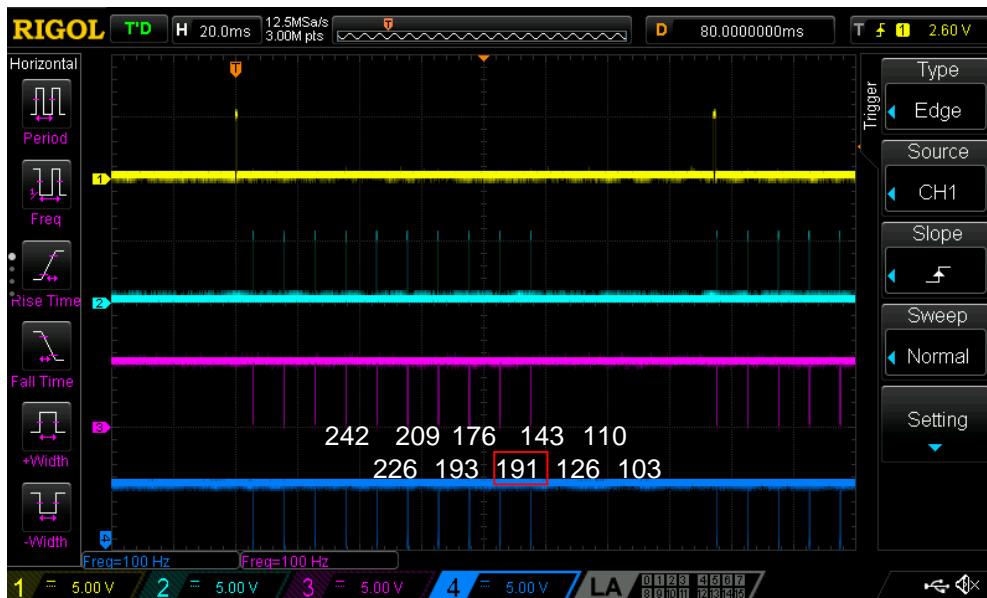
Figure 9

Asynchronous interaction between the CNT/DLY clock input and the I2C latch signal (generated by an I2C read command of the CNT/DLY block's count value) can result in an incorrect I2C data read. The CNT/DLY block will count accurately, but the count value transferred into the block's I2C read register might be loaded incompletely if the I2C latch signal and the clock input occur at about the same time.

The example data capture below shows ten periodic I2C reads of CNT2/DLY2 configured to count down at about 16 clocks per read. The sixth read sample erroneously shows a value greater than that of the fifth. The seventh sample reads as if the previous I2C error never occurred - the difference from the fifth sample (176) to the seventh (143) is 33 clocks or 16 clocks + 17 clocks as expected.

If the possibility of incorrect I2C data reads can't be accommodated for by external software checks, one can guarantee proper operation by stopping the CNT/DLY block's clock during I2C reads through one of the following methods: by disabling the oscillator block, by reconfiguring the CNT/DLY block's clock source, or by gating an external clock using a LUT (Look-up Table) in the signal matrix. After disabling the CNT/DLY block's clock, the count registers can be read without error. Please note that this workaround will add the I2C read and processing time to the counter's overall clock period.

The best workaround depends on the resource constraints of the application. If the oscillator block doesn't clock other logic elements within the design, a matrix output can be used to manually power down the oscillators for the I2C read. When the CNT/DLY block's clock source is routed internally from the oscillator block, I2C commands can temporarily reconfigure the CNT/DLY block's clock source registers to select "Ext. CLK. (From Matrix)." This action will disable the clock by connecting it to ground. If the CNT/DLY block is clocked from the signal matrix, a LUT can be used to gate the clock during an I2C read.

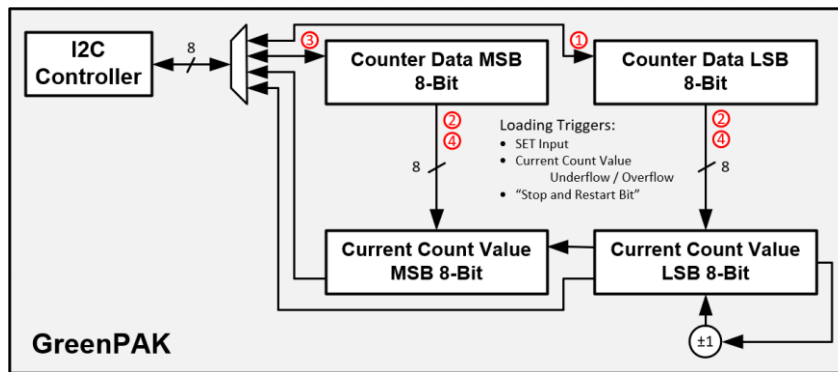
Figure 11: 16-Bit I2C Counter Block Diagram

This behavior results in two output pulses on OUT when only one pulse is expected. Observing this behavior depends upon the asynchronous timing between the counter’s clock and the I2C write command to the Counter Data registers. For some applications, the extra pulse on OUT can be ignored and the counter will self-correct after underflowing, overflowing, or being SET/RESET through the GreenPAK connection matrix.

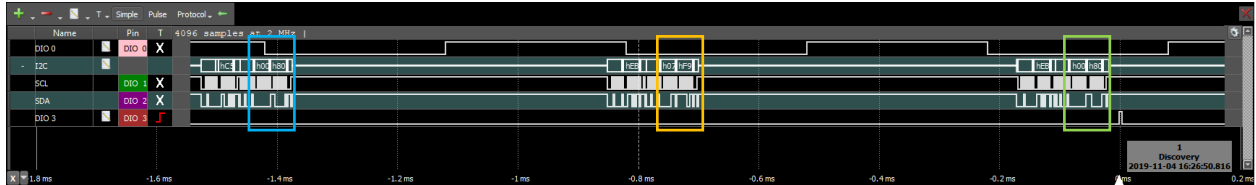
Figure 12: Counter Behavior

For the following condition, the Counter Data register contents are unexpectedly loaded into the counter's DFF chain. This behavior occurs when there is a falling edge on the counter block's clock input during the data return portion of an I2C read of the Counter Data registers. Figure 12 shows this falling edge boxed in light blue followed by two I2C reads of the Current Count Value registers.

As you can see by the MCU data log below, the Current Count Value gradually increases from 0xF904 to 0xF907 but is unexpectedly reset to 0x8000. Please note that the colored HEX values in the MCU Log correspond to the boxed I2C read commands shown in the waveform above. As previously described, this reset occurs because there is a falling edge on the counter's clock input while the GreenPAK device is responding to an I2C read request to 0xC5 and 0xC6. (Note that 0xC5/0xC6 are the Counter Data registers and 0xEB/0xEC are the Current Count Value registers for CNT0.)

The reason that the counter isn't set to 0x8000 on the I2C read immediately following the Counter Data query is because the counter requires two rising edges on its clock input to load the data from the Counter Data registers into the DFF chain. Note that all rising edges during Tstop will be gated internally by the "Stop and Restart" feature.

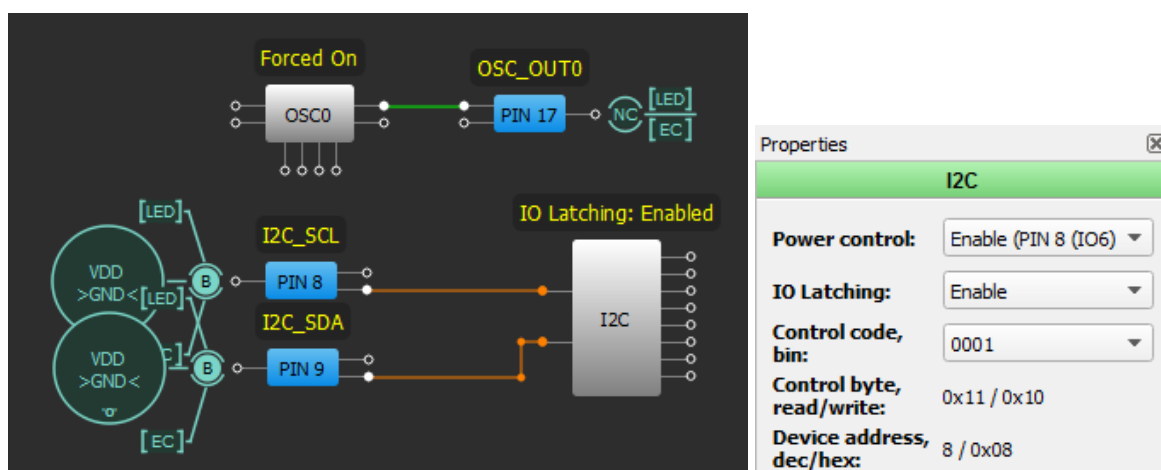
Figure 13

The GreenPAK device does not check for a matching I2C Slave address condition before triggering ‘IO Latching’. A Start bit on the I2C bus will trigger IO Latching. A Start bit is when I2C\_SDA goes low first followed by I2C\_SCL going low after.

In the example below, we will be monitoring the OSC output, which is measured by a scope on Channel 3 via PIN17 (“OSC\_OUT0”). The I2C bus will be forced low to create a START bit.

Disable IO Latching in programmed OTP. This register is I2C-write locked during normal operation and therefore should be disabled in configuration file.

Do not share I2C bus with other devices and make sure the I2C bus is not powered down while the GreenPAK is still powered through VDD.

If the above cannot be satisfied, then consider using the SLG4658x devices, where this errata has been fixed.

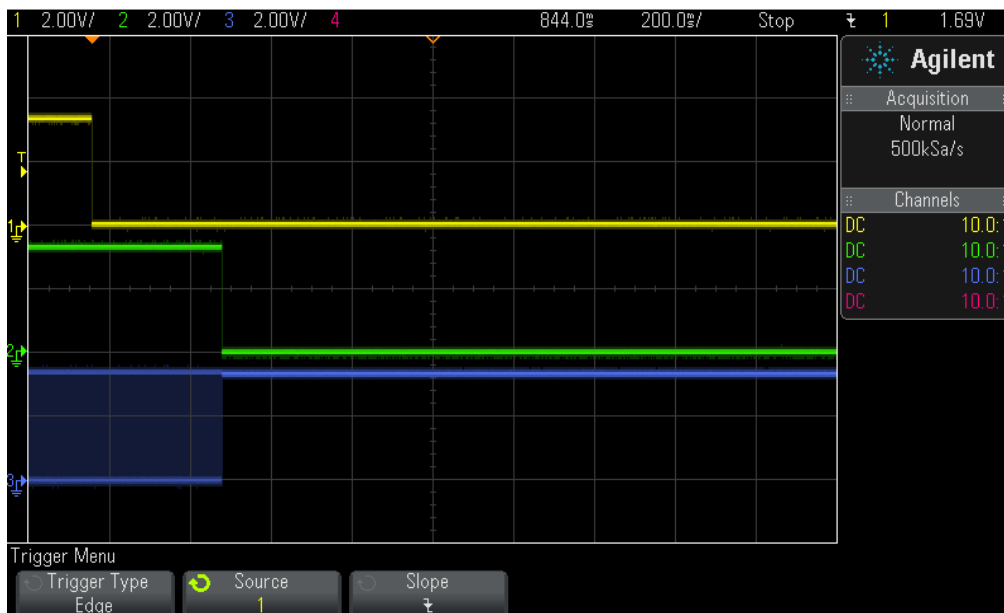
Figure 14

By toggling I2C\_SDA low and then I2C\_SCL low, the GreenPAK registers this as a start bit and latches all General Purpose Outputs such as PIN#17 (“OSC\_OUT0”). In the [Figure 14](#), notice that PIN#17 (OSC\_OUT0) stops toggling.

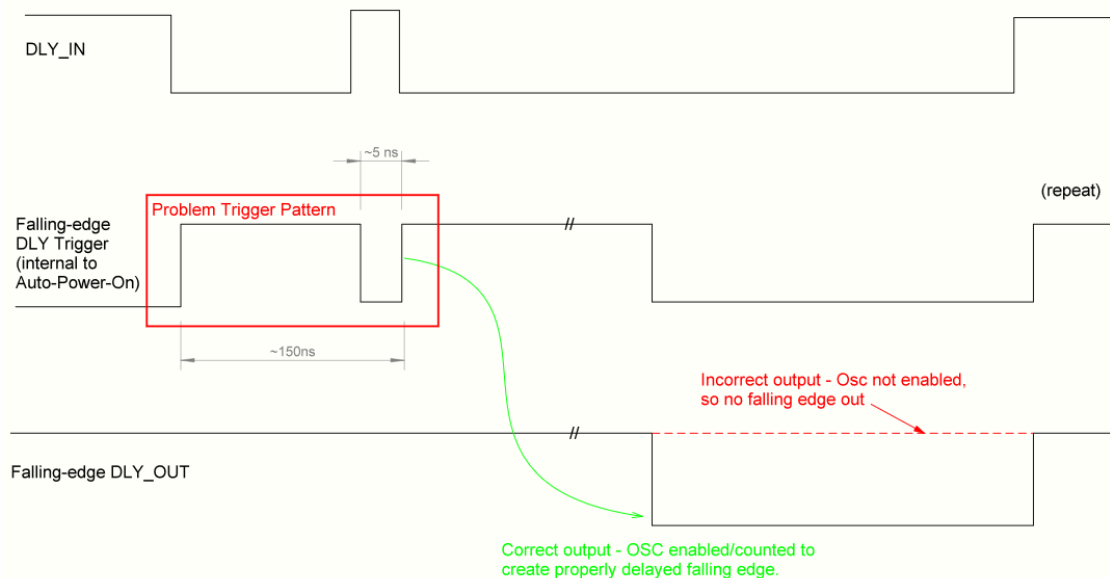
**Figure 15: Problem Trigger Pattern**

For this chip, the Auto Power On circuitry of the 25 kHz/2 MHz generators contains a circuit errata, which can potentially fail to power on the OSC for a specific pattern and timing of the OR of all related DLY trigger signals. The pattern is shown in [Figure 15](#) (boxed in red) and consists of a relatively longer pulse (~145 ns) followed by a shorter (~5 ns) glitch of opposite polarity.

1. Use signal conditioning circuits to prevent glitch on DLY inputs < 200 ns. Examples:
  - a. ACMP with Hysteresis
  - b. External RC in front of Digital Input with Schmitt Trigger
  - c. Filter cell.
2. Set OSC power mode to Force Power On mode instead of Auto Power On.
3. Use different oscillator, such as 25 MHz Ring OSC, which does not have Auto Power On issue.

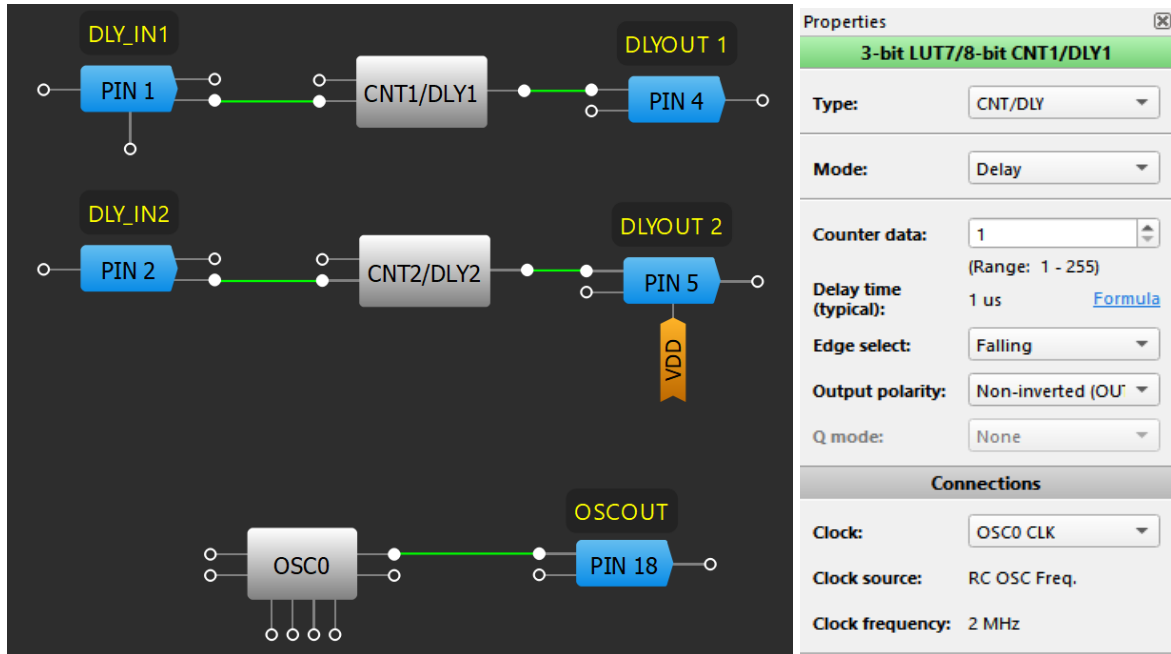
Figure 16: Test Circuit

The error is difficult to capture as the timing must be exact within ns, and short (ns) pulses are difficult to generate glitch precise enough to induce the problem. GPIO naturally filter out ns pulses, so for purposes of errata capture, two simultaneous falling-edge DLY circuits (as shown in [Figure 16](#)) were used. By lining up two delays precisely at a particular timing relationship, we can use the internal Auto Power On (OR logic) to generate the glitch pattern necessary to cause the error.

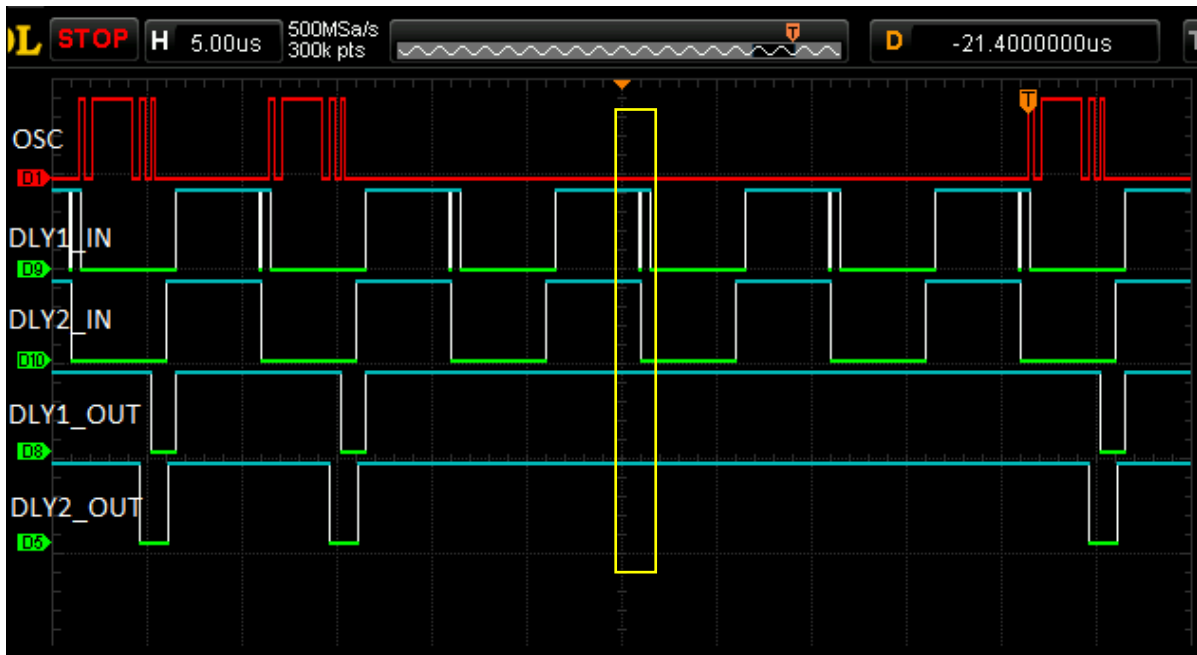
Figure 17: Errata Capture (Zoom Out)

Figure 17 shows a series of DLY output events are missing, where the OSC is correspondingly not triggering when it was supposed to. Figure 18 is a zoom in of the boxed region from Figure 17. The total glitch/chatter time was measured in this case at 152 ns. By using the composite OR of the two delay channels, we can asynchronously strobe with tiny frequency variations, and so tune the timing to induce this errata. Note that the error is not persistent – the system is recovered when all DLYs are returned to inactive state, such as when input of falling edge DLY goes high, thus canceling delay, or after DLY out finishes.
