# Errata

## SLG4653x Errata

### CE-GP-002

*This document contains the known errata for SLG46533, SLG46534, SLG46535, SLG46536, SLG46537, SLG46538 and the recommended workarounds.*

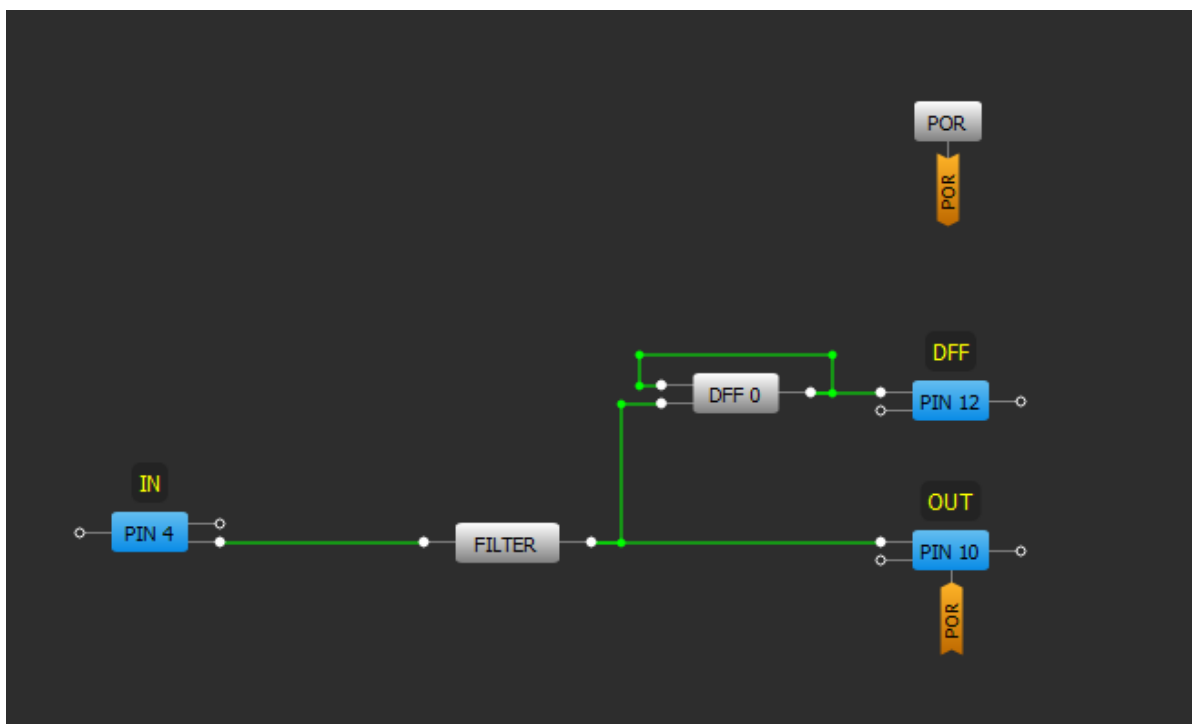
Figure 4

If clock type high frequency input comes in, the FILTER cell may not filter out it. There are several factors like input frequency, duty cycle, and LOW duration in such signal that may lead to its passing through FILTER block.

Channel 1 (yellow/top line) – PIN#4 (IN).

Channel 2 (light blue/2nd line) – PIN#10 (OUT).

Channel 3 (magenta /3rd line) – PIN#12 (DFF).

Currently there is no workaround for this issue. Filter block is good at filtering short spontaneous glitches. It is intended to be used in series connection before the delay cell to avoid its latching.

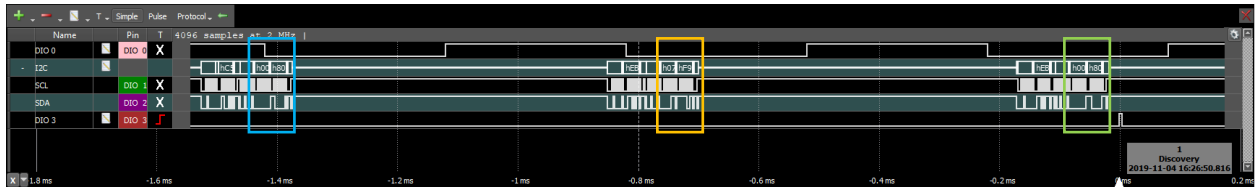
Figure 12: Counter Behavior

For the following condition, the Counter Data register contents are unexpectedly loaded into the counter's DFF chain. This behavior occurs when there is a falling edge on the counter block's clock input during the data return portion of an I2C read of the Counter Data registers. Figure 12 shows this falling edge boxed in light blue followed by two I2C reads of the Current Count Value registers.

DIO0 – External Clock for Counter Block.

DIO3 – MCU trigger for Scope Capture.

As you can see by the MCU data log below, the Current Count Value gradually increases from 0xF904 to 0xF907 but is unexpectedly reset to 0x8000. Please note that the colored HEX values in the MCU Log correspond to the boxed I2C read commands shown in the waveform above. As previously described, this reset occurs because there is a falling edge on the counter's clock input while the GreenPAK device is responding to an I2C read request to 0xC5 and 0xC6. (Note that 0xC5/0xC6 are the Counter Data registers and 0xEB/0xEC are the Current Count Value registers for CNT0.)

The reason that the counter isn't set to 0x8000 on the I2C read immediately following the Counter Data query is because the counter requires two rising edges on its clock input to load the data from the Counter Data registers into the DFF chain. Note that all rising edges during Tstop will be gated internally by the "Stop and Restart" feature.

For systems that require I2C write access to the Counter Data registers while the counter is clocking, enable the "Stop and Restart Bit." (Case 2)

I2C Read of Counter Data: Avoid reading Counter Data via I2C while the counter is being clocked.

Within the MCU, we recommend saving the Counter Data register configuration as a software variable so that the Counter Data register does not need to be read during counter operation.
