## SLG46580

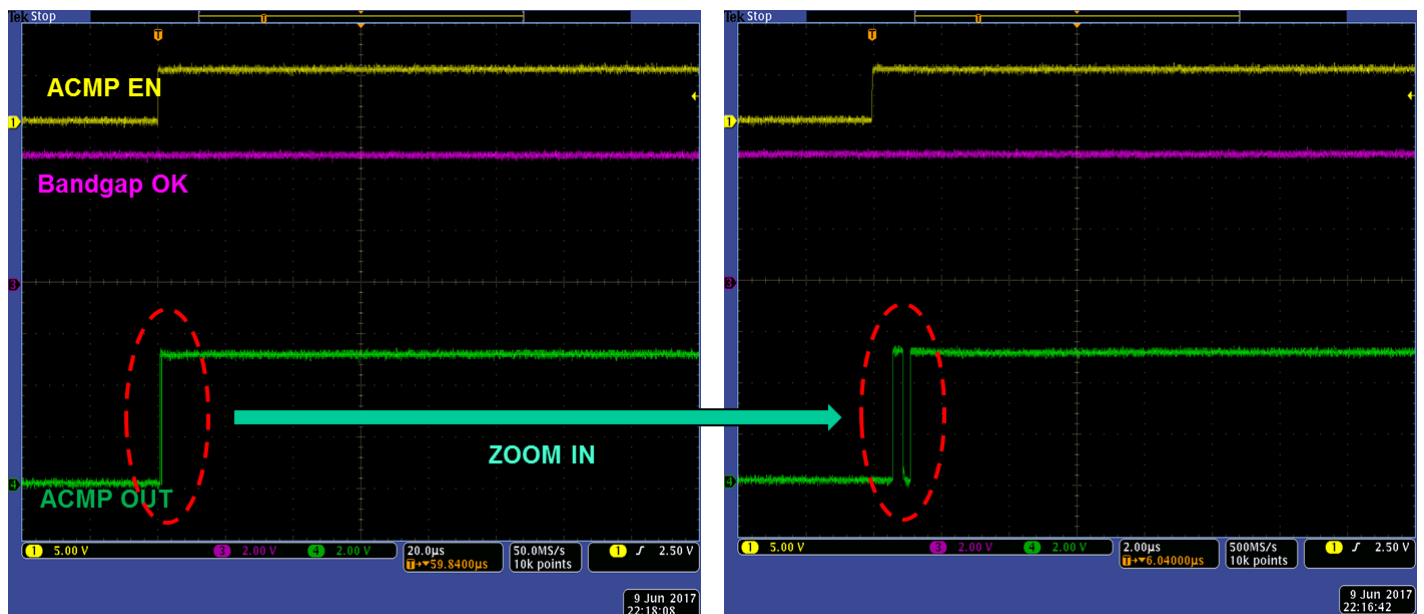
After power-up, if LDO is enabled earlier than ACMP, its output may generate a glitch.

VDD = 5.0 V, ACMP IN+ > IN-, one of LDOs enabled.

Because BG\_OK is already released by LDO, there is no gating signal. Depending on the ACMP VREF condition & the positive input value, it is possible for the ACMP to have a glitch. Subsequently, the other ACMP will not have an issue unless the customer repeats LDO enable first and ACMP later during power stable.

- Use both edge delay on the output to filter out the glitch.

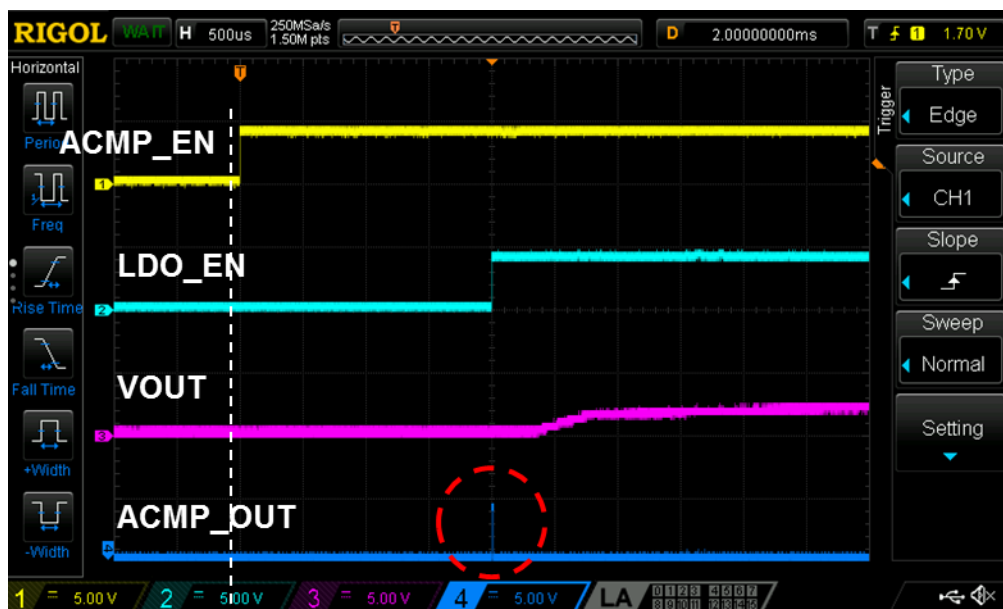
If an LDO's Low Power Mode is selected (for example tied to VDD) a glitch may appear on the ACMP's output after the first LDO is enabled. When the first LDO is turned on, the Low Power Mode switch causes a drop in the internal bandgap voltage that is used to derive the ACMP reference voltages.

- Use both edge delay on the output to filter out the glitch.
- Use some logic to avoid turning on Low Power Mode before enabling LDO and powering up the ACMP. Example is shown below.

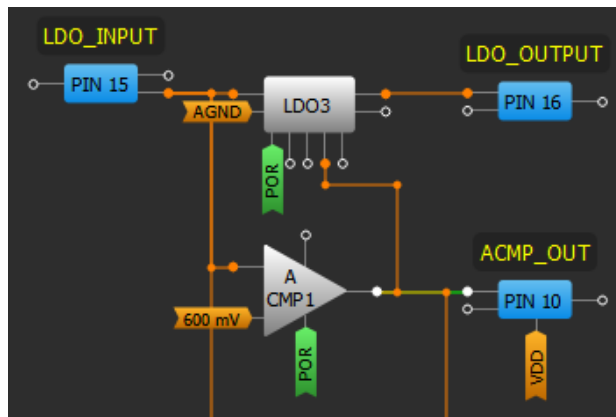
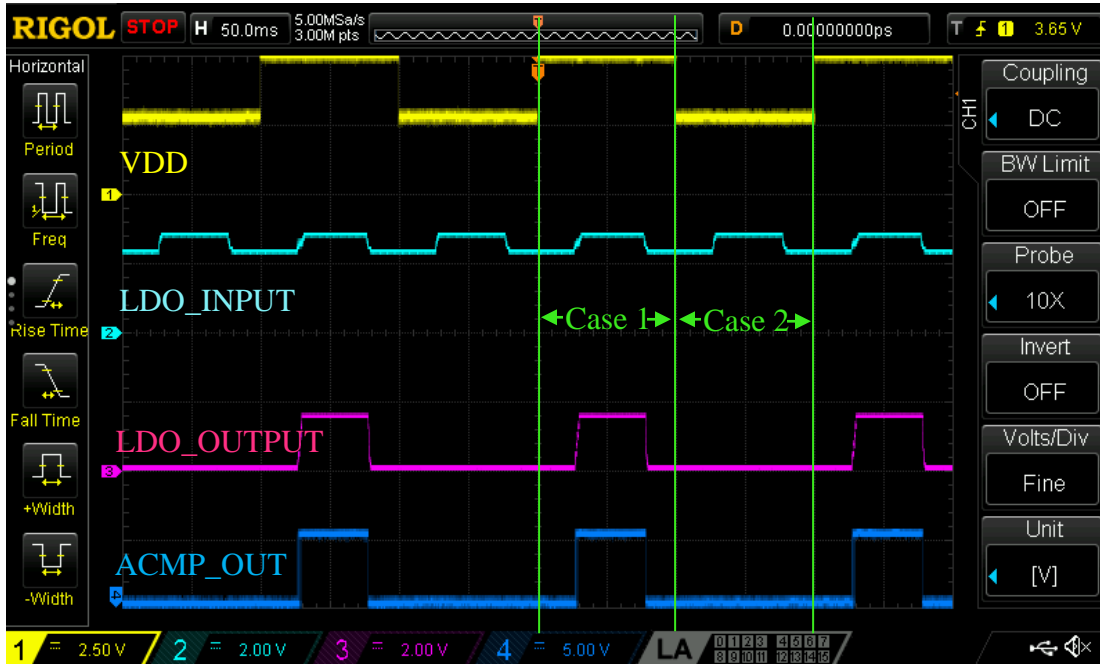
If an LDO's VIN pin (LDO\_INPUT) has an internal connection (depicted with an orange wire) to the ACMP's IN+ port, the ACMP's output may give an erroneous result with respect to the LDO's input voltage. The switch between the LDO's VIN pin and the ACMP's IN+ port is implemented using an NMOS-only based transmission gate with its gate controlled by logic supplied from VDD. As a result, this switch is unable to pass LDO input voltages that are close to VDD. This can result in the ACMP's IN+ port seeing a lower voltage than the actual voltage present at LDO\_INPUT. This lower input voltage may cause the output of the ACMP to behave unexpectedly.

If the LDO's UVLO feature is enabled, the ACMP's output will cause unexpected LDO behavior that results from the previously described transmission gate voltage drop.

Case 1: proper behavior at VDD = 5 V.

With a 5 V VDD, the NMOS transmission gate passes the 2.25 and 2.75 V LDO\_INPUT pin voltages to the ACMP's IN+ port. When the input voltage exceeds the 2.4 V IN- threshold of the ACMP, the LDO is enabled.

Case 2: erroneous behavior at VDD = 2.75 V.

When the VDD is reduced to 2.75 V, the NMOS transmission gate is unable to pass LDO\_INPUT's full magnitude to the ACMP's IN+ port. Since the IN+ port of the ACMP doesn't exceed the 2.4 V IN- threshold, the ACMP's output stays low and keeps the LDO disabled.

- If the GreenPAK's VDD is always powered up before the LDO's VIN input, you can externally short the LDO's VIN to another dedicated analog input pin for the desired ACMP.

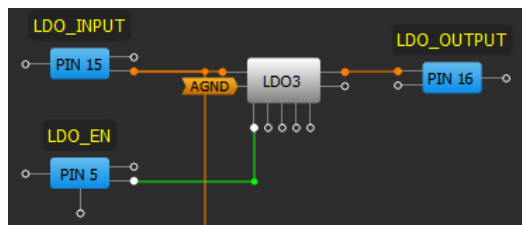
When a GreenPAK's first LDO is enabled, the LDO's VOUT will step to a non-zero voltage during its 500  $\mu$ s wait time. The magnitude of this step is directly proportional to the LDO's VIN and the GreenPAK's VDD. With a large LDO input voltage and VDD, this step can exceed 500 mV.

VDD = 5.5 V, LDO\_INPUT = 5.5 V, all other LDOs disabled.

- If your GreenPAK design has an unused LDO, you can reduce the magnitude of this voltage step by keeping an unused LDO enabled in high power mode.

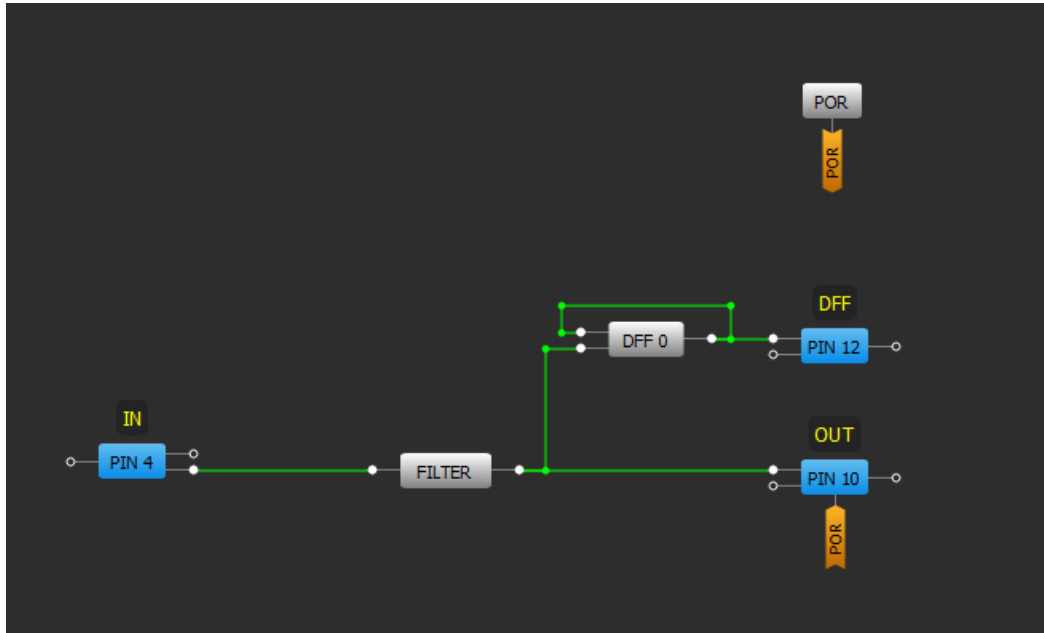
If the FILTER cell's input signal contains multiple consecutive pulses within short time intervals, the FILTER cell may not filter the input pulses as expected. The errant behavior applies only to repeated input pulses and depends on both their frequency and duty cycle.

Channel 1 (yellow/top line) – PIN#4 (IN).  
 Channel 2 (light blue/2nd line) – PIN#10 (OUT).  
 Channel 3 (magenta /3rd line) – PIN#12 (DFF).

Currently, there is no workaround for this issue. The FILTER block correctly filters isolated glitches, but it shouldn't be used to filter repetitive, high frequency input signals.

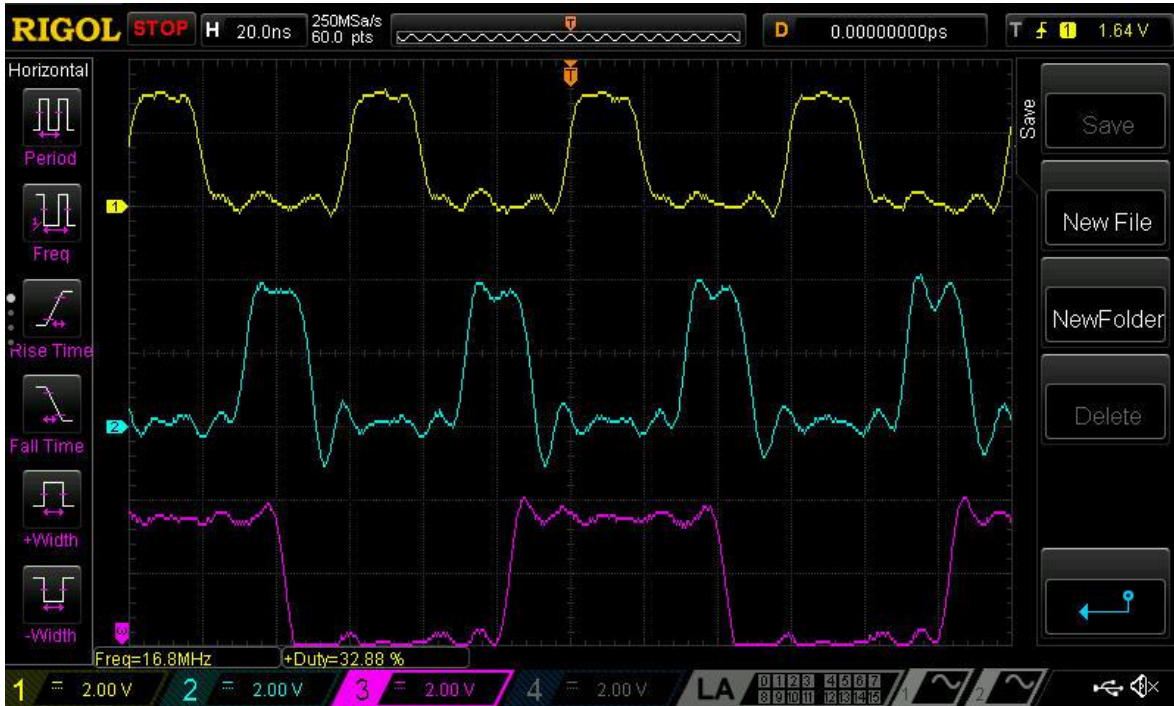
- Period is 60 ns. Pulse width is 20 ns, DC = 33.3 % (incorrect functionality).

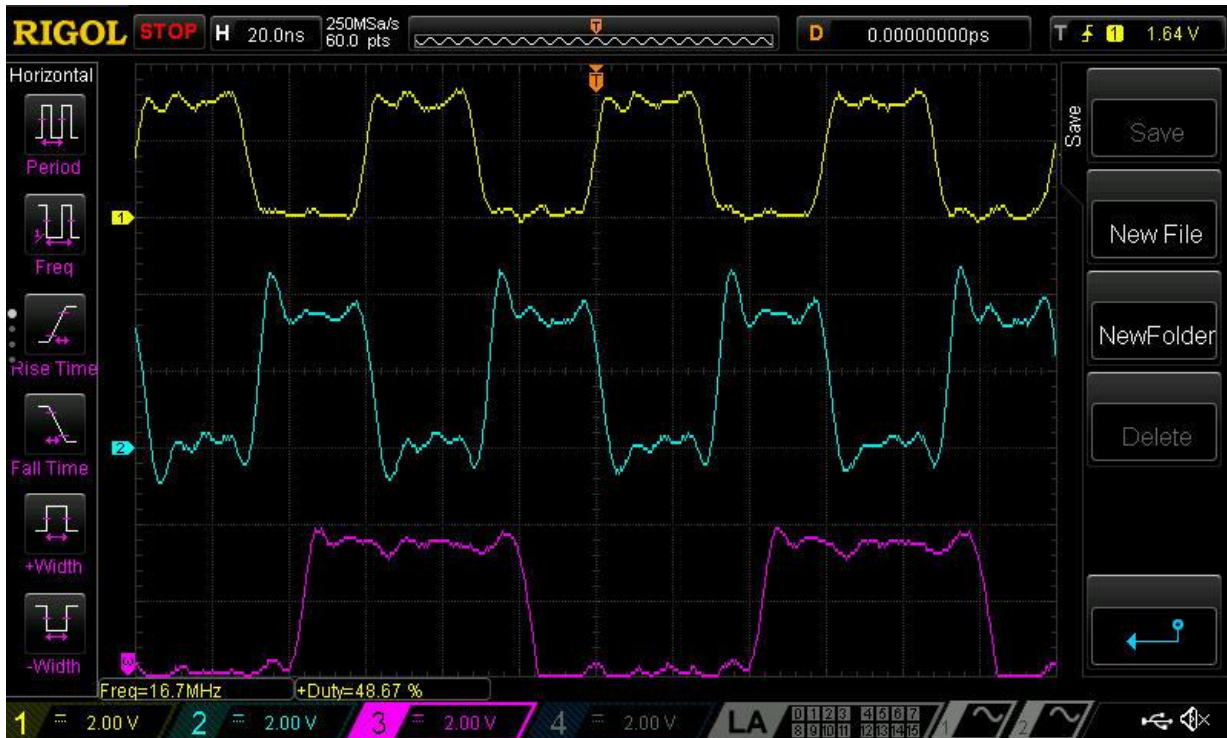
- Period is 60 ns. Pulse width is 30 ns, DC = 50 % (incorrect functionality).

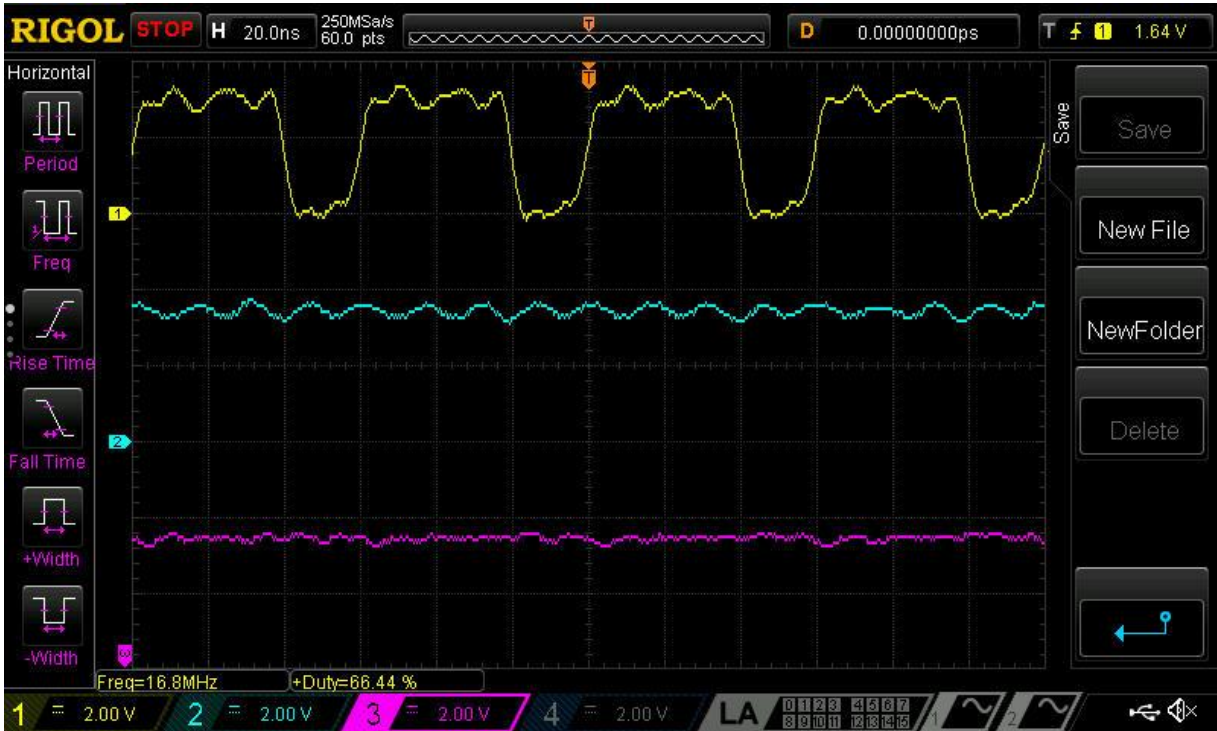
4. Period is 60 ns. Pulse width is 40 ns, DC = 66.67 % (correct functionality).

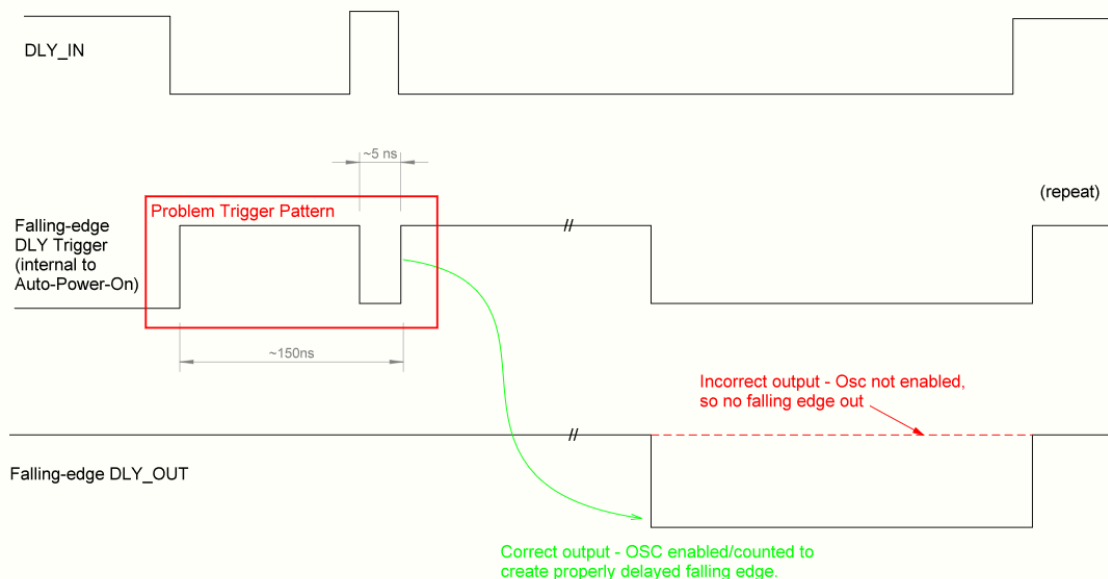
Figure 1: Problem Trigger Pattern

For this chip, the Auto Power On circuitry of the 25 kHz/2 MHz generators contains a circuit errata, which can potentially fail to power on the OSC for a specific pattern and timing of the OR of all related DLY trigger signals. The pattern is shown in [Figure 1](#) (boxed in red) and consists of a relatively longer pulse (~145 ns) followed by a shorter (~5 ns) glitch of opposite polarity.

1. Use signal conditioning circuits to prevent glitch on DLY inputs < 200 ns. Examples:
  - a. ACMP with Hysteresis
  - b. External RC in front of Digital Input with Schmitt Trigger
  - c. Filter cell.
2. Set OSC power mode to Force Power On mode instead of Auto Power On.

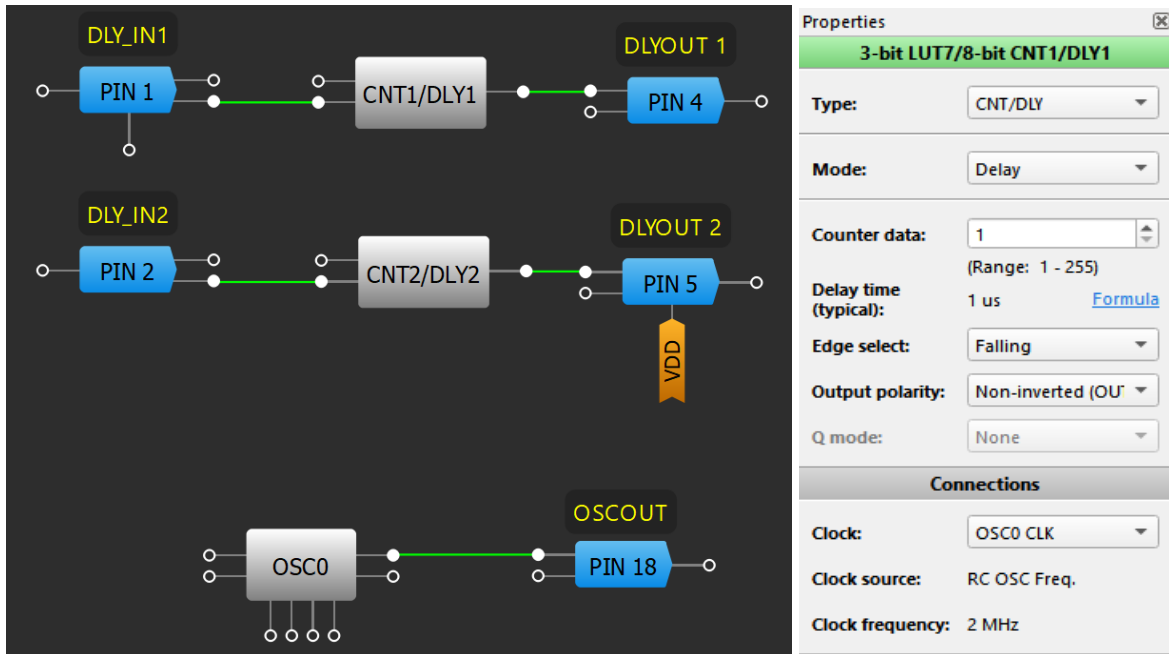
Figure 2: Test Circuit

The error is difficult to capture as the timing must be exact within ns, and short (ns) pulses are difficult to generate glitch precise enough to induce the problem. GPIO naturally filter out ns pulses, so for purposes of errata capture, two simultaneous falling-edge DLY circuits (as shown in Figure 2) were used. By lining up two delays precisely at a particular timing relationship, we can use the internal Auto Power On (OR logic) to generate the glitch pattern necessary to cause the error.

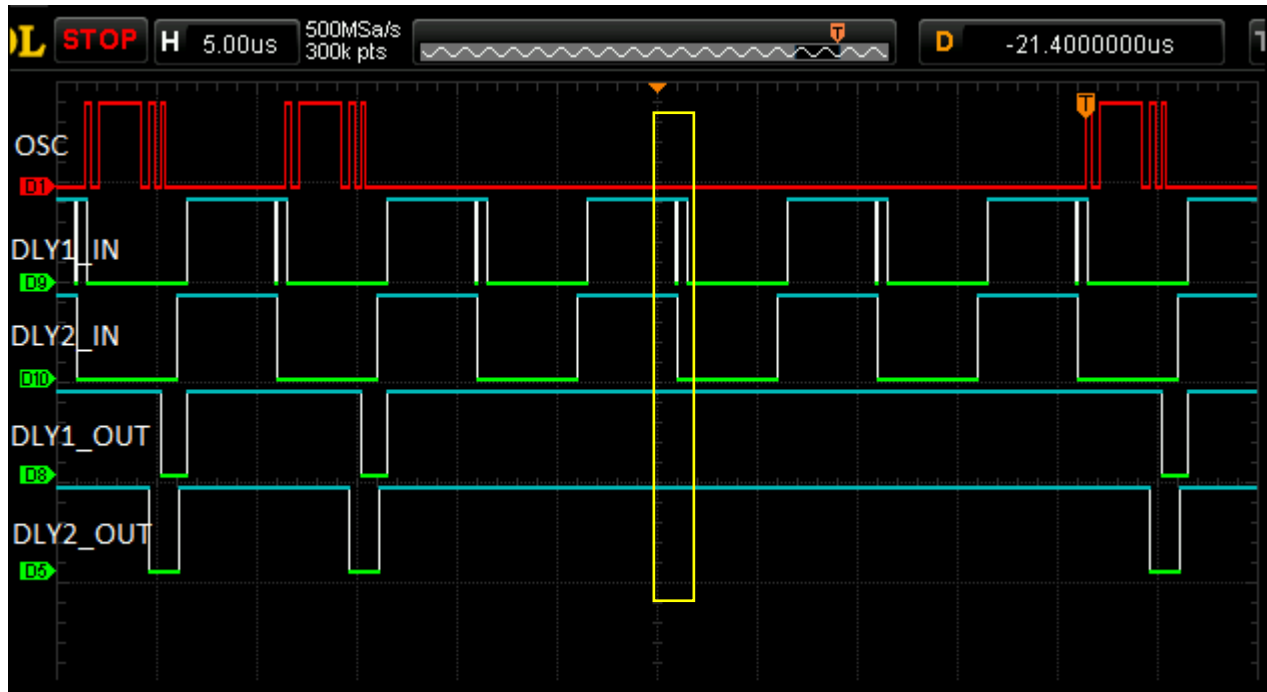
Figure 3: Errata Capture (Zoom Out)

Figure 3 shows a series of DLY output events are missing, where the OSC is correspondingly not triggering when it was supposed to. Figure 4 is a zoom in of the boxed region from Figure 3. The total glitch/chatter time was measured in this case at 152 ns. By using the composite OR of the two delay channels, we can asynchronously strobe with tiny frequency variations, and so tune the timing to induce this errata. Note that the error is not persistent – the system is recovered when all DLYs are returned to inactive state, such as when input of falling edge DLY goes high, thus canceling delay, or after DLY out finishes.
