## SLG46583

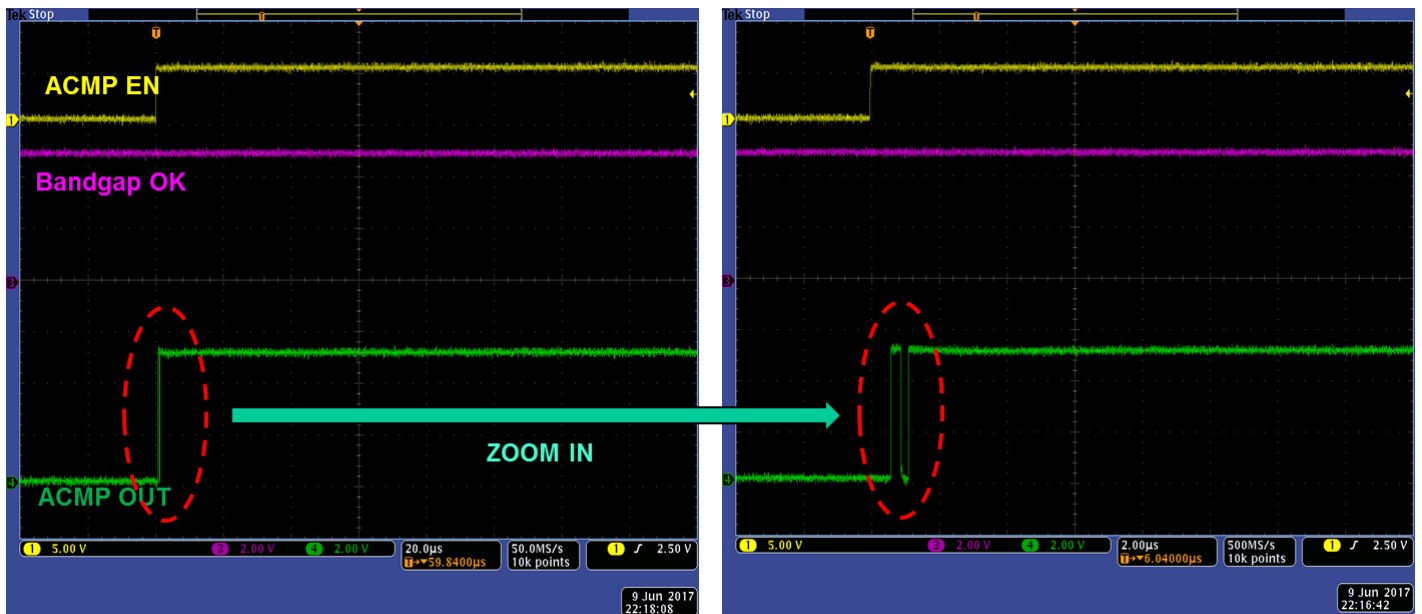
After power-up, if LDO is enabled earlier than ACMP, its output may generate a glitch.

VDD = 5.0 V, ACMP IN+ > IN-, one of LDOs enabled.

Because BG\_OK is already released by LDO, there is no gating signal. Depending on the ACMP VREF condition & the positive input value, it is possible for the ACMP to have a glitch. Subsequently, the other ACMP will not have an issue unless the customer repeats LDO enable first and ACMP later during power stable.

- Use both edge delay on the output to filter out the glitch.

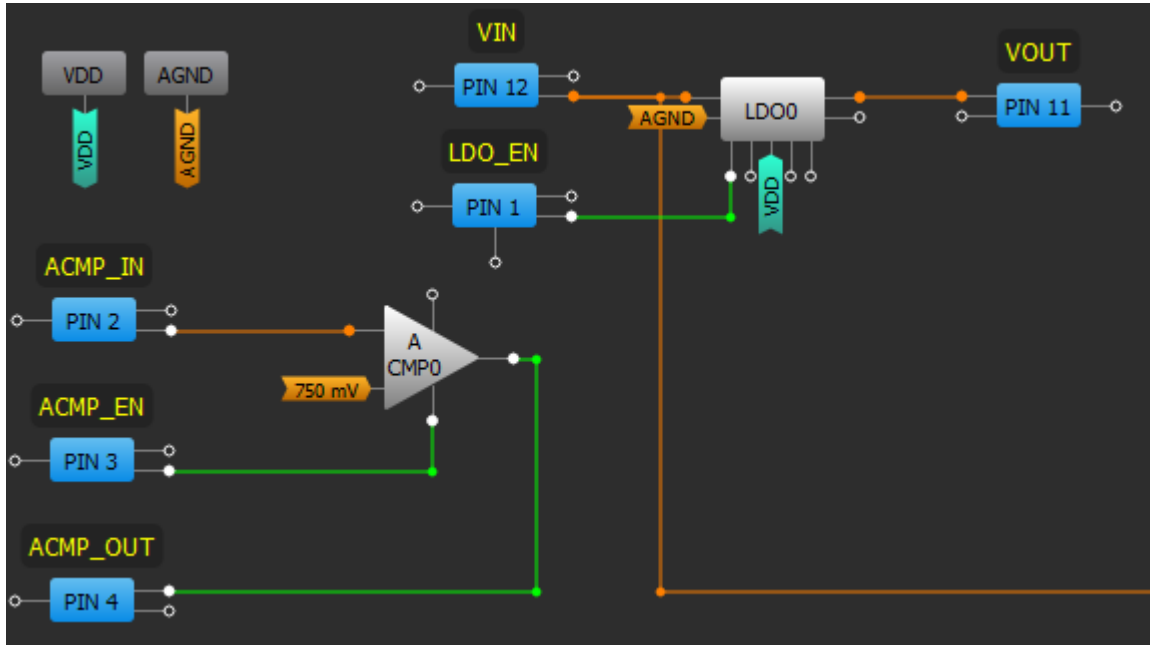
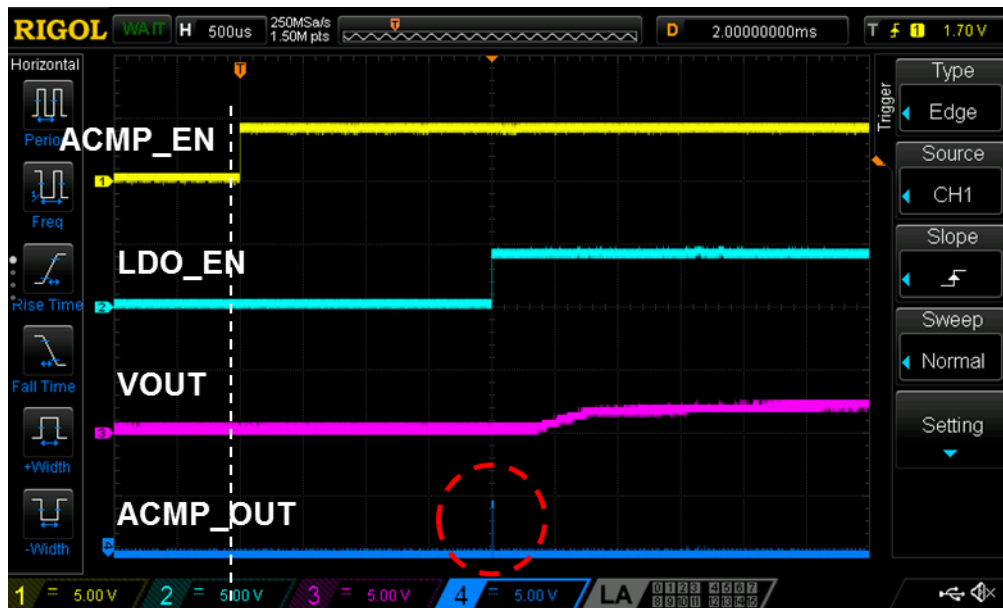
If an LDO's Low Power Mode is selected (for example tied to VDD) a glitch may appear on the ACMP's output after the first LDO is enabled. When the first LDO is turned on, the Low Power Mode switch causes a drop in the internal bandgap voltage that is used to derive the ACMP reference voltages.

- Use both edge delay on the output to filter out the glitch.
- Use some logic to avoid turning on Low Power Mode before enabling LDO and powering up the ACMP. Example is shown below.

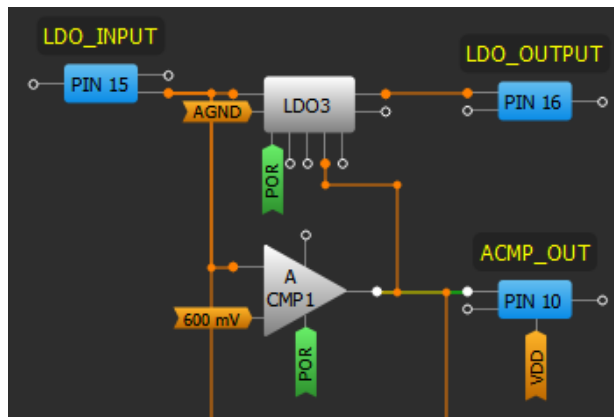
If an LDO's VIN pin (LDO\_INPUT) has an internal connection (depicted with an orange wire) to the ACMP's IN+ port, the ACMP's output may give an erroneous result with respect to the LDO's input voltage. The switch between the LDO's VIN pin and the ACMP's IN+ port is implemented using an NMOS-only based transmission gate with its gate controlled by logic supplied from VDD. As a result, this switch is unable to pass LDO input voltages that are close to VDD. This can result in the ACMP's IN+ port seeing a lower voltage than the actual voltage present at LDO\_INPUT. This lower input voltage may cause the output of the ACMP to behave unexpectedly.

If the LDO's UVLO feature is enabled, the ACMP's output will cause unexpected LDO behavior that results from the previously described transmission gate voltage drop.

Case 1: proper behavior at VDD = 5 V.

With a 5 V VDD, the NMOS transmission gate passes the 2.25 and 2.75 V LDO\_INPUT pin voltages to the ACMP's IN+ port. When the input voltage exceeds the 2.4 V IN- threshold of the ACMP, the LDO is enabled.

Case 2: erroneous behavior at VDD = 2.75 V.

When the VDD is reduced to 2.75 V, the NMOS transmission gate is unable to pass LDO\_INPUT's full magnitude to the ACMP's IN+ port. Since the IN+ port of the ACMP doesn't exceed the 2.4 V IN- threshold, the ACMP's output stays low and keeps the LDO disabled.

- If the GreenPAK's VDD is always powered up before the LDO's VIN input, you can externally short the LDO's VIN to another dedicated analog input pin for the desired ACMP.

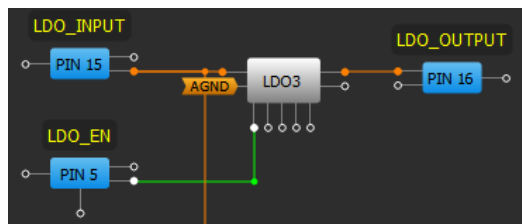
When a GreenPAK's first LDO is enabled, the LDO's VOUT will step to a non-zero voltage during its 500  $\mu$ s wait time. The magnitude of this step is directly proportional to the LDO's VIN and the GreenPAK's VDD. With a large LDO input voltage and VDD, this step can exceed 500 mV.

VDD = 5.5 V, LDO\_INPUT = 5.5 V, all other LDOs disabled.

- If your GreenPAK design has an unused LDO, you can reduce the magnitude of this voltage step by keeping an unused LDO enabled in high power mode.

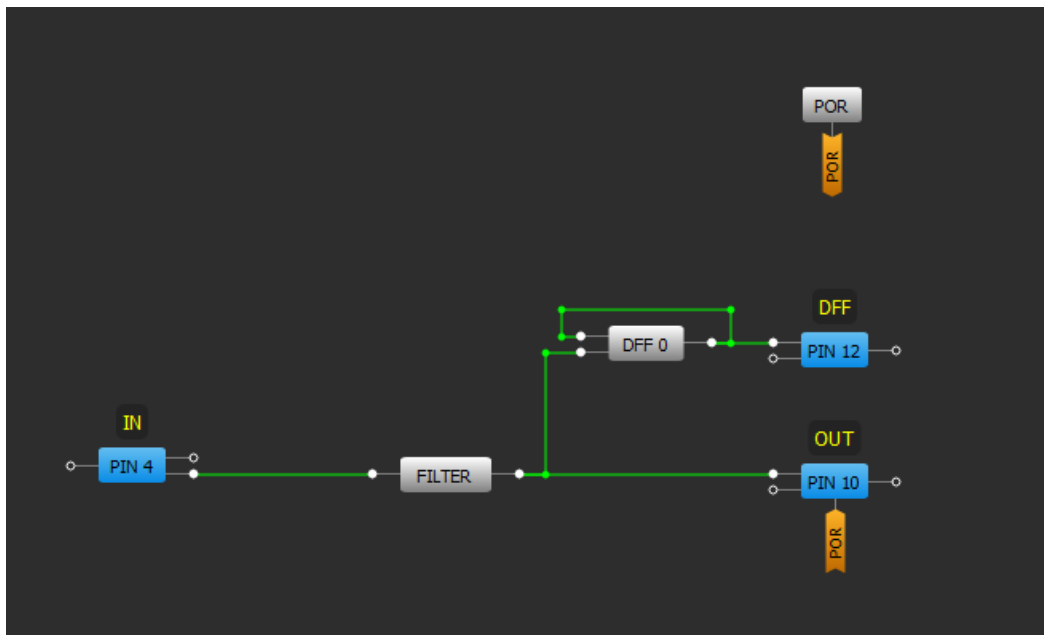
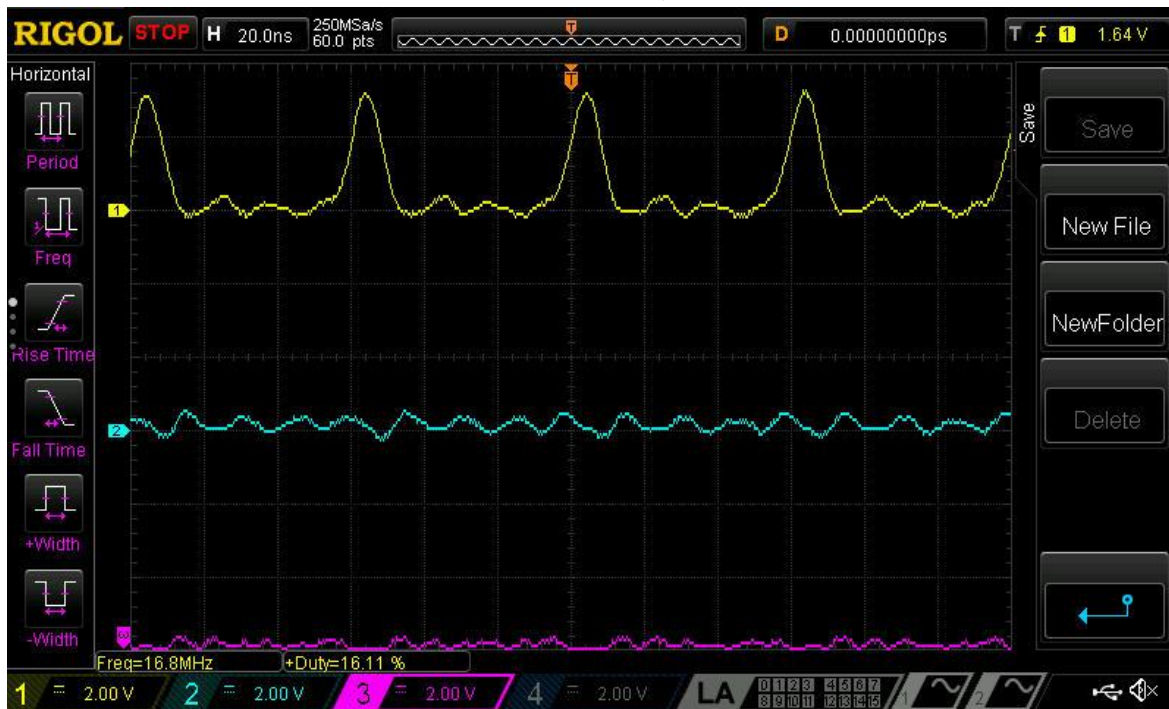
If the FILTER cell's input signal contains multiple consecutive pulses within short time intervals, the FILTER cell may not filter the input pulses as expected. The errant behavior applies only to repeated input pulses and depends on both their frequency and duty cycle.

Channel 1 (yellow/top line) – PIN#4 (IN).  
 Channel 2 (light blue/2nd line) – PIN#10 (OUT).  
 Channel 3 (magenta /3rd line) – PIN#12 (DFF).

1. Period is 60 ns. Pulse width is 10 ns, DC = 16.7 % (correct functionality).

Currently, there is no workaround for this issue. The FILTER block correctly filters isolated glitches, but it shouldn't be used to filter repetitive, high frequency input signals.

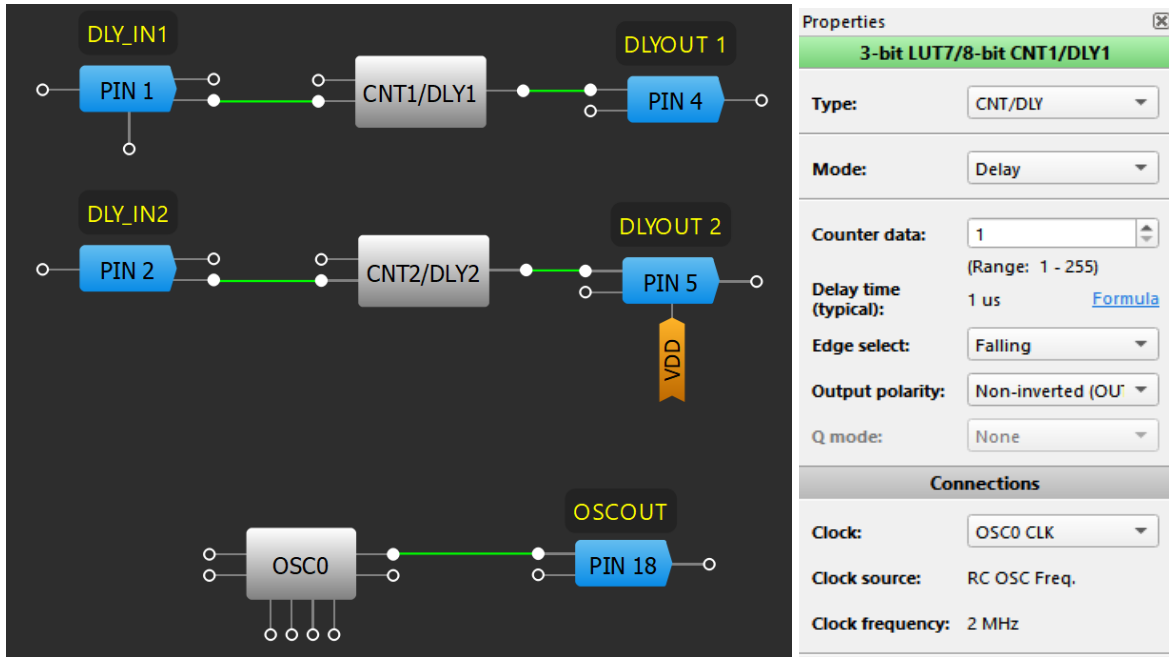
Figure 2: Test Circuit

The error is difficult to capture as the timing must be exact within ns, and short (ns) pulses are difficult to generate glitch precise enough to induce the problem. GPIO naturally filter out ns pulses, so for purposes of errata capture, two simultaneous falling-edge DLY circuits (as shown in Figure 2) were used. By lining up two delays precisely at a particular timing relationship, we can use the internal Auto Power On (OR logic) to generate the glitch pattern necessary to cause the error.

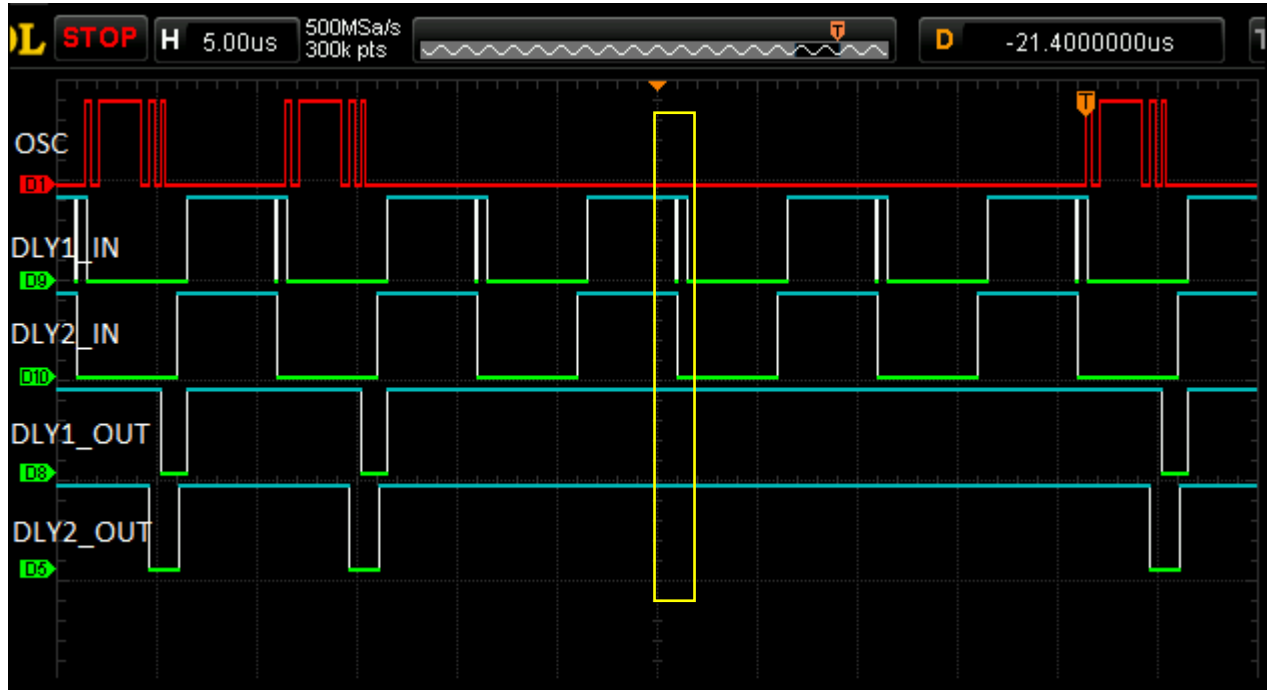
Figure 3: Errata Capture (Zoom Out)

Figure 3 shows a series of DLY output events are missing, where the OSC is correspondingly not triggering when it was supposed to. Figure 4 is a zoom in of the boxed region from Figure 3. The total glitch/chatter time was measured in this case at 152 ns. By using the composite OR of the two delay channels, we can asynchronously strobe with tiny frequency variations, and so tune the timing to induce this errata. Note that the error is not persistent – the system is recovered when all DLYs are returned to inactive state, such as when input of falling edge DLY goes high, thus canceling delay, or after DLY out finishes.

1. Use signal conditioning circuits to prevent glitch on DLY inputs < 200 ns. Examples:
  - a. ACMP with Hysteresis
  - b. External RC in front of Digital Input with Schmitt Trigger
  - c. Filter cell.
2. Set OSC power mode to Force Power On mode instead of Auto Power On.
