### ISSUE 1: FILTER Cell does not Filter Out Repetitive Glitches

## SLG46585

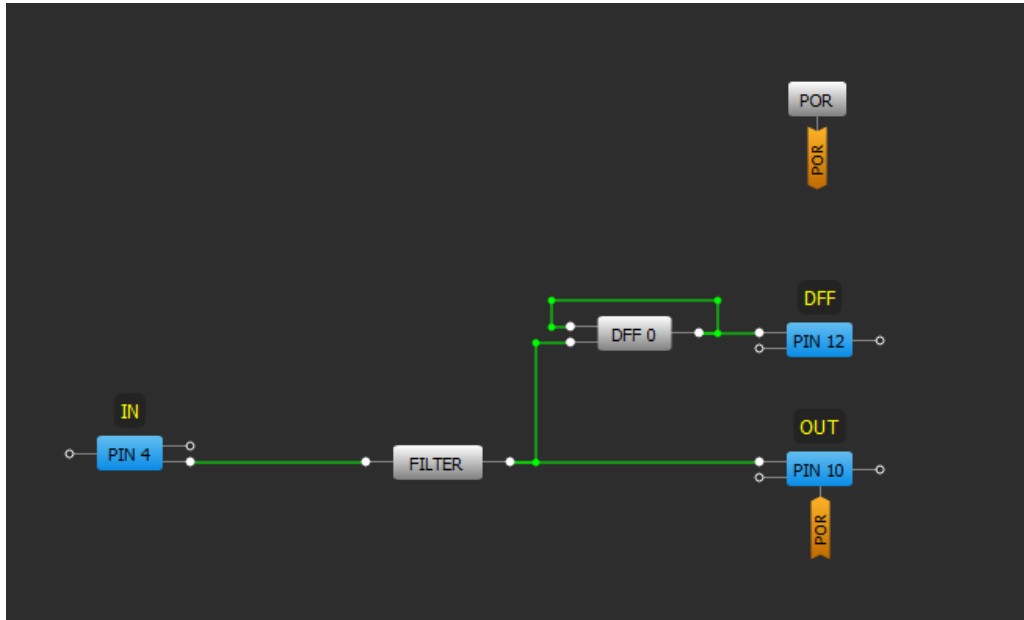
If the FILTER cell's input signal contains multiple consecutive pulses within short time intervals, the FILTER cell may not filter the input pulses as expected. The errant behavior applies only to repeated input pulses and depends on both their frequency and duty cycle.

Channel 1 (yellow/top line) – PIN#4 (IN).  
 Channel 2 (light blue/2nd line) – PIN#10 (OUT).  
 Channel 3 (magenta /3rd line) – PIN#12 (DFF).

Currently, there is no workaround for this issue. The FILTER block correctly filters isolated glitches, but it shouldn't be used to filter repetitive, high frequency input signals.

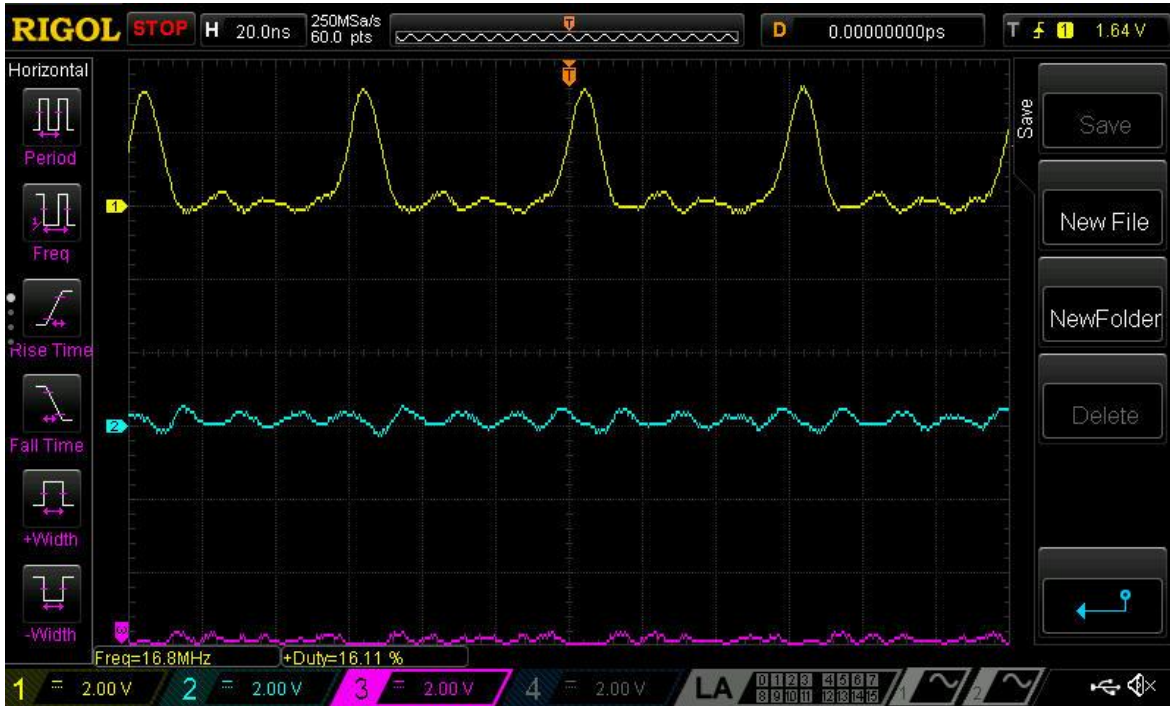
1. Period is 60 ns. Pulse width is 10 ns, DC = 16.7 % (correct functionality).

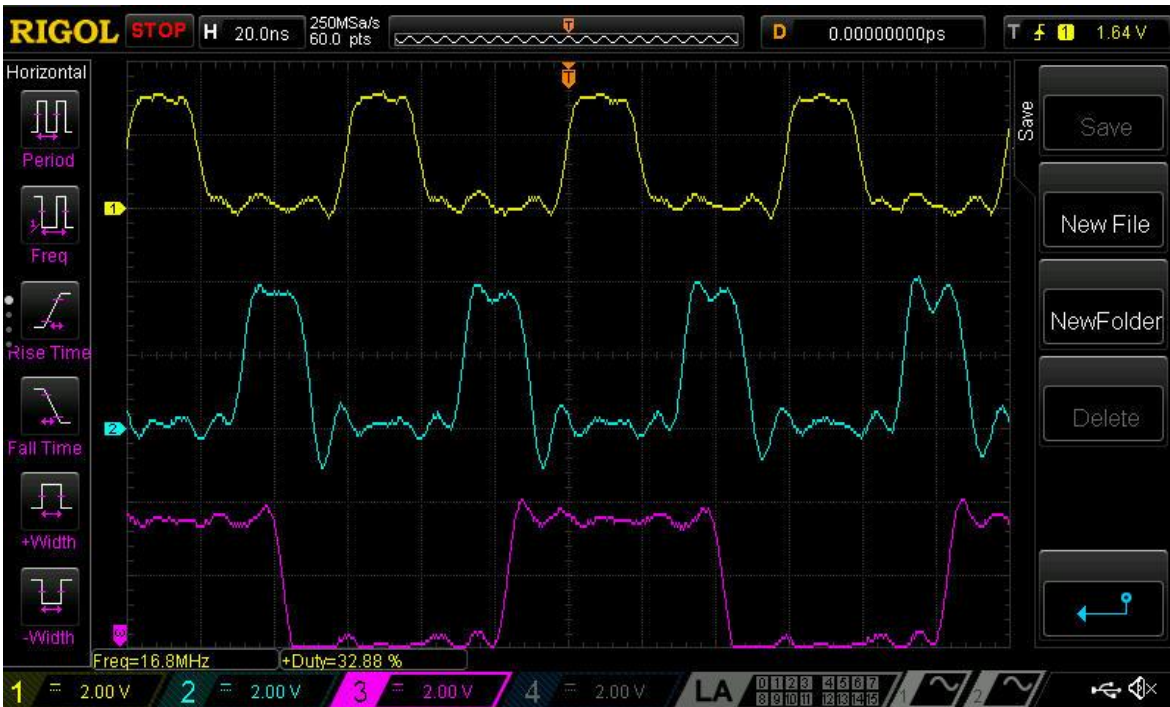
2. Period is 60 ns. Pulse width is 20 ns, DC = 33.3 % (incorrect functionality).

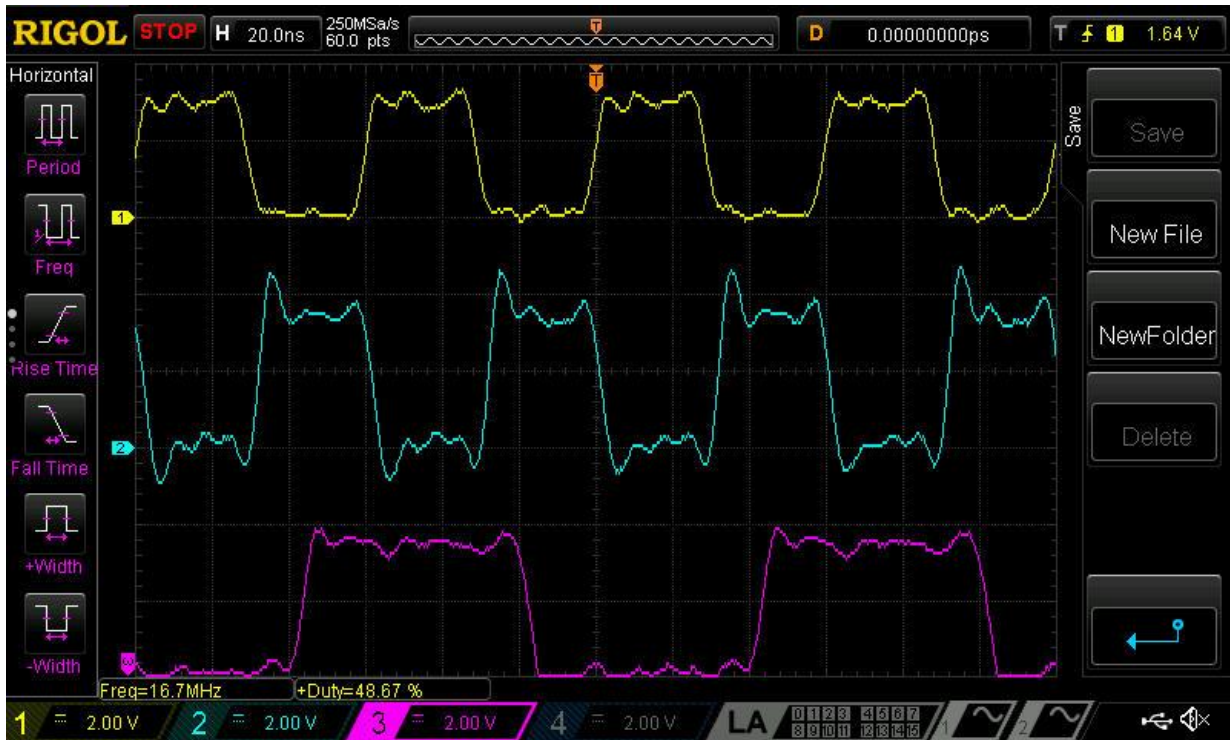
3. Period is 60 ns. Pulse width is 30 ns, DC = 50 % (incorrect functionality).

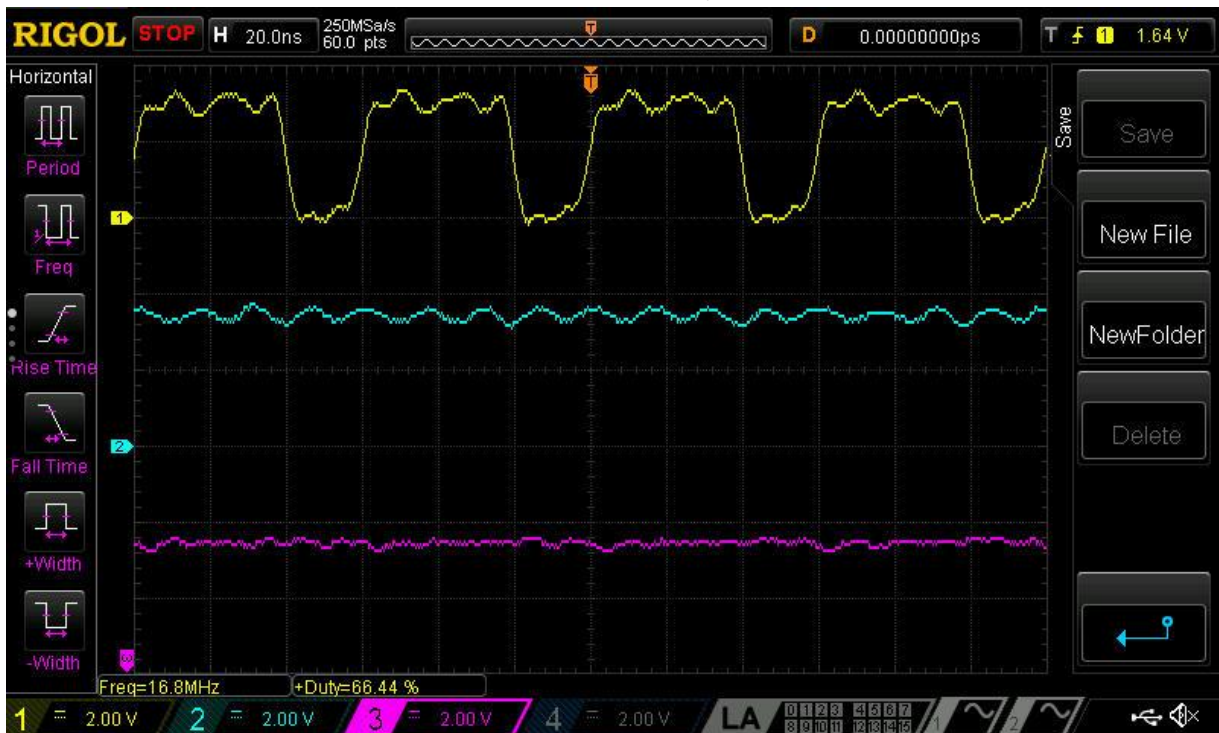
4. Period is 60 ns. Pulse width is 40 ns, DC = 66.67 % (correct functionality).

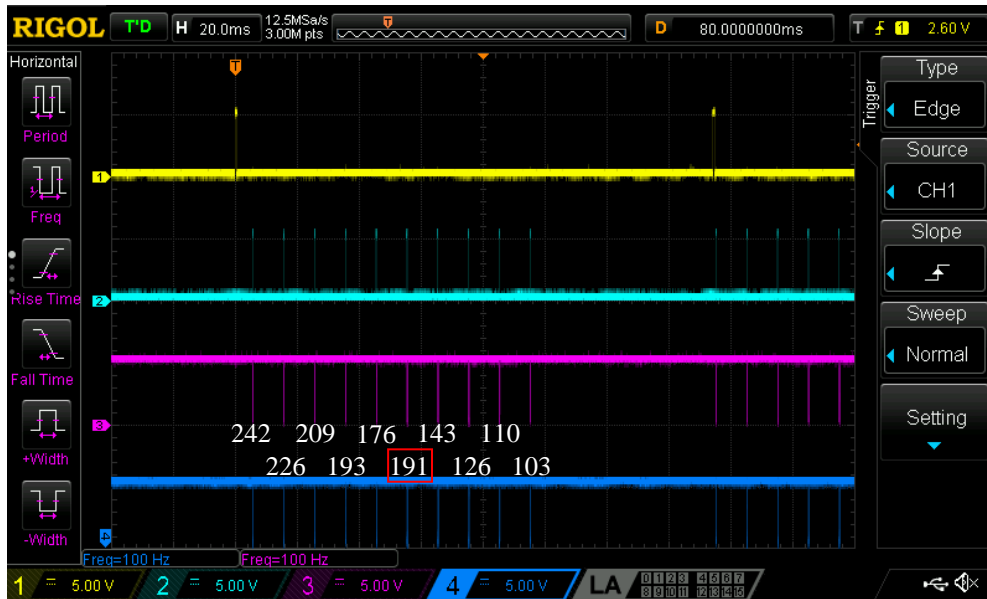
Asynchronous interaction between the CNT/DLY clock input and the I<sup>2</sup>C latch signal (generated by an I<sup>2</sup>C read command of the CNT/DLY block's count value) can result in an incorrect I<sup>2</sup>C data read. The CNT/DLY block will count accurately, but the count value transferred into the block's I<sup>2</sup>C read register might be loaded incompletely if the I<sup>2</sup>C latch signal and the clock input occur at about the same time.

The example data capture below shows ten periodic I<sup>2</sup>C reads of CNT2/DLY2 configured to count down at about 16 clocks per read. The sixth read sample erroneously shows a value greater than that of the fifth. The seventh sample reads as if the previous I<sup>2</sup>C error never occurred - the difference from the fifth sample (176) to the seventh (143) is 33 clocks or 16 clocks + 17 clocks as expected.

- Channel 1 (yellow/top line) – PIN#2 (CNT2/DLY2 Out).
- Channel 2 (light blue/2nd line) – PIN#1 (I<sup>2</sup>C Read Triggers).
- Channel 3 (magenta /3rd line) – PIN#8 (I<sup>2</sup>C SCL).
- Channel 3 (dark blue /4th line) – PIN#9 (I<sup>2</sup>C SDA).

If the possibility of incorrect I<sup>2</sup>C data reads can't be accommodated for by external software checks, one can guarantee proper operation by stopping the CNT/DLY block's clock during I<sup>2</sup>C reads through one of the following methods: by disabling the oscillator block, by reconfiguring the CNT/DLY block's clock source, or by gating an external clock using a LUT (Look-up Table) in the signal matrix. After disabling the CNT/DLY block's clock, the count registers can be read without error. Please note that this workaround will add the I<sup>2</sup>C read and processing time to the counter's overall clock period.

The best workaround depends on the resource constraints of the application. If the oscillator block doesn't clock other logic elements within the design, a matrix output can be used to manually power down the oscillators for the I<sup>2</sup>C read. When the CNT/DLY block's clock source is routed internally from the oscillator block, I<sup>2</sup>C commands can temporarily reconfigure the CNT/DLY block's clock source registers to select "Ext. CLK. (From Matrix)." This action will disable the clock by connecting it to ground. If the CNT/DLY block is clocked from the signal matrix, a LUT can be used to gate the clock during an I<sup>2</sup>C read.

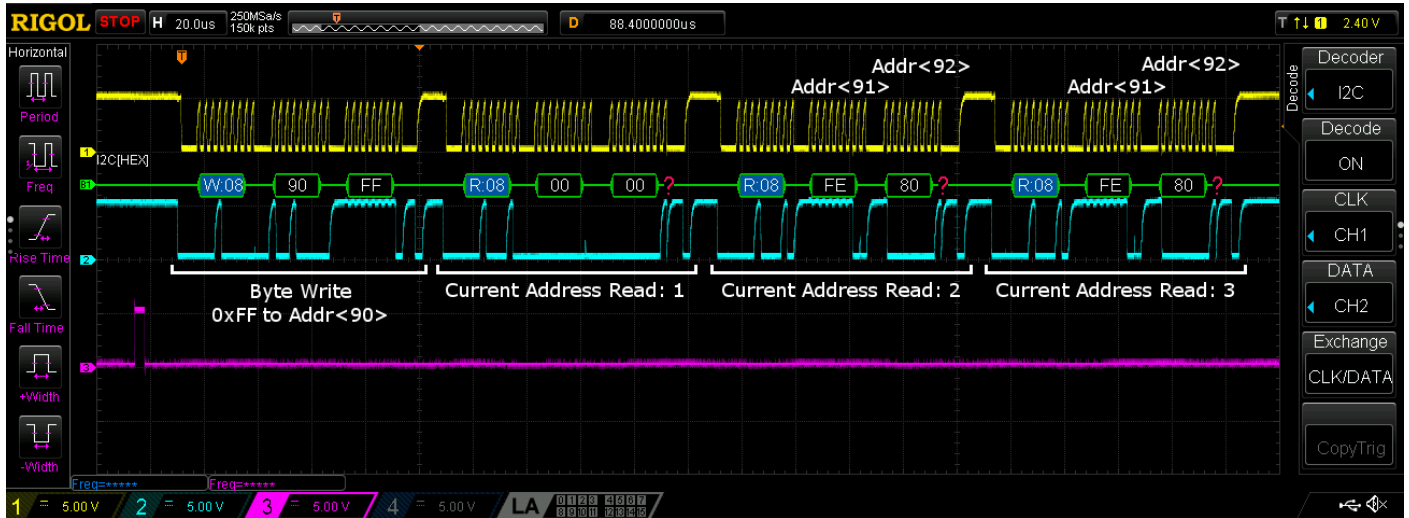
The first “Current Address Read” or “Sequential Read” command following an I<sup>2</sup>C “Byte Write” or a “Sequential Write” command will produce incorrect data. Additional read commands will return the expected data. See the waveform below for more information.

Channel 1 (yellow/top line) – PIN#8 (SCL).

Channel 2 (light blue/2nd line) – PIN#9 (SDA).

Channel 3 (magenta /3rd line) – I<sup>2</sup>C Software Trigger.

*Note: In the GreenPAK test design, Addr<91> and Addr<92> expect FE and 80 respectively.*

If possible, use the “Random Read” command as described in the datasheet for SLG46585. This command will output the correct data.

If you expect consecutive reads of the same register, we recommend sending a “Random Read” command to the register preceding the register of interest. After the “Random Read” command finishes, the chip’s register pointer will increment to the desired register and the following “Current Address Read” or “Sequential Read” commands will produce the correct data. Note that the “Current Address Read” and “Sequential Read” commands don’t increment the GreenPAK’s register pointer.

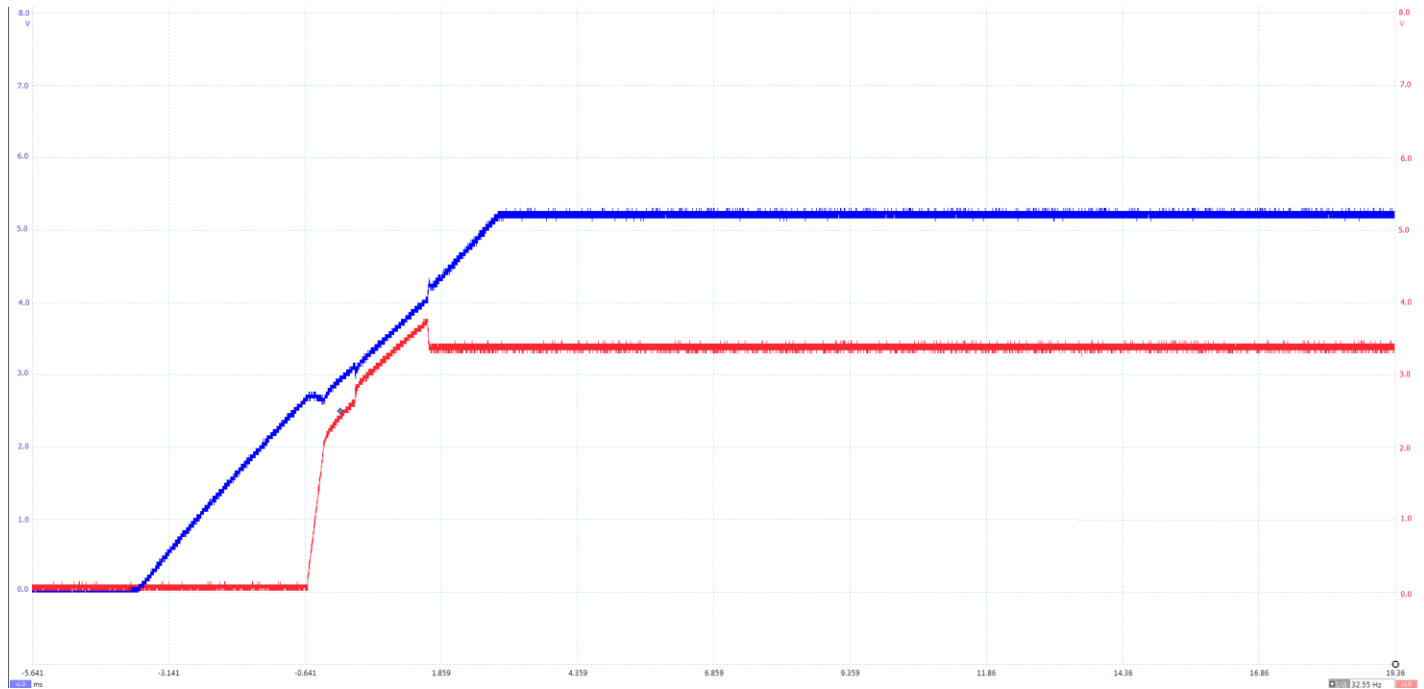
The maximum DC\_VOUT to DC\_VIN duty cycle ratio is 80 % for fsw=1.5 MHz and 75 % for fsw=2 MHz (See Table 20 in Datasheet section 5.11 parameter *Maximum Duty Cycle*). This voltage glitch issue only occurs if the DC\_VOUT to DC\_VIN ratio exceeds this maximum, meaning DC\_VIN does not have enough headroom above DC\_VOUT.

For DC\_VOUT selections 1.2 V, 1.5 V, and 1.8 V, the UVLO can block the ON/OFF signal from enabling the DC/DC Buck Converter until DC\_VIN is greater than 2.3 V. However, for selections 2.5 V, 3.0 V, and 3.3 V, which are greater than the UVLO threshold, there is no protection against enabling the DC/DC while the DC\_VIN does not satisfy the Maximum Duty Cycle ratio specified above.

This glitch can be seen in an application where there is a slow DC\_VIN/VDD ramp and the DC/DC’s enable signal is tied to DC\_VIN/VDD, as shown in the example capture below.

The example capture below shows DC\_VIN/VDD ramping from 0 V to 5.5 V at 1 V/ms. The output voltage is set to 3.3 V.

Channel 1 (blue/top line) – PIN#14/PIN#16 (DC\_VIN/VDD).  
 Channel 2 (red/2nd line) – PIN#10 (DC\_VOSNS).

Use an ACMP to detect when DC\_VIN is greater than DC\_VOUT divided by Maximum Duty Cycle, and then AND the ACMP output with the ON/OFF signal.

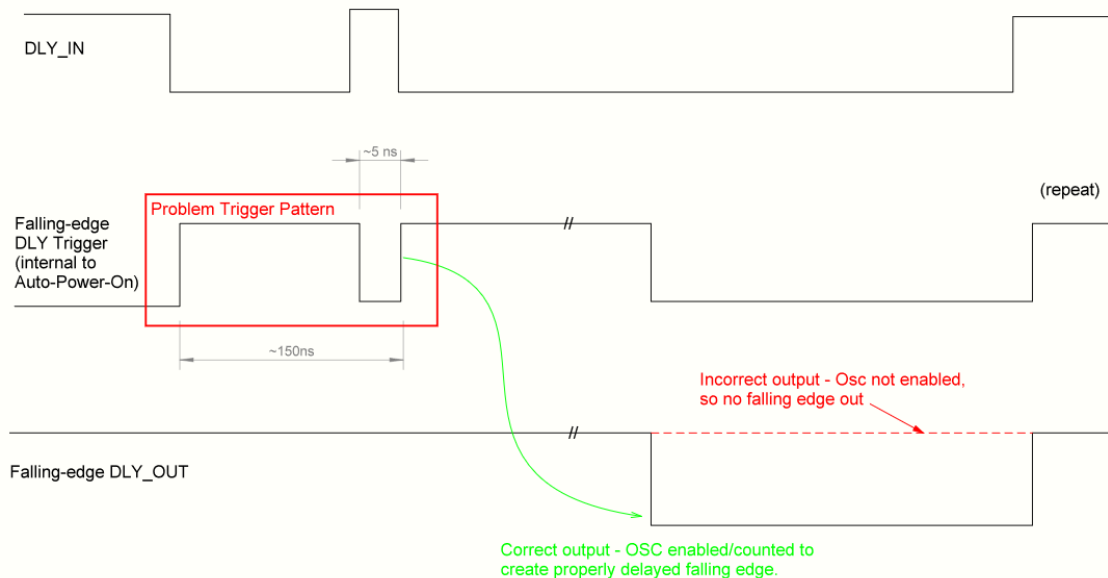
**Figure 1: Problem Trigger Pattern**

For this chip, the Auto Power On circuitry of the 25 kHz/2 MHz generators contains a circuit errata, which can potentially fail to power on the OSC for a specific pattern and timing of the OR of all related DLY trigger signals. The pattern is shown in [Figure 1](#) (boxed in red) and consists of a relatively longer pulse (~145 ns) followed by a shorter (~5 ns) glitch of opposite polarity.

1. Use signal conditioning circuits to prevent glitch on DLY inputs < 200 ns. Examples:
  - a. ACMP with Hysteresis
  - b. External RC in front of Digital Input with Schmitt Trigger
  - c. Filter cell.
2. Set OSC power mode to Force Power On mode instead of Auto Power On.
3. Use different oscillator, such as 25 MHz Ring OSC, which does not have Auto Power On issue.

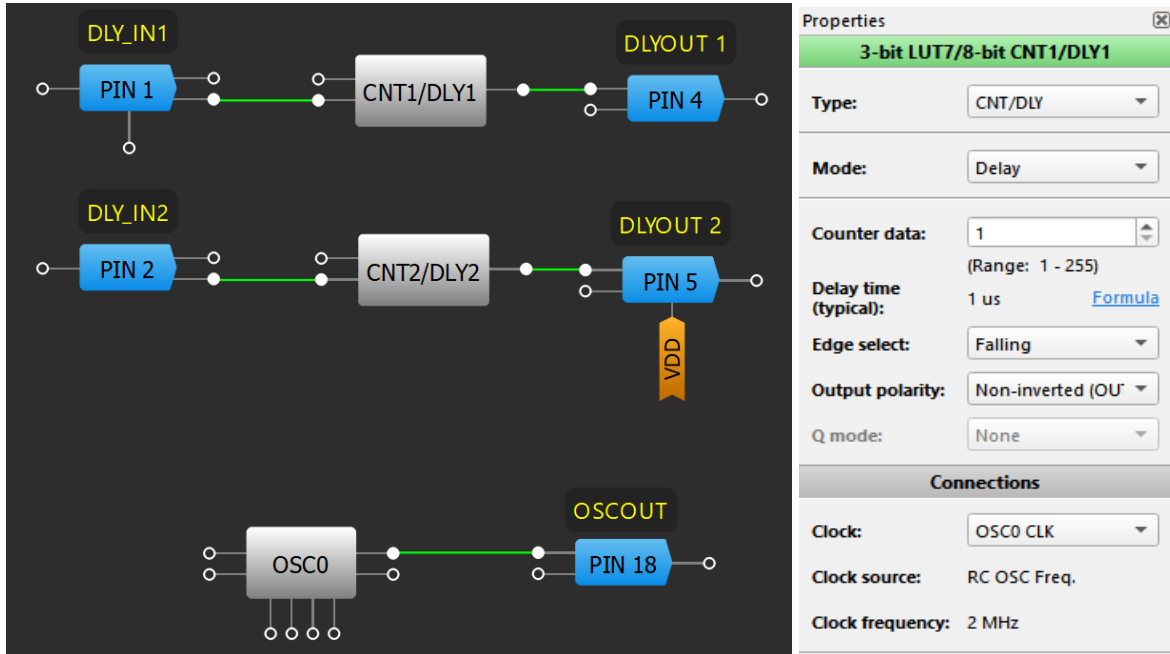
Figure 2: Test Circuit

The error is difficult to capture as the timing must be exact within ns, and short (ns) pulses are difficult to generate glitch precise enough to induce the problem. GPIO naturally filter out ns pulses, so for purposes of errata capture, two simultaneous falling-edge DLY circuits (as shown in [Figure 2](#)) were used. By lining up two delays precisely at a particular timing relationship, we can use the internal Auto Power On (OR logic) to generate the glitch pattern necessary to cause the error.

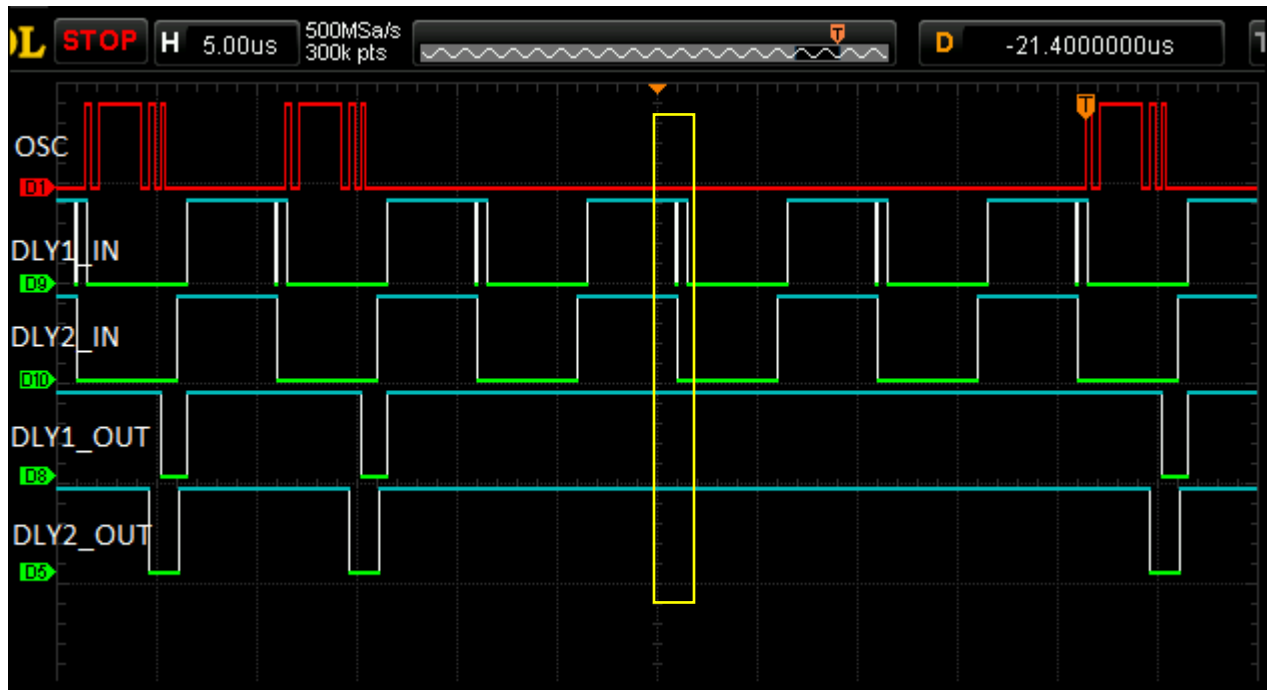
Figure 3: Errata Capture (Zoom Out)

Figure 3 shows a series of DLY output events are missing, where the OSC is correspondingly not triggering when it was supposed to. Figure 4 is a zoom in of the boxed region from Figure 3. The total glitch/chatter time was measured in this case at 152 ns. By using the composite OR of the two delay channels, we can asynchronously strobe with tiny frequency variations, and so tune the timing to induce this errata. Note that the error is not persistent – the system is recovered when all DLYs are returned to inactive state, such as when input of falling edge DLY goes high, thus canceling delay, or after DLY out finishes.
