SLG46620

ISSUE 1: ACMP IN- Leakage Current when Powered Down

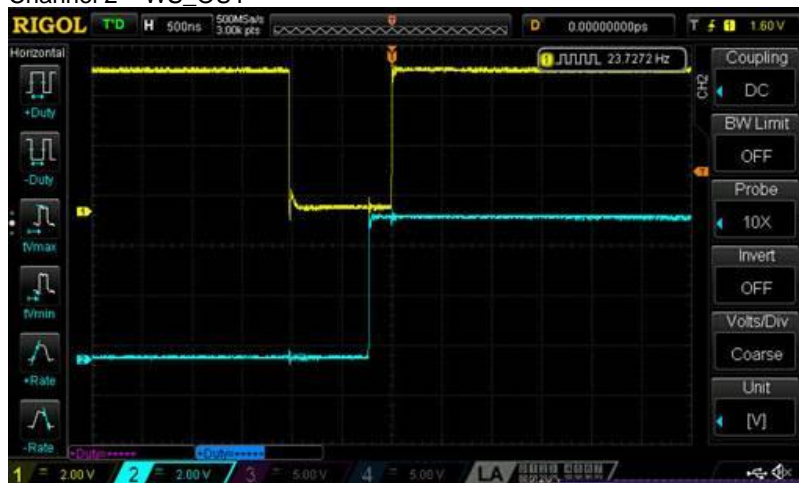
The output of the ACMP incorrectly goes low even when IN+ is greater than IN- if the RING OSC is active when the WS signal rises

Channel 1 – ACMP out

Channel 2 – WS_OUT

- Avoid using the RING OSC with the WS Controller, or add a filtering block on the ACMP output to filter out the glitch.

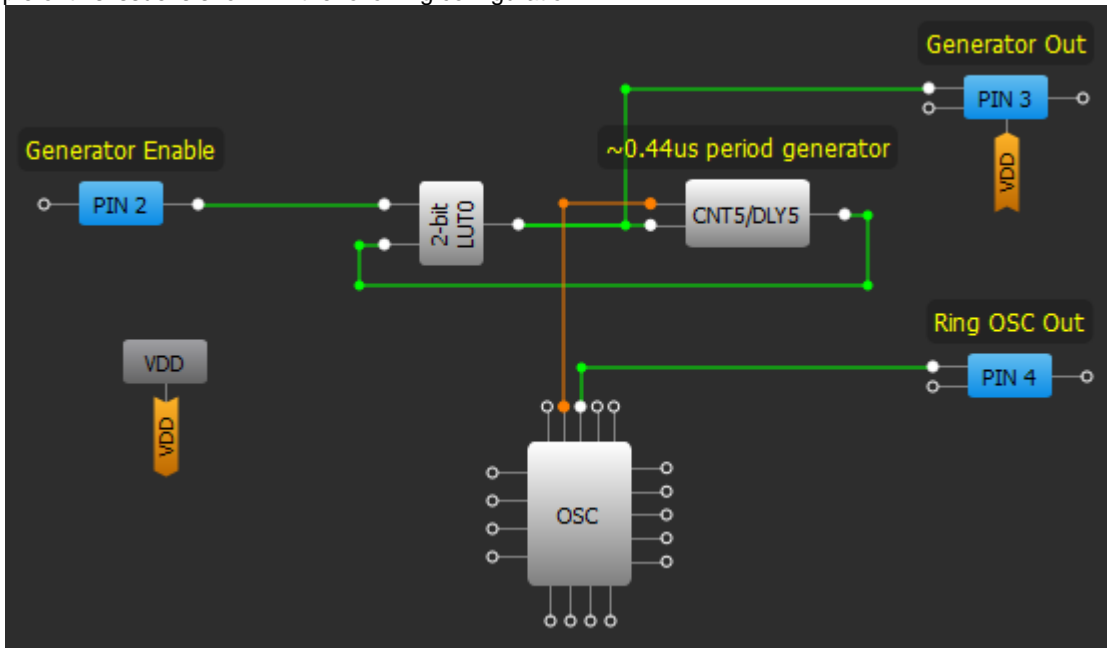
The Ring OSC has a longer settling time when configured as Auto Power On in the designs that have very short Ring OSC disable time. An example of this issue is shown in the following configuration:

The configuration shown above generates a periodical signal with a frequency defined by the Delay cell and started by a high signal on PIN2. The issue becomes apparent in a longer settling time when the scheme generates short pulses (Delay is configured as a rising edge delay only). See waveform below.

- Set Ring OSC power mode to “Force Power On”
- or, Set Turn on by register option in BG (Band Gap) block as “Enable”

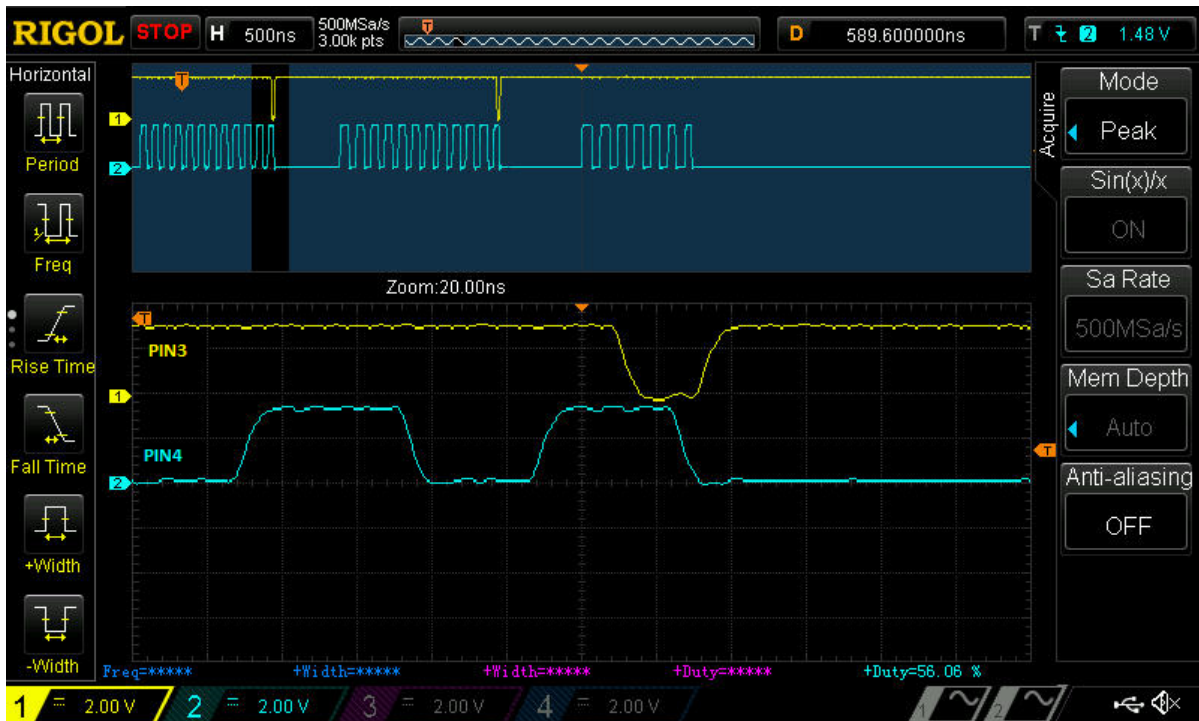
Channel 1 – 2-bit LUT0 output; Channel 2 – Ring OSC output

Such behavior will lead to substantial error in period calculations if the delay time is relatively small.

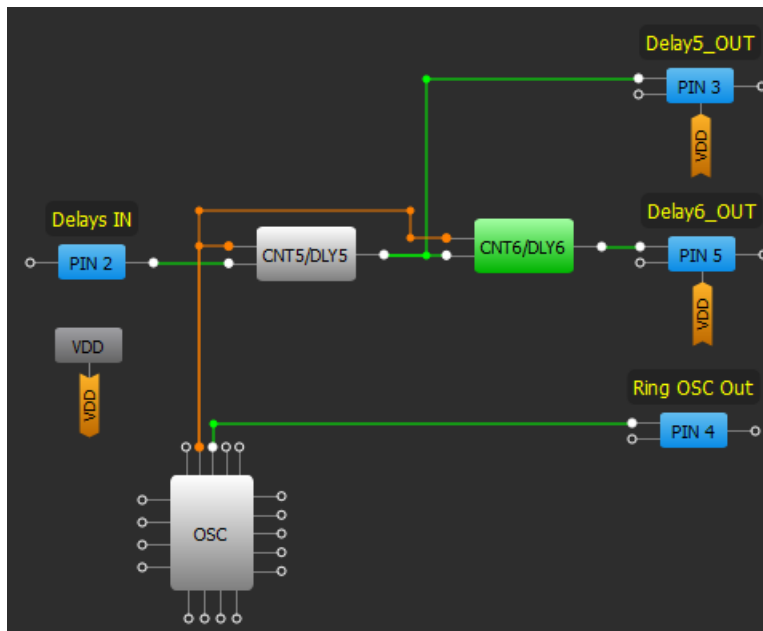
A similar situation can occur while using two connected delays (all edge detect types except for a pair “Rising edge DLY – Falling edge DLY”).

In the following example, Delay5 and Delay6 are configured in the same way. However, Delay5 time is 11.4us instead of expected 0.4us (Delay5 time).

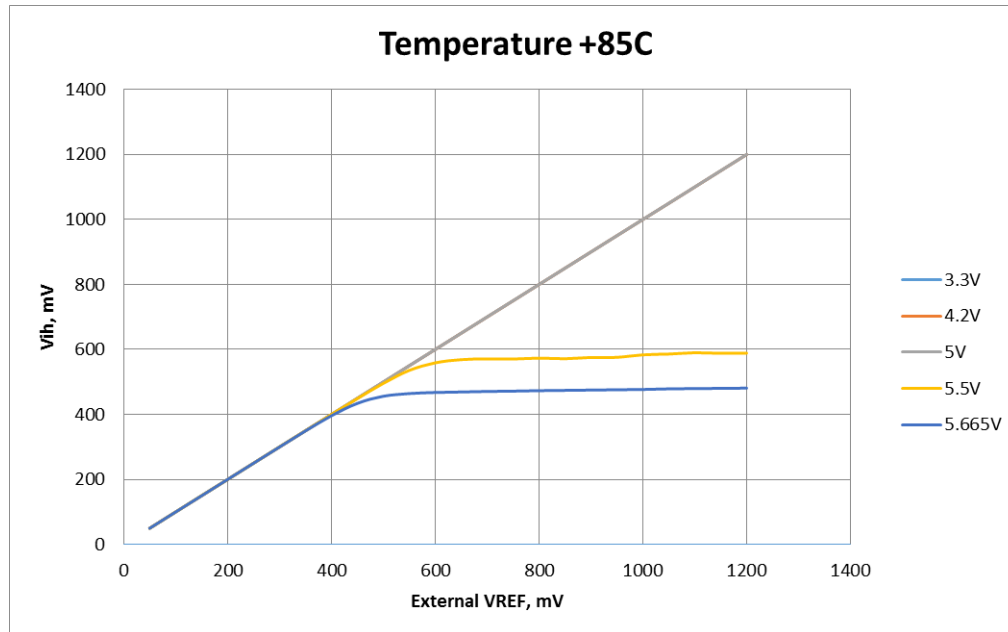
When using external Vref source, the ACMP comparison may happen at wrong threshold if the external Vref voltage is higher than a particular value (please see figure below) at high VDD values (> 5V) and high temperature.

- Avoid using ACMPs in such conditions.

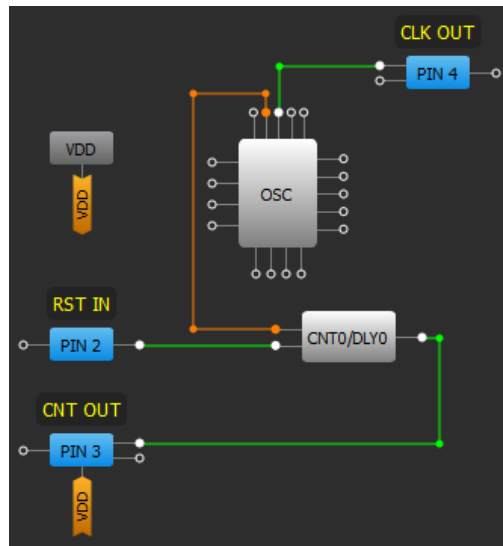
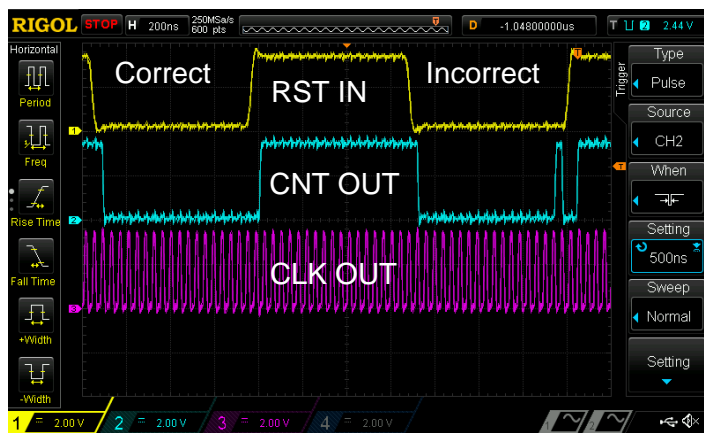
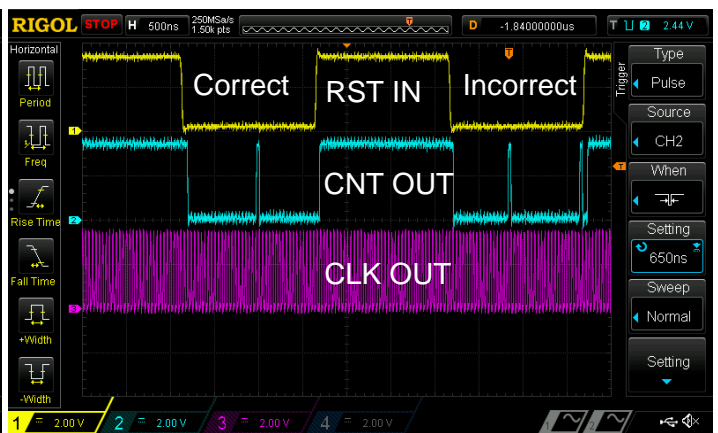
If the Counter Reset occurs at a time very close to a rising edge of the clock signal during clock signal generation (for example OSC operation), there is a possibility that the Counter Data of the Counter is reset incorrectly and the counter end signal (HIGH pulse) may appear faster than expected. This phenomena appears more frequently the higher the clock frequency is.

- Synchronize RESET input of the Counter with its CLK using 2 DFF cells as shown in the image below.

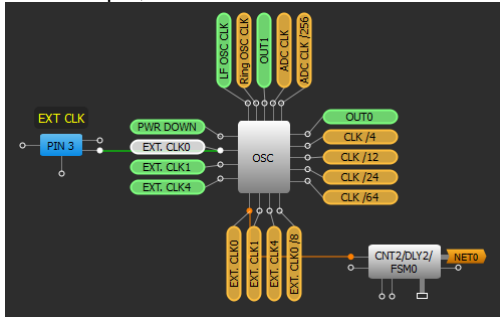
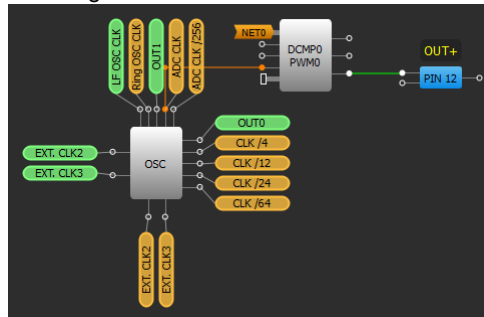
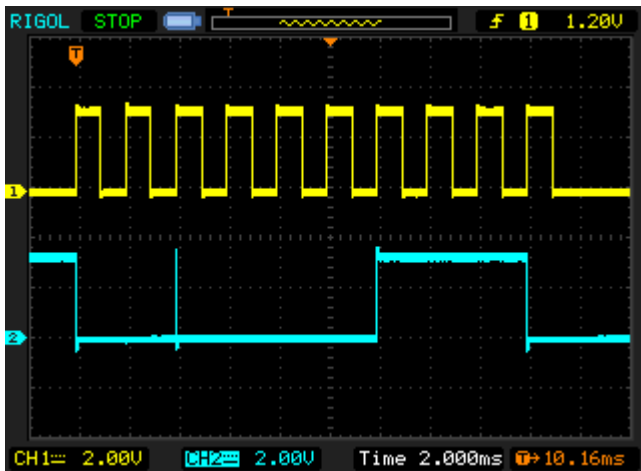
DCMP's OUT+ output may have a glitch when the input data is changed. This issue appears more frequently the higher DCMP clock is.

For example, DCMP IN+ sources from FSM0 and IN- from Register0. DCMP is clocked from the Ring OSC.

- Synchronize the data source clock with the DCMP clock source using 2 DFF cells as shown in the images below.
