## SLG46620-EV Errata Note

This document contains the known errata for SLG46620-EV and the recommended workarounds.

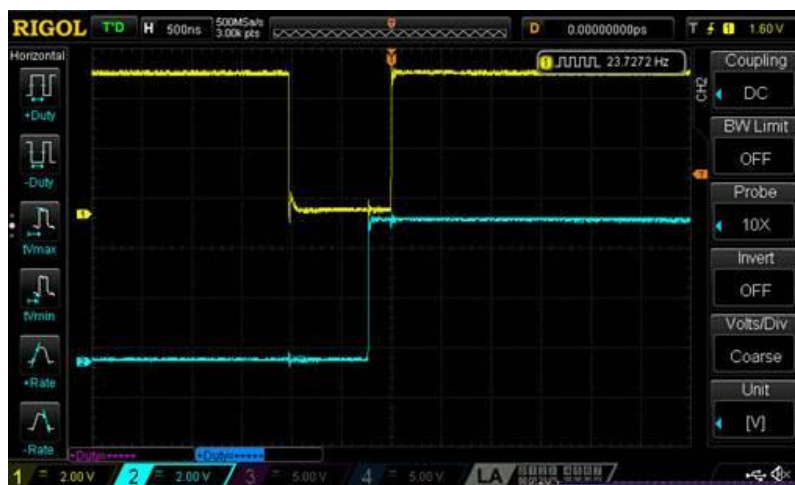
The output of the ACMP incorrectly goes low even when IN+ is greater than IN- if the RING OSC is active when the WS signal rises.

Channel 1 – ACMP out

Channel 2 – WS\_OUT

Avoid using the RING OSC with the WS Controller, or add a filtering block on the ACMP output to filter out the glitch.

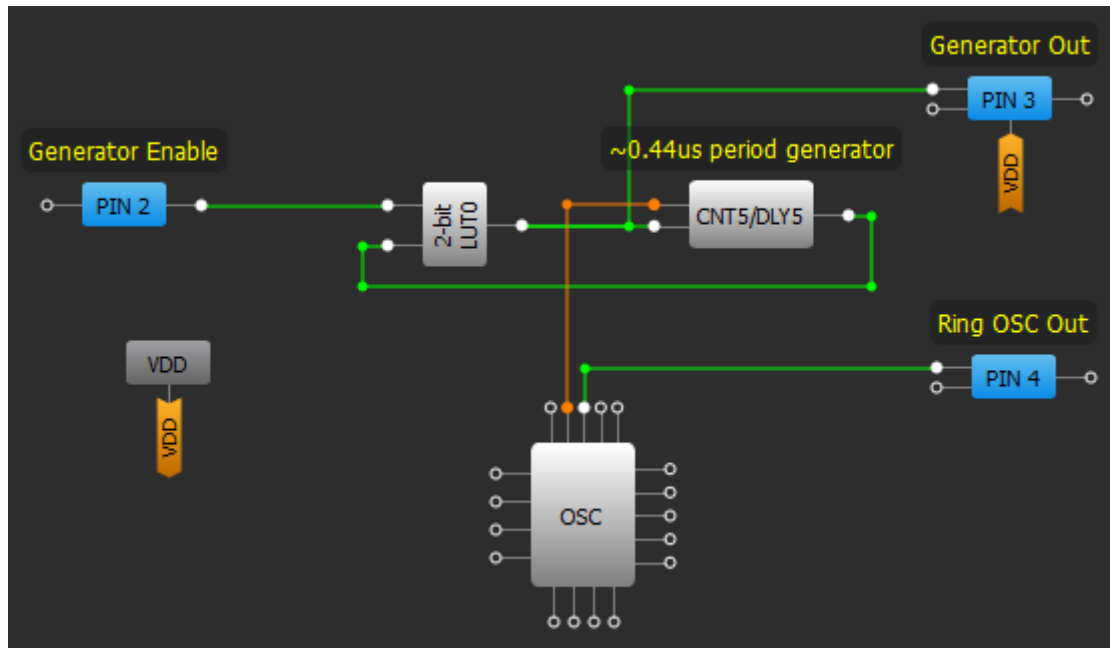
The Ring OSC has a longer settling time when configured as Auto Power On in the designs that have very short Ring OSC disable time. An example of this issue is shown in the following configuration:

- Set Ring OSC power mode to “Force Power On”
- or, Set Turn on by register option in BG (Band Gap) block as “Enable”

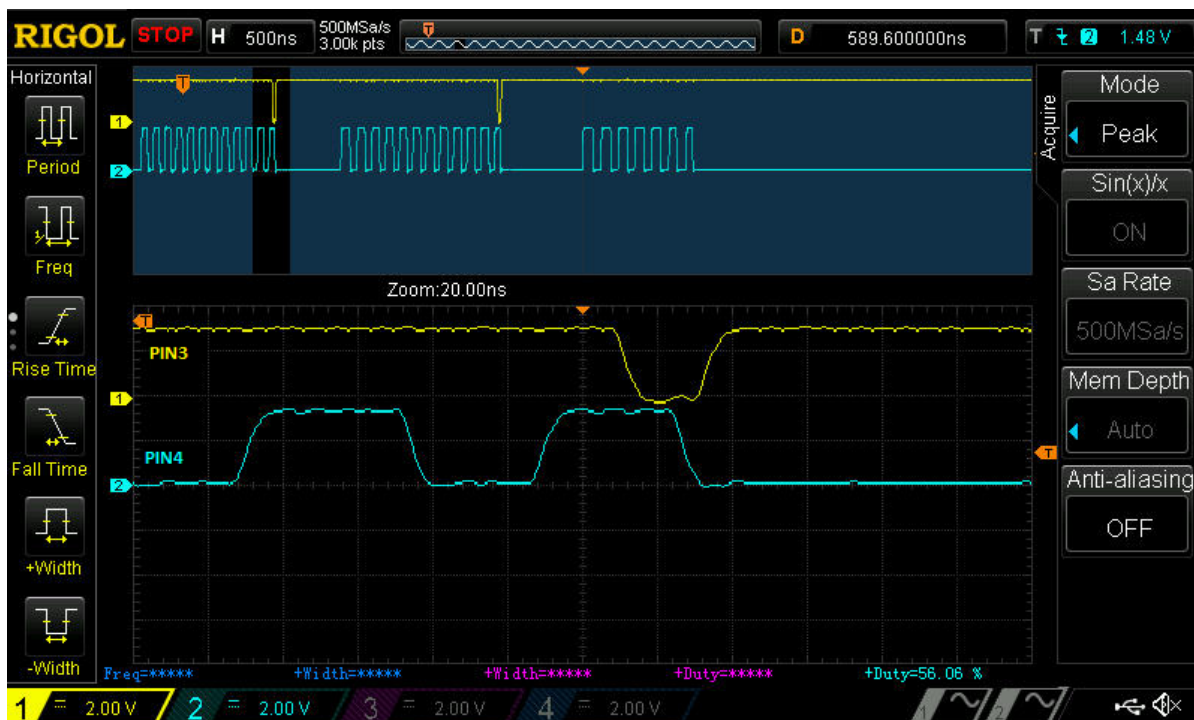
The configuration shown above generates a periodical signal with a frequency defined by the Delay cell and started by a high signal on PIN2. The issue becomes apparent in a longer settling time when the scheme generates short pulses (Delay is configured as a rising edge delay only). See waveform below.

Channel 1 – 2-bit LUT0 output; Channel 2 – Ring OSC output

Such behavior will lead to substantial error in period calculations if the delay time is relatively small.

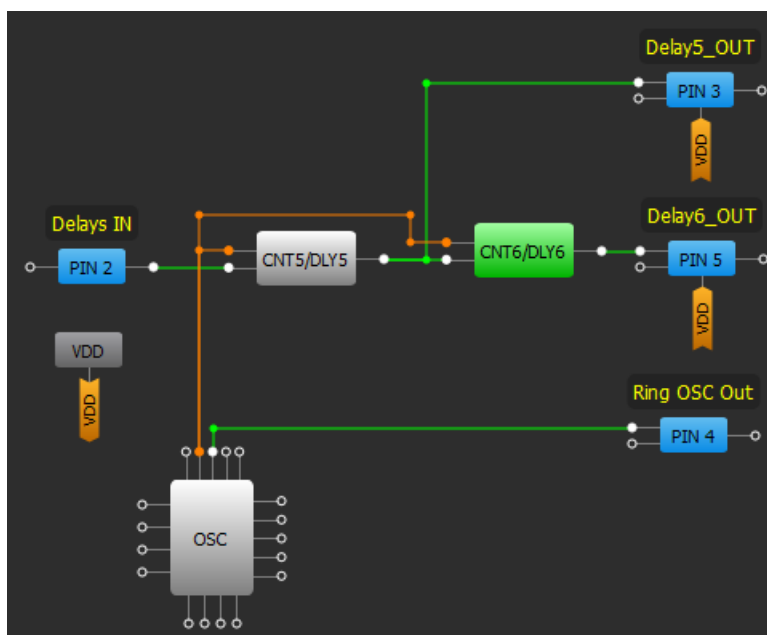
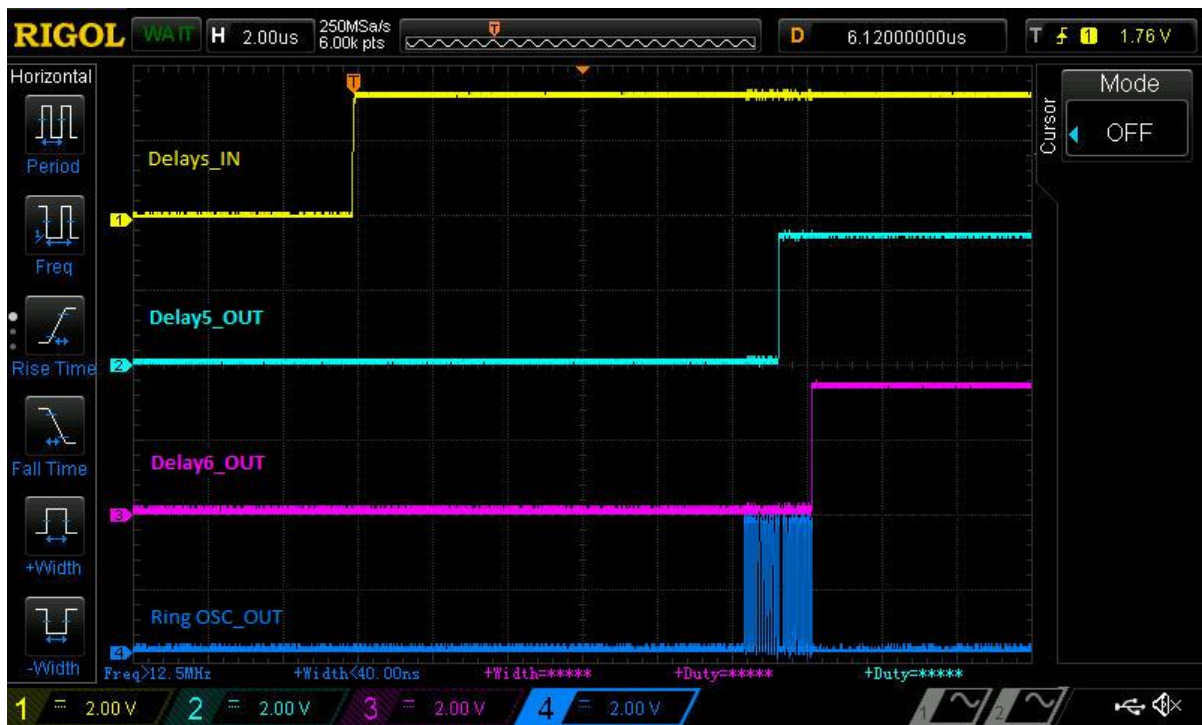
A similar situation can occur while using two connected delays (all edge detect types except for a pair “Rising edge DLY – Falling edge DLY”).

In the following example, Delay5 and Delay6 are configured in the same way. However, Delay5 time is 11.4us instead of expected 0.4us (Delay5 time).

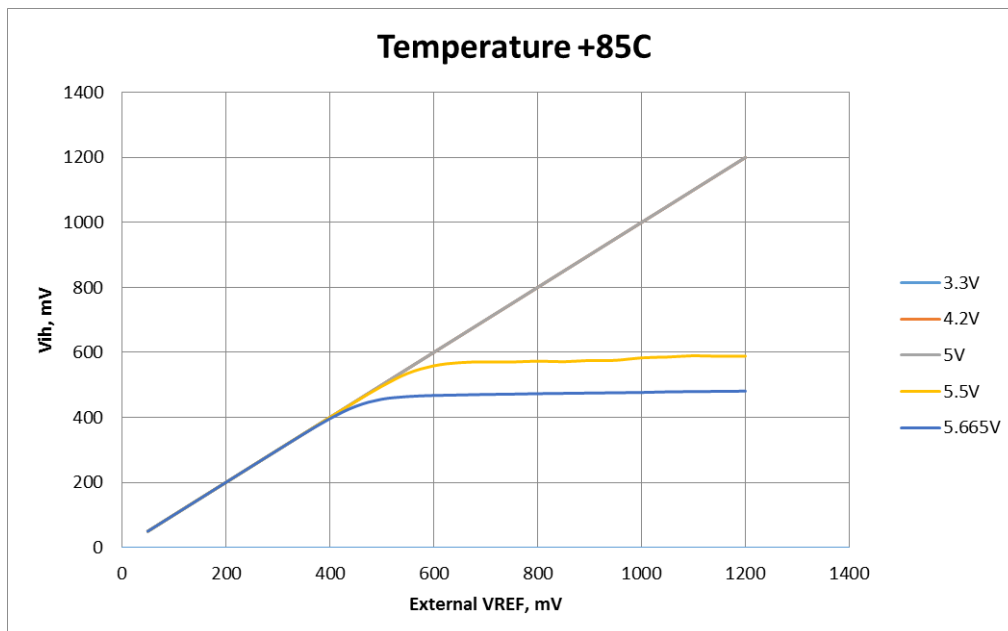
When using external Vref source, the ACMP comparison may happen at wrong threshold if the external Vref voltage is higher than a particular value (please see figure below) at high VDD values (> 5V) and high temperature.

Avoid using ACMPs in such conditions.

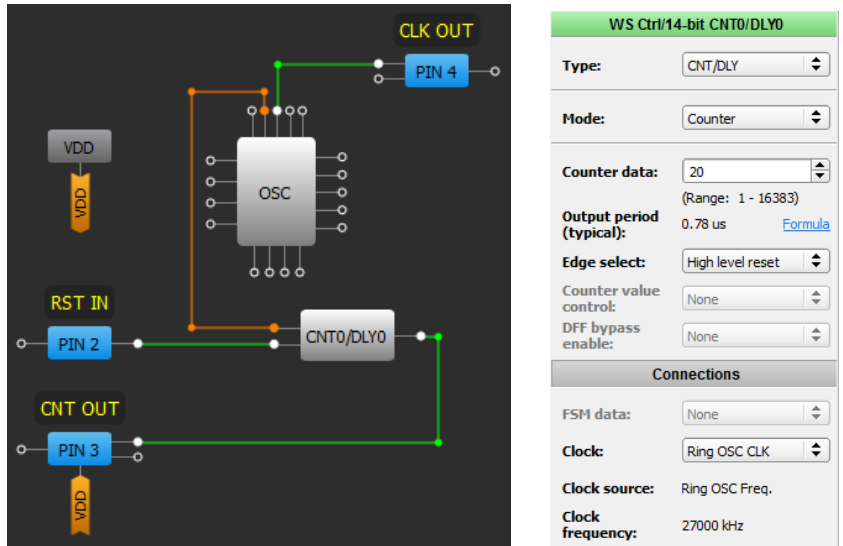
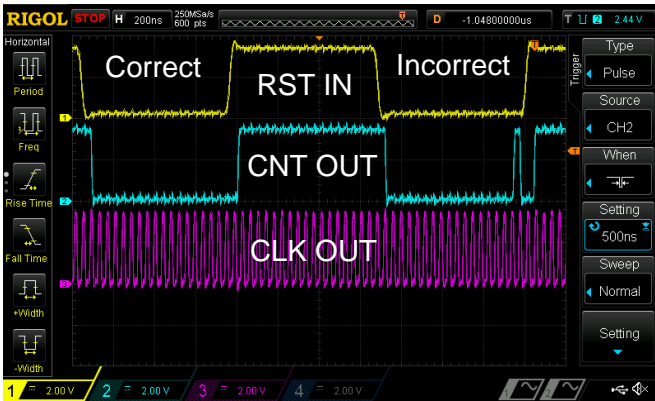
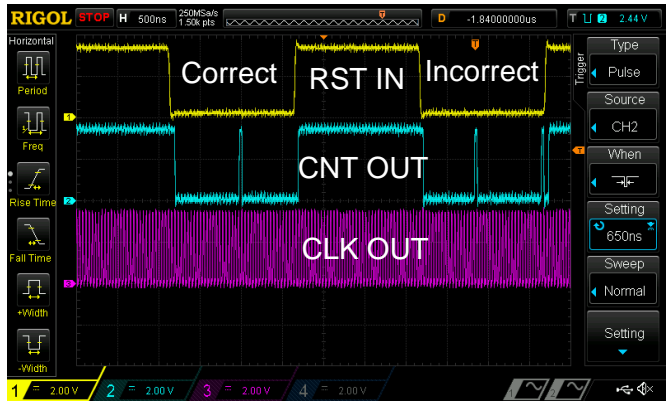
If the Counter Reset occurs at a time very close to a rising edge of the clock signal during clock signal generation (for example OSC operation), there is a possibility that the Counter Data of the Counter is reset incorrectly and the counter end signal (HIGH pulse) may appear faster than expected. This phenomena appears more frequently the higher the clock frequency is.

Synchronize RESET input of the Counter with its CLK using 2 DFF cells as shown in the image below.

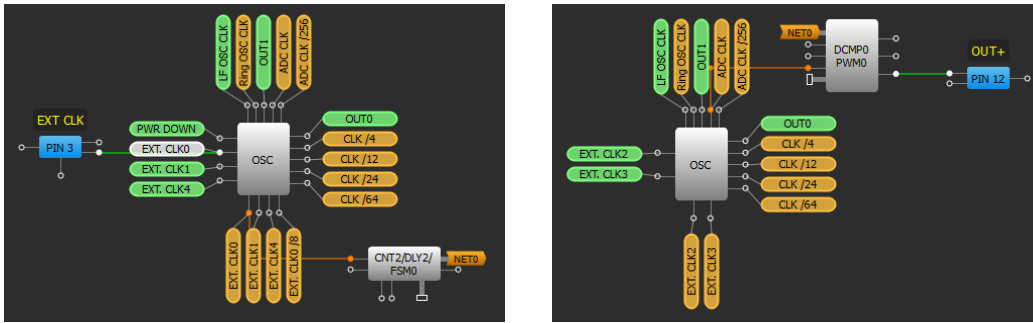
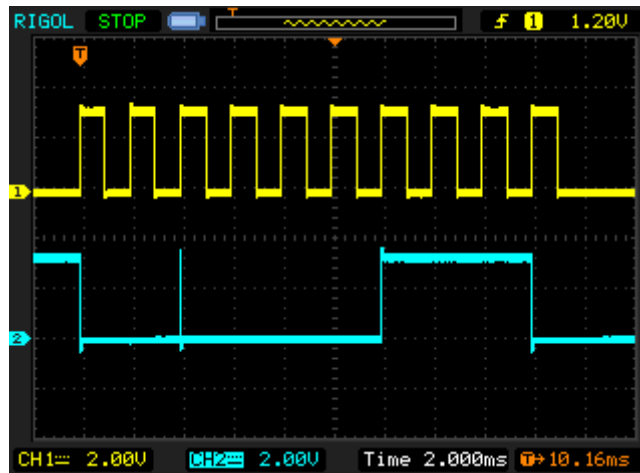
DCMP's OUT+ output may have a glitch when the input data is changed. This issue appears more frequently the higher DCMP clock is.

For example, DCMP IN+ sources from FSM0 and IN- from Register0. DCMP is clocked from the Ring OSC.

Synchronize the data source clock with the DCMP clock source using 2 DFF cells as shown in the images below.
