Errata

SLG46811

CE-GP-008

3.1 Incorrect 64 mV Hysteresis Operation while Using MS ACMP in Regular ACMP Mode

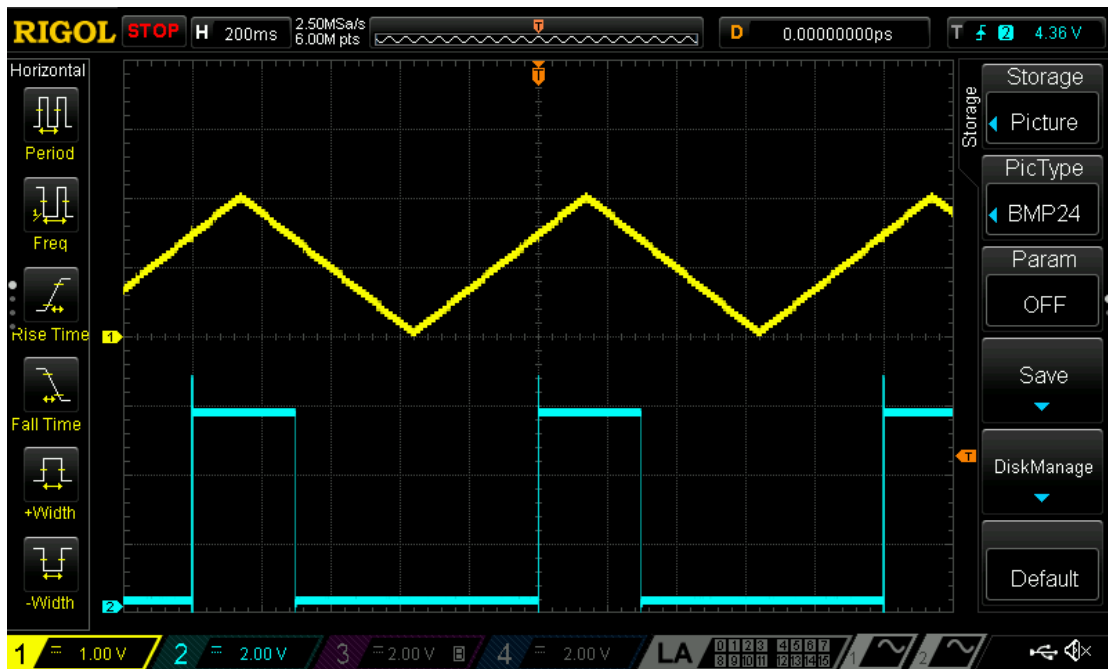
Figure 2: ACMP Output during Glitching

MS ACMP in Regular ACMP Mode with 64 mV hysteresis, $V_{DD} = 4.0$ V or higher, $V_{ref} = 1344$ mV or higher.

If using MS ACMP in Regular ACMP mode with 64 mV hysteresis, MS ACMP output could be glitching when MS ACMP positive input (IN+) close to the negative input (IN-). It can happen when $V_{DD} = 4.0$ V or higher and $V_{ref} = 1344$ mV or higher.

1. Waveform at $V_{ref} = 1536$ mV, hysteresis is equal to 64 mV.

1. Use the deglitch filter connected to the MS ACMP output.
2. Decrease the reference (below 1344 mV) at $IN-$ and add the $IN+$ gain to keep the needed threshold.
3. Use MS ACMP in multichannel mode.

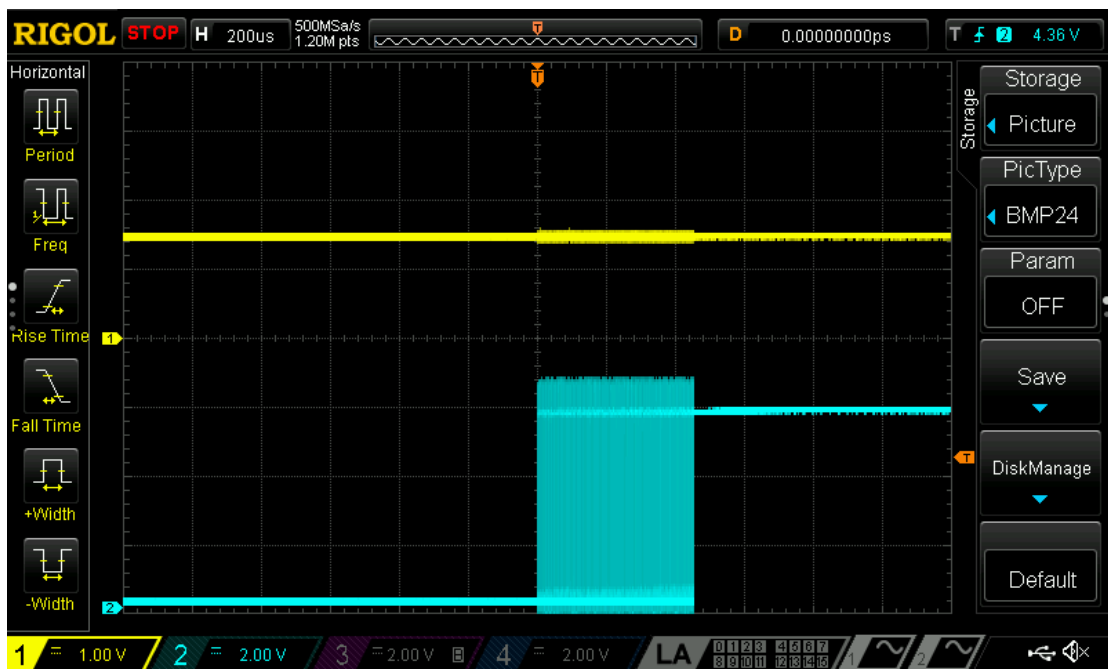
Figure 3: Zoomed ACMP Output during Glitching

2. Waveform at $V_{ref} = 1536 \text{ mV}$, hysteresis is equal to 64 mV (zoomed rising edge).
