SLG47525/28 Errata Note

This document contains the known errata for SLG47525/28 and the recommended workarounds.

<b>Package(s)</b>	14-pin STQFN (SLG47525): 2.0 mm x 2.2 mm x 0.55 mm, 0.4 mm pitch
	20-pin STQFN (SLG47528): 2.0 mm x 3.0 mm x 0.55 mm, 0.4 mm pitch

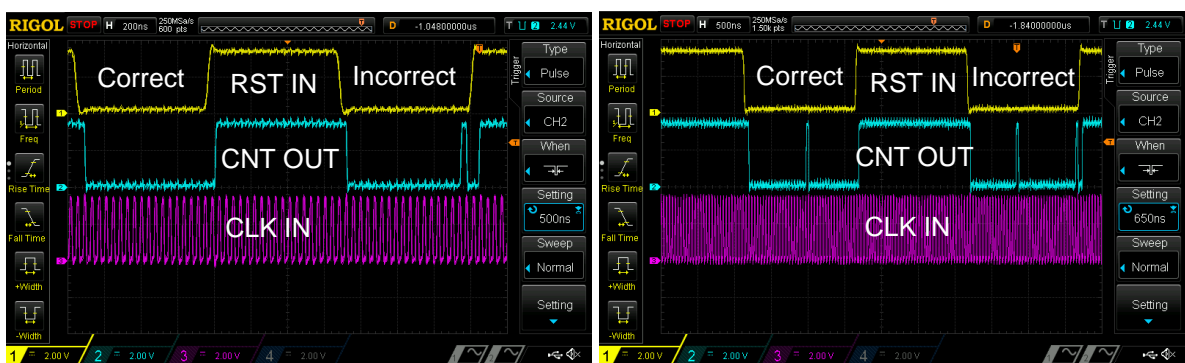
If the Counter Reset is asserted at the same time as a rising clock edge, it is possible that the Counter Data will be reset incorrectly and the counter output may appear faster than expected. This phenomenon appears more often as the clock frequency increases.

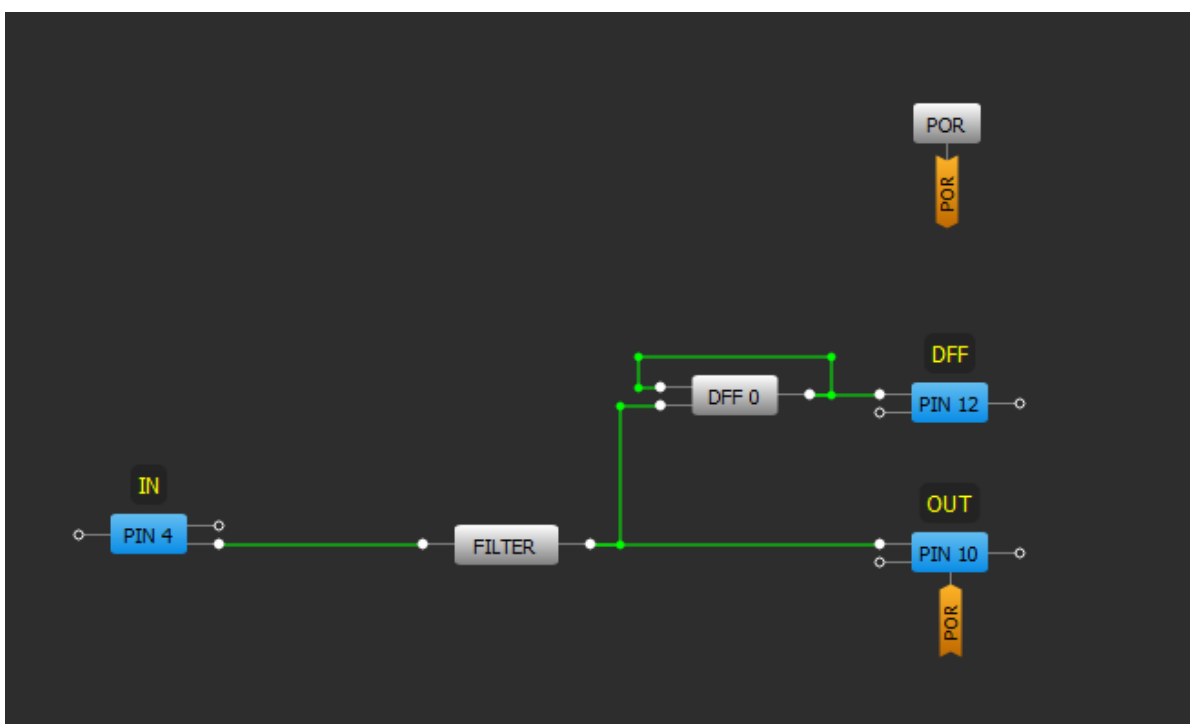
Figure 4

If clock type high frequency input comes in, the FILTER cell may not filter it out. There are several factors like input frequency, duty cycle, and LOW duration in such signal that may lead to its passing through FILTER block.

Currently there is no workaround for this issue. Filter block is good at filtering short spontaneous glitches. It is intended to be used in series connection before the delay cell to avoid its latching.

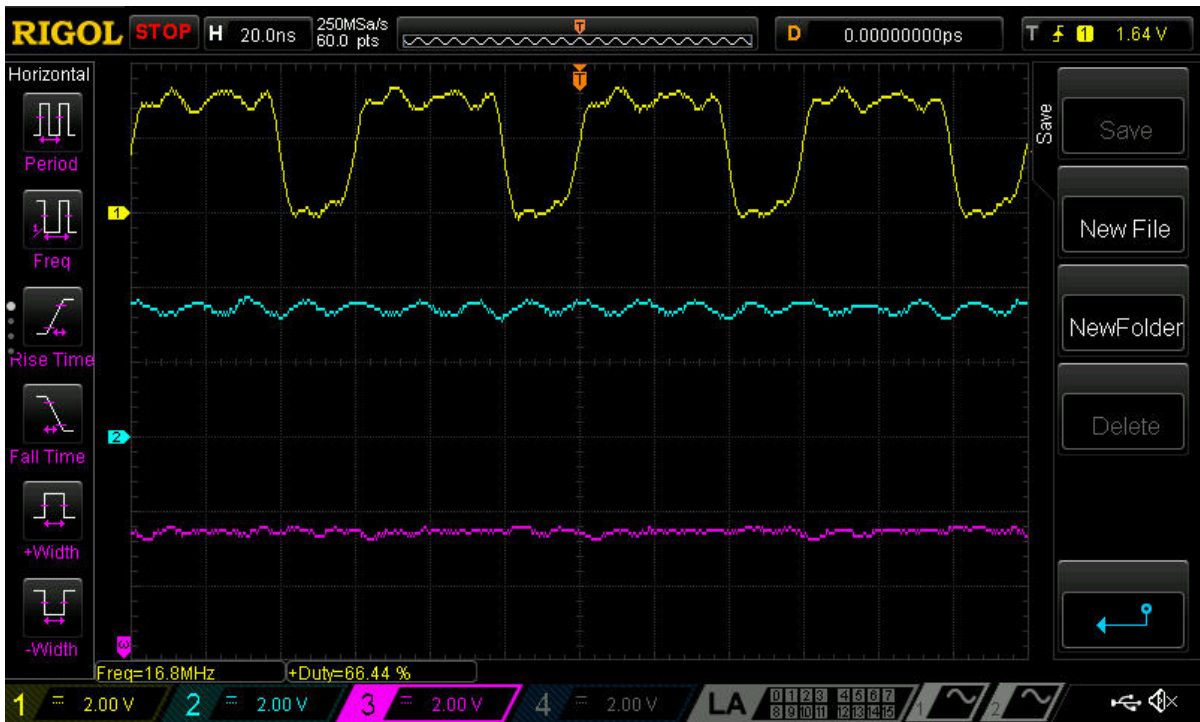
Figure 8

- Period is 60 ns. Pulse width is 40 ns, DC = 66.67 % (correct functionality).

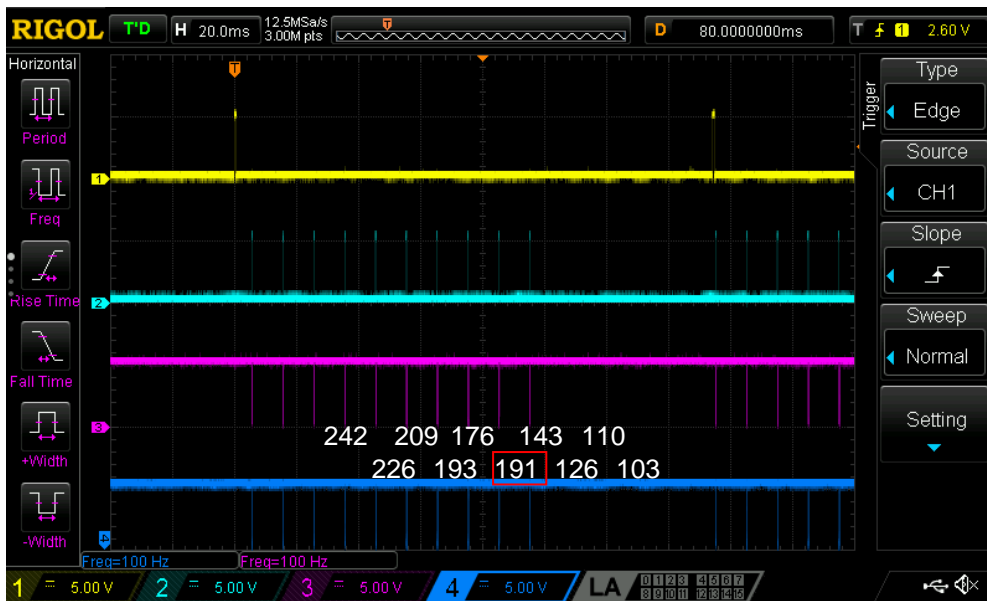
Asynchronous interaction between the CNT/DLY clock input and the I<sup>2</sup>C LATCH signal (generated by an I<sup>2</sup>C read command of the CNT/DLY block's count value) can result in an incorrect I<sup>2</sup>C data read. The CNT/DLY block will count accurately, but the count value transferred into the block's I<sup>2</sup>C read register might be loaded incompletely if the I<sup>2</sup>C LATCH signal and the clock input occur at about the same time.

The example data capture in Figure 9 shows ten periodic I<sup>2</sup>C reads of CNT2/DLY2 configured to count down at about 16 clocks per read. The sixth read sample erroneously shows a value greater than that of the fifth. The seventh sample reads as if the previous I<sup>2</sup>C error never occurred - the difference from the fifth sample (176) to the seventh (143) is 33 clocks or 16 clocks + 17 clocks as expected.

If the possibility of incorrect I<sup>2</sup>C data reads cannot be accommodated for by external software checks, one can guarantee proper operation by stopping the CNT/DLY block's clock during I<sup>2</sup>C reads through one of the following methods: by disabling the oscillator block, by reconfiguring the CNT/DLY block's clock source, or by gating an external clock using a LUT (Look Up Table) in the signal matrix. After disabling the CNT/DLY block's clock, the count registers can be read without error. Please note that this workaround will add the I<sup>2</sup>C read and processing time to the counter's overall clock period.

The best workaround depends on the resource constraints of the application. If the oscillator block does not clock other logic elements within the design, a matrix output can be used to manually power down the oscillators for the I<sup>2</sup>C read. When the CNT/DLY block's clock source is routed internally from the oscillator block, I<sup>2</sup>C commands can temporarily reconfigure the CNT/DLY block's clock source registers to select "Ext. CLK. (From Matrix)". This action will disable the clock by connecting it to ground. If the CNT/DLY block is clocked from the signal matrix, a LUT can be used to gate the clock during the I<sup>2</sup>C read.

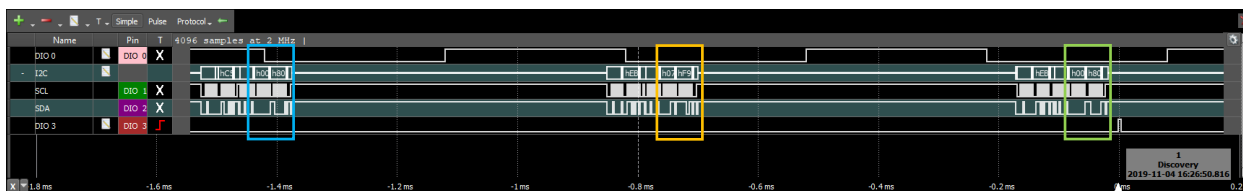
Figure 12. Counter Behavior

For the following condition, the Counter Data register contents are unexpectedly loaded into the counter’s DFF chain. This behavior occurs when there is a falling edge on the counter block’s clock input during the data return

portion of the I<sup>2</sup>C read of the Counter Data registers. Figure 12 shows this falling edge boxed in light blue followed by two I<sup>2</sup>C reads of the Current Count Value registers.

As you can see by the MCU data log below, the Current Count Value gradually increases from 0xF904 to 0xF907 but is unexpectedly reset to 0x8000. Please note that the colored HEX values in the MCU Log correspond to the boxed I<sup>2</sup>C read commands shown in the waveform above. As previously described, this reset occurs because there is a falling edge on the counter’s clock input while the GreenPAK device is responding to the I<sup>2</sup>C read request to 0xC5 and 0xC6 (note that 0xC5/0xC6 are the Counter Data registers and 0xEB/0xEC are the Current Count Value registers for CNT0).

The reason that the counter is not set to 0x8000 on the I<sup>2</sup>C read immediately following the Counter Data query is because the counter requires two rising edges on its clock input to load the data from the Counter Data registers into the DFF chain. Note that all rising edges during T<sub>stop</sub> will be gated internally by the “Stop and Restart” feature.
