**CASE STUDY**

# How System Level Noise in Digital Interfaces can Lead to Spurious Errors in Serial Flash Memory

Paul Hill, Renesas Electronics Corporation

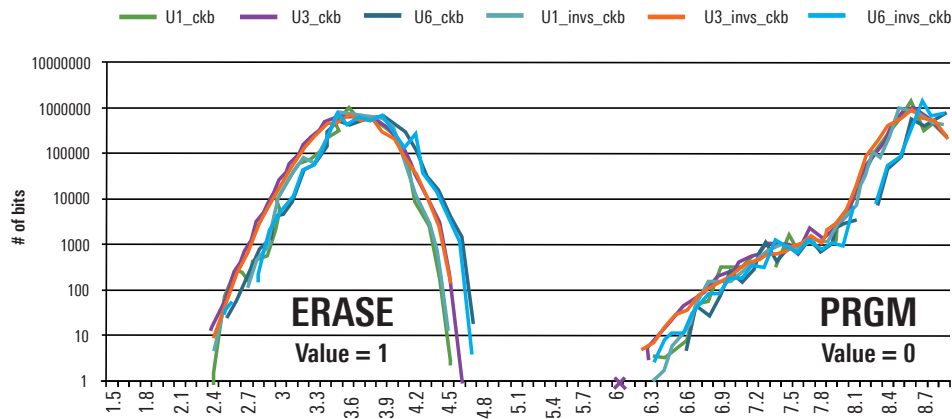
As an example, consider the image in Figure 1. It shows healthy cell margins for six flash devices. Two distinct patterns emerge between cells programmed with data representing logical 1 (2V to 5V) and 0 (>6v). By comparison, the image in Figure 2 shows memory cell margin for three flash devices that have suffered data corruption caused by overshoot and undershoot on the control lines.

Figure 1: This image shows good cell margin separation data for flash memory that has been programmed and erased.

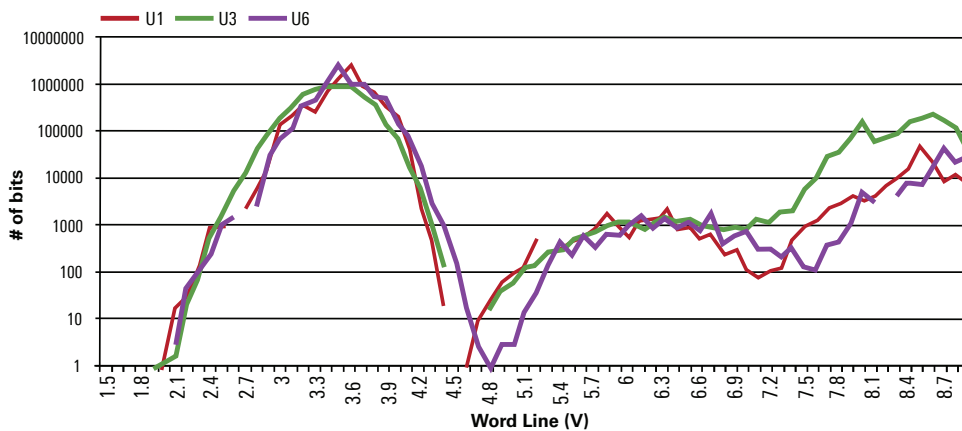
Figure 2: This image shows poor cell margin separation data for flash memory where there has been significant noise present on the SPI lines

Multiple factors can contribute to the noise level, such as frequency of operation, amplitude of the signal, MCU drive levels, and the energy contained in the noise spikes. PCB design and cross talk between signals may also be contributing factors.

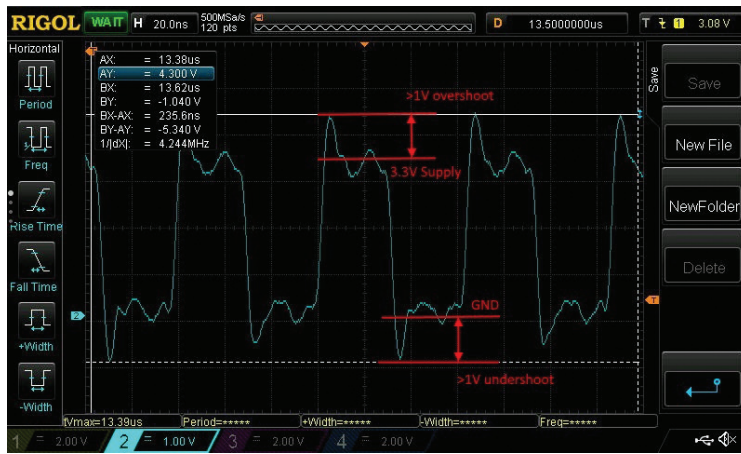
The data in Figure 2 shows the effects of excessive overshoot and undershoot on the serial interface. Figure 3 below shows a representation of what this overshoot would look like in a real application.

The result of this noise was erroneous device operation, which showed up as errors in the serial flash memory stored values. Initially, the true impact of the errors was missed, as polling the STATUS register on a less frequent basis reported fewer errors, leading the designer to make incorrect assumptions on the root cause of the failure.

Although this fault appeared as a memory failure, the root cause was not with the flash devices. This was discovered by Renesas engineers by probing the SPI signals and identifying the system noise present. While the noise could be partly attributed to an impedance mismatch present on the PCB track between the MCU and flash memory, it wasn't the full story. The source of the noise was actually the MCU interface, which defaults to a high drive level at power-up. The excessive drive was enough to cause overshoot and undershoot on the SPI lines, which in some cases can be misinterpreted as signal transitions, leading to read or write errors. However, in this instance it was found that the overshoot held sufficient energy to disrupt the flash charge pump, which was in turn causing the errors.

Figure 3: This trace image clearly shows the overshoot and undershoot present on the SPI lines was resulting in a peak-to-peak voltage of 5.65V, which exceeds the absolute maximum value documented in the flash memory specification.

In the customer's design, the microcontroller being used provided a configurable drive current for its I/O, which defaults to HIGH at start-up. As the application code did not modify this level during initialization it remained high in normal operation. The impact of this may not be apparent for other devices on the SPI bus, as digital interfaces are typically designed to be robust. The sensitive nature of flash memory, the need to operate at much higher frequencies, and in particular, the operation of the charge pump, made the memory susceptible to overshoot/undershoot. This led to erroneous operation that was initially misinterpreted as a fault in the flash memory device.

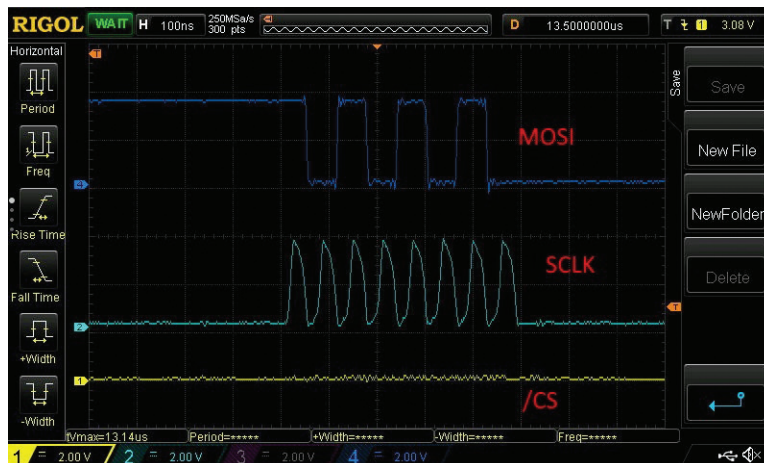
Figure 4: With no overshoot apparent, the serial flash memory's charge pump was able to operate correctly and provide reliable functionality

Reducing the drive current, through firmware, reduced the overshoot and undershoot to effectively zero (Figure 4), and in turn resulted in error-free operation of the flash memory.
