# 1 Purpose of Document

This document summarizes the changes between the previous ASI4U silicon revision C and the current silicon revision E. These include requested UART design changes. The purpose of the redesign was to correct reported timing errors by the UART in the following modes: Master, Monitor, and Repeater. A problem with slave communication in special network constellations was also fixed.

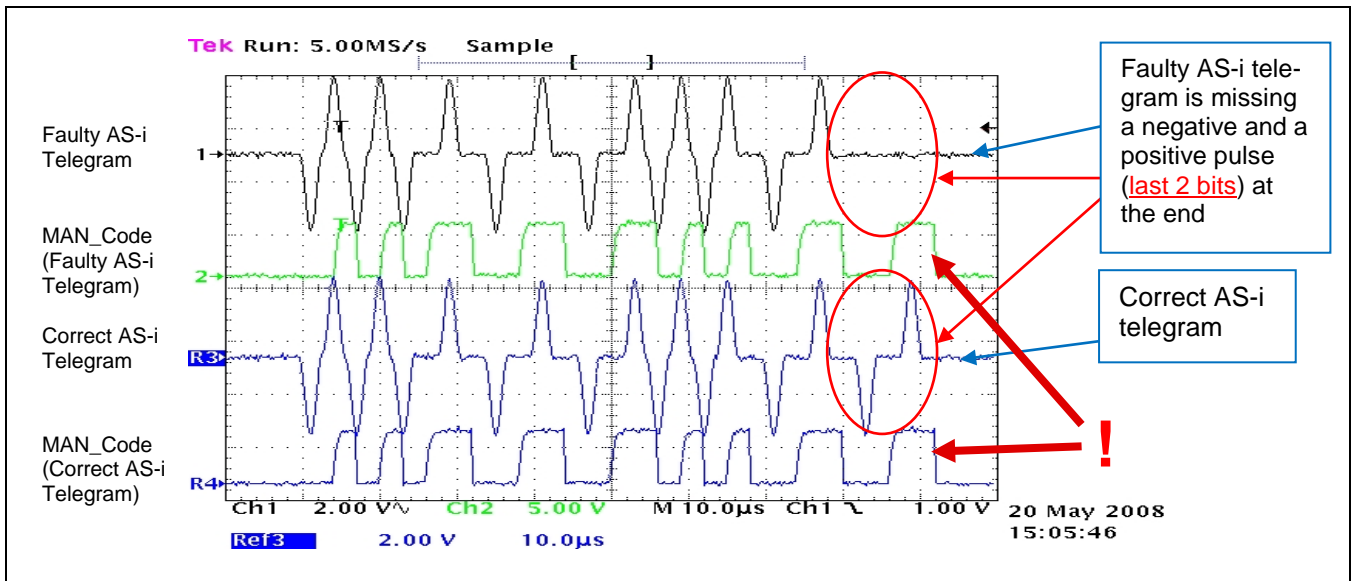
If the ASI4U revision C operates in Master Mode, Monitor Mode or Repeater Mode, the error signaling for an *End\_Bit\_Error* does not work correctly. In some special cases, the generated MAN-Code of a signal with an *End\_Bit\_Error* looks similar to the MAN-Code of a signal without any errors as demonstrated in Figure 2.1.

This malfunction of the ASI4U revision C results in an MAN-coded output signal that does not allow distinction between correct AS-I pulse sequences and pulse sequences that are shortened (missing one negative and one positive pulse). It occurs only under the following conditions:

- The parity of the signal is even.
- The last bit of the corrupt telegram is equal to binary 1.
- The *Stop\_Bit* and the *Parity\_Bit* or the *Start\_Bit* and the *Control\_Bit* are missing.
- If the *Start\_Bit* and the *Control\_Bit* are missing, the first pulse must have a negative polarity.

**Figure 2.1 Comparison of Valid MAN-Code Signal to Faulty MAN-Code Signal**

1. The last pulse of the MAN-coded LED1 output signal is now always kept in ACTIVE state for 9 $\mu$ s if an ASI telegram with an *Endbit\_error* is received.

The polarity of the ACTIVE State depends on the signal setting at the DI ports in Master Mode, Monitor Mode, and Repeater Mode. If DI2 and DI3 are driven by equal input signals, the MAN output signal at LED1 is configured ACTIVE LOW. If DI2 and DI3 are driven by unequal input signals, LED1 becomes inverted and is configured ACTIVE HIGH.

Since a 9 $\mu$ s-wide MAN pulse is an out-of-specification event for the AS-I MAN signal, it will allow the connected microcontroller to recognize the error in the AS-I pulse signal on the AS-I line.

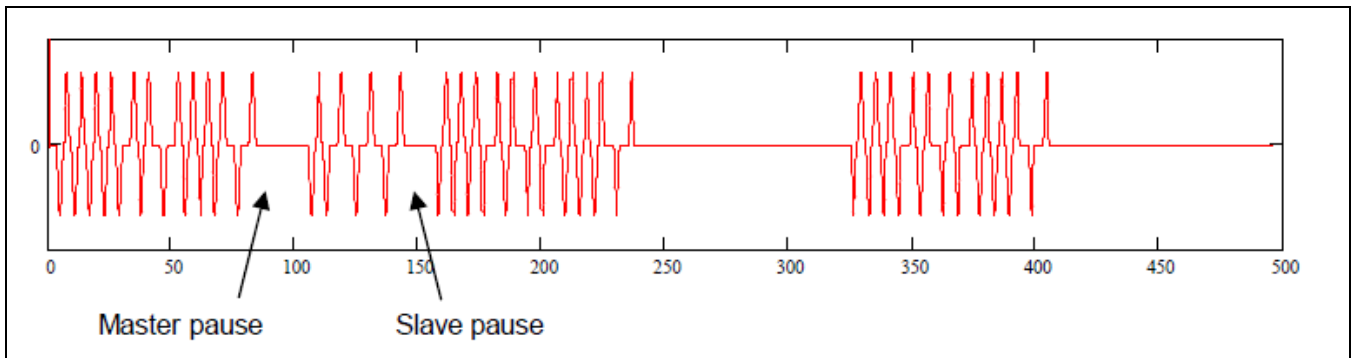
If the previous ASI4U revision C is operated in Slave Mode, the UART Master Pause detection does not always function correctly when the UART must listen to slave responses from a different slave. Depending on the actual AS-I line pulse timing, a slave response from a different slave is sometimes not recognized correctly, which results in a UART communication error. This prevents the Slave from understanding the next Master telegram correctly. If the Master telegram addresses the Slave itself, the error leads to a missing slave response and the Slave replies on a second repetition of the Master Call to its own address in asynchronous mode.

This behavior was mostly observed in mixed networks that used modules with the ASI4U, SAP5, and SAP4.1.

Figure 3.1 shows a telegram test case to reproduce the error. The AS-I signals shown in Figure 3.1 were generated by a signal generator that allowed sweeping the Master Pause and Slave Pause duration over the allowed specification limit. The first Master Call contains a different slave address than the tested slave. The second and third master calls address the tested slave. The tested slave replied with the erroneous behavior for certain Master pause and Slave pause scenarios only. The majority of the test cases were passed without error.

**Figure 3.1 Test for ASI4U Revision C Error in Master Pause Detection**

A new principle of AS-i telegram pause detection was implemented in ASI4U silicon revision E that is more precise and able to cover all valid timing scenarios for Master and Slave pauses. The new principle is now independent of the internal timing constraints of the UART state machine.
