# RENESAS TECHNICAL UPDATE

| Product Category | MPU/MCU | | Document No. | TN-RH8-B0567B/E | Rev. | 2.00 |
| Title | RH850 G3M stuck Issue | | Information Category | Technical Notification | | |

We confirmed that the G3M CPU gets stuck while running a certain program code.

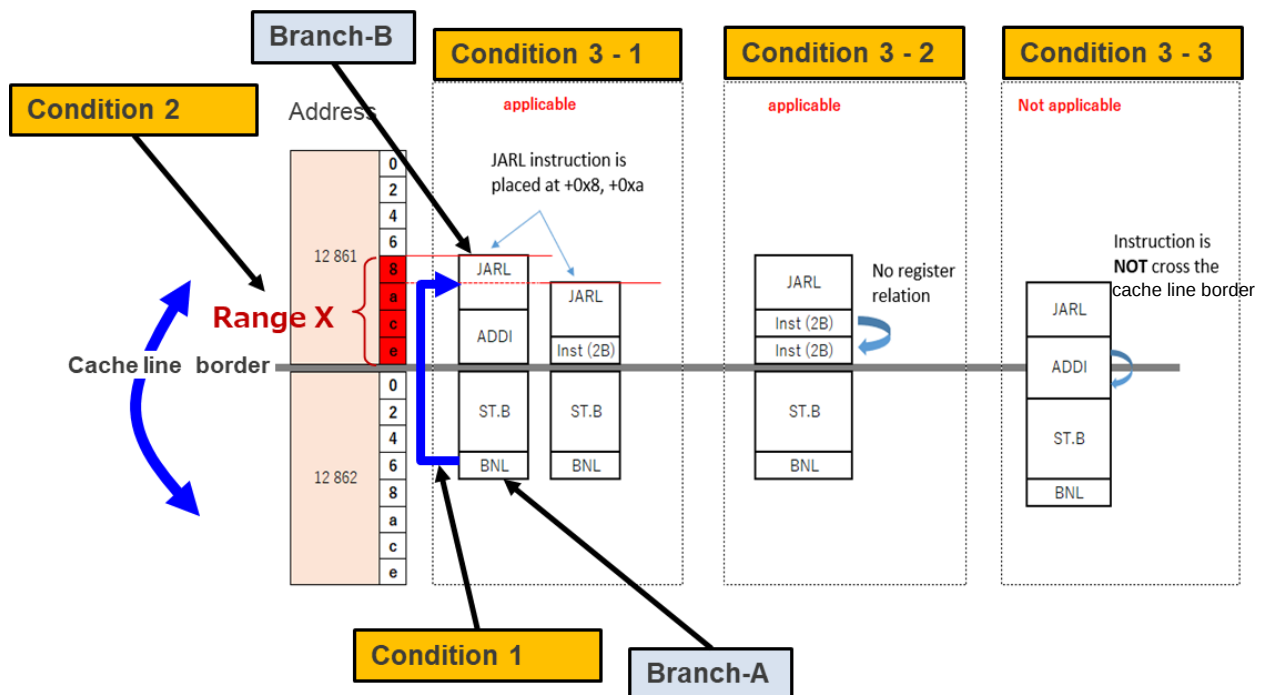
If All below condition are applicable to source code, source code has possibility to generate issue.

Condition 1: Branch to backward address

Condition 2: [Branch instruction B] place to after jump target of [Branch instruction A]. And, each instruction address are place to different cache line (16-byte placement block) and adjacent.

3-1. [Branch Instruction B] is placed to address +0x8 ~ +0xf [Range X]

3-2. 1 or 2 instruction are placed between [Branch instruction B] and cache line border except following condition

- [1 instruction]: SYNCI
- [2 instruction]: 2 instruction doesn't use same register (doesn't occur conflict of register)  
or either instruction is NOP/SYNCI/SYNCP/SYNCM/part of FPU instruction

3-3. Instruction doesn't cross the cache line (16-byte placement block) in [Range X]

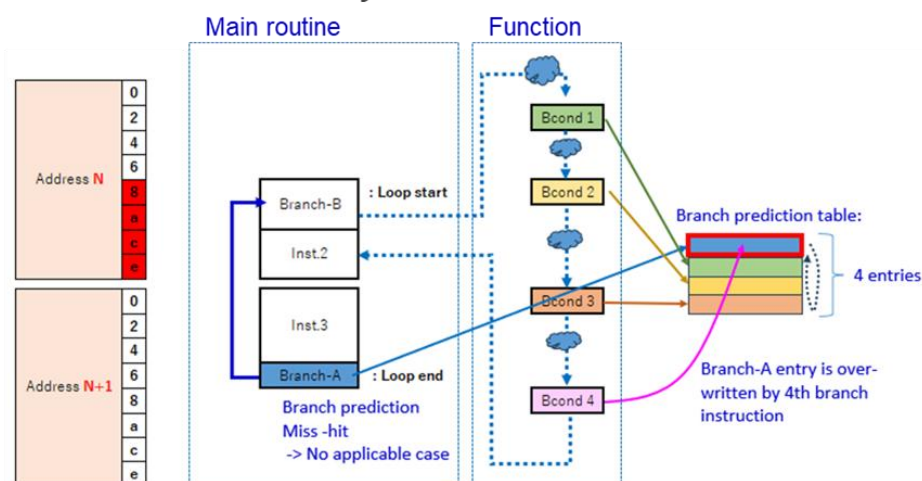
## ➤ Branch Prediction Entry Status

One of the dynamic conditions is the number of branches in the code sequence from [Branch instruction B] (the call to "Function")

- From the viewpoint of the HW mechanism, one of the applicable conditions is that "the branch prediction when [Branch instruction A] is executed is a hit".
- If the "function" called from [Branch instruction B] has four or more branch instructions (Bcond 1,2,3,4) <\*1> the branch prediction table entry for [Branch instruction A] will be lost by re-executing the [Branch instruction A], and it will not be applicable.
