SLG46625-A Errata Note

This document contains the known errata for SLG46625-A and the recommended workarounds.

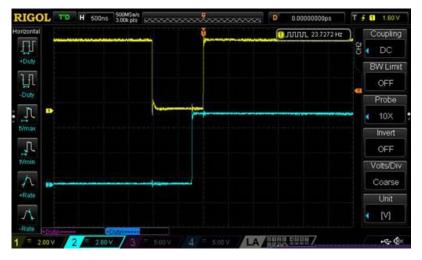
Figure 1. ACMP Output Glitch

The output of the ACMP incorrectly goes low even when IN+ is greater than IN- if the RING OSC is active when the WS signal rises.

Channel 1 - ACMP out

Channel 2 - WS_OUT

Avoid using the RING OSC with the WS Controller or add a filtering block on the ACMP output to filter out the glitch.

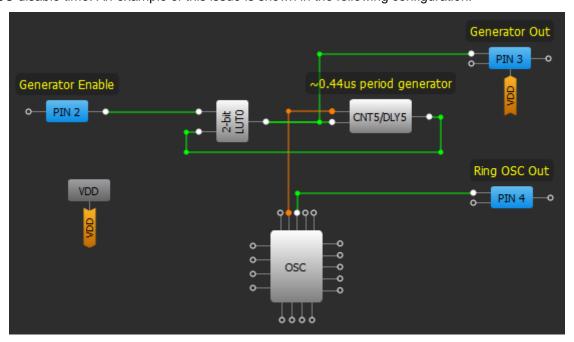
Figure 2. Ring OSC Test Design

The Ring OSC has a longer settling time when configured as Auto Power On in the designs that have very short Ring OSC disable time. An example of this issue is shown in the following configuration:

Set Ring OSC power mode to "Force Power On" or Set Turn on by register option in BG (Band Gap) block as "Enable".

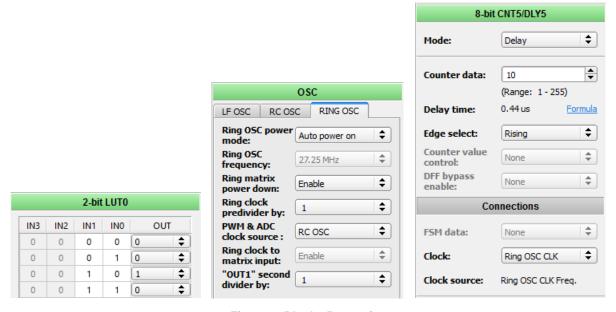
Figure 3. Blocks Properties

The configuration shown above generates a periodical signal with a frequency defined by the Delay cell and started by a high signal on PIN2. The issue becomes apparent in a longer settling time when the scheme generates short pulses (Delay is configured as a rising edge delay only). See the waveform in Figure 4.

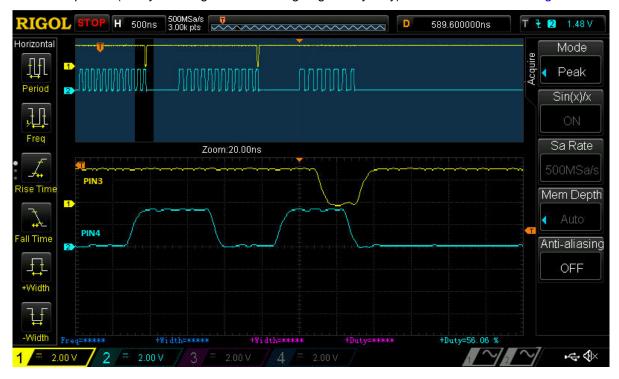
Figure 4. Ring OSC Output

Channel 1 - 2-bit LUT0 output

Channel 2 - Ring OSC output

Such behavior will lead to substantial error in period calculations if the delay time is relatively small.

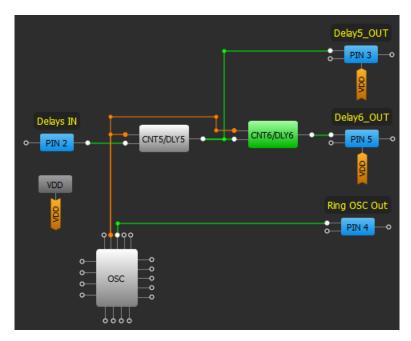
Figure 5. Ring OSC with DLY5, DLY6 Test Design

A similar situation can occur while using two connected delays (all edge detect types except for a pair "Rising edge DLY – Falling edge DLY").

In Figure 5, Delay5 and Delay6 are configured in the same way. However, Delay5 time is 11.4 us instead of expected 0.4 us (Delay5 time).

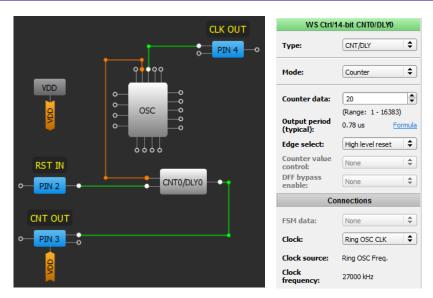
Figure 7. CNT Test Design

If the Counter Reset occurs at a time very close to a rising edge of the clock signal during clock signal generation (for example OSC operation), there is a possibility that the Counter Data of the Counter is reset incorrectly and the counter end signal (HIGH pulse) may appear faster than expected. This phenomena appears more frequently the higher the clock frequency is.

Synchronize RESET input of the Counter with its CLK using 2 DFF cells as shown in Figure 9.
