R20TS0239EJ0101

RX600 and RX200 Series

I²C Bus Single Master Control Software Using RIIC Serial Interface

Outline

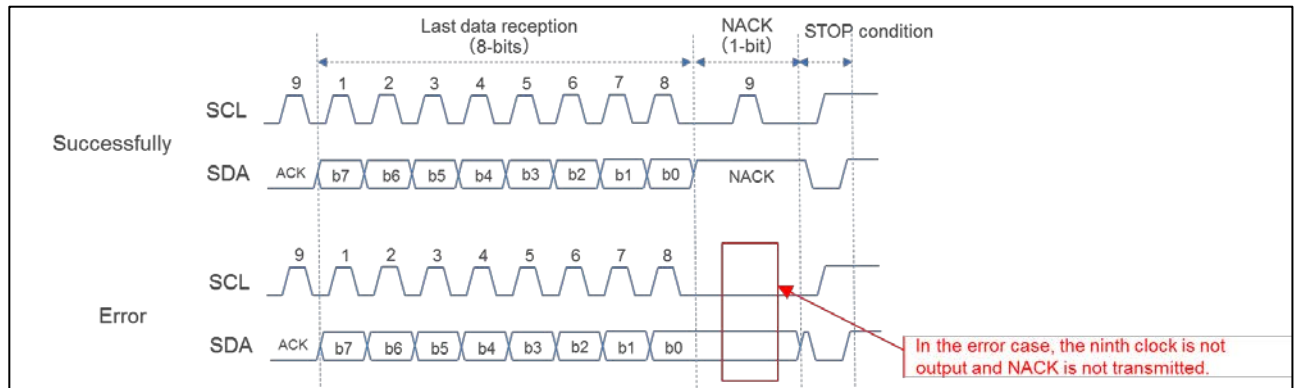
Figure 1 Last Data Reception Waveform in Successful and Error Cases

In successful reception of the last data, the MCU receives 8-bit data, and then transmits 1-bit NACK. However, in the error case, NACK is not transmitted even after reception of the last data.

The problem arises when all of the conditions listed below are met.

- (1) The software control protocol is set to master reception or master composite.
- (2) System clock (ICLK) > peripheral module clock (PCLK) > SCL clock is established^(Note).

The problem is more likely to occur with larger differences between SCL clock and ICLK or PCLK.

Note: (Reference values) The problem occurs when ICLK = 100 MHz, PCLK = 50 MHz, SCL clock =< 100 KHz.

1.5 Workaround

Change the source code for the following function as shown in red.

r_iic_drv_receive_end_setting() function of r_iic_drv_sfr_rxXXX.c^(Note)

This problem will be fixed in the next version. The release date has not yet been decided.

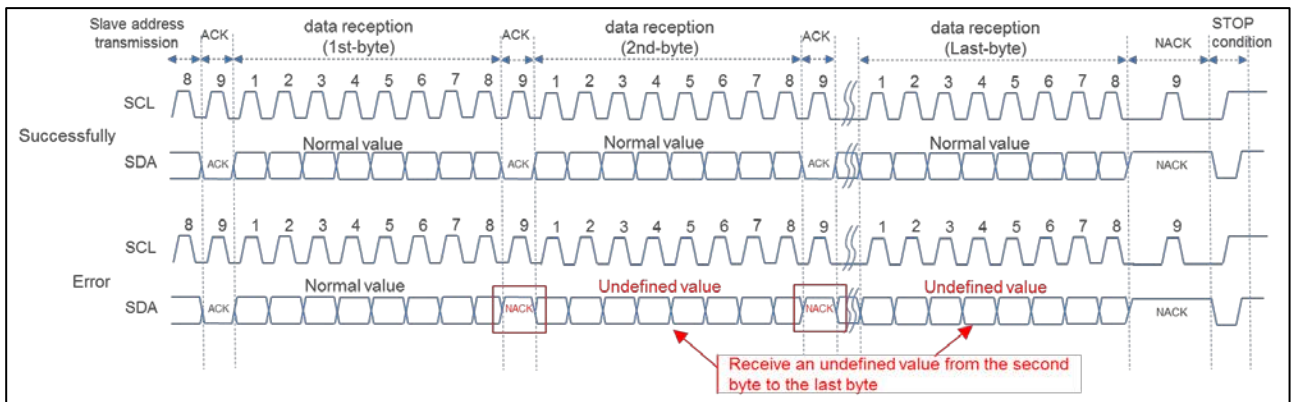
Figure 2 Communication Waveform When Using a Channel Other Than Channel 0 of the RIIC in Successful and Error Cases

In successful reception of data, the MCU receives 8-bit data, and then transmits 1-bit ACK (for the last data, NACK). In the error case, NACK is always transmitted after reception of data. Therefore, an undefined value is received from the slave device during the period from reception of the second byte of data to reception of the last data^(Note).

The problem arises when all of the conditions listed below are met.

- (1) The software control protocol is set to master reception or master composite.
- (2) A channel other than channel 0 of the RIIC is used.
- (3) An interrupt other than the RIIC occurs in the period from when the ICDRR register is read to when the ICMR3.ACKBT bit is set to "1" in the last data reception processing.
- (4) A stop condition has been issued during the interrupt processing of (3).
- (5) Data reception is re-executed after the issue of a stop condition of (4).

2.5 Workaround

Change the source code for the following function as shown in red.

r_iic_drv_next_comm_setting() function of r_iic_drv_sfr_rxXXX.c^(Note)

This problem will be fixed in the next version. The release date has not yet been decided.
