SLG46108-EV Errata Note

This document contains the known errata for SLG46108-EV and the recommended workarounds.

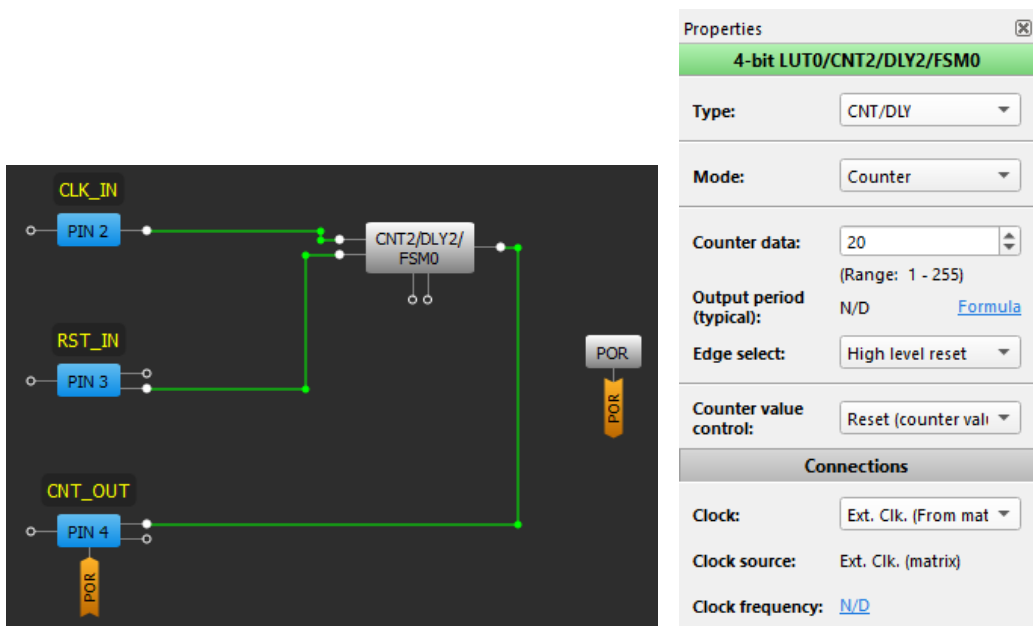
Figure 1. Testing Design and Settings

If the Counter Reset is asserted at the same time as a rising clock edge, it is possible that the Counter Data will be reset incorrectly and the counter output may appear faster than expected, it doesn't depend on the edge select option. This phenomenon appears more often as the clock frequency increases.

Synchronize the RESET input of the Counter with its CLK using 2 DFF cells as shown in Figure 3.

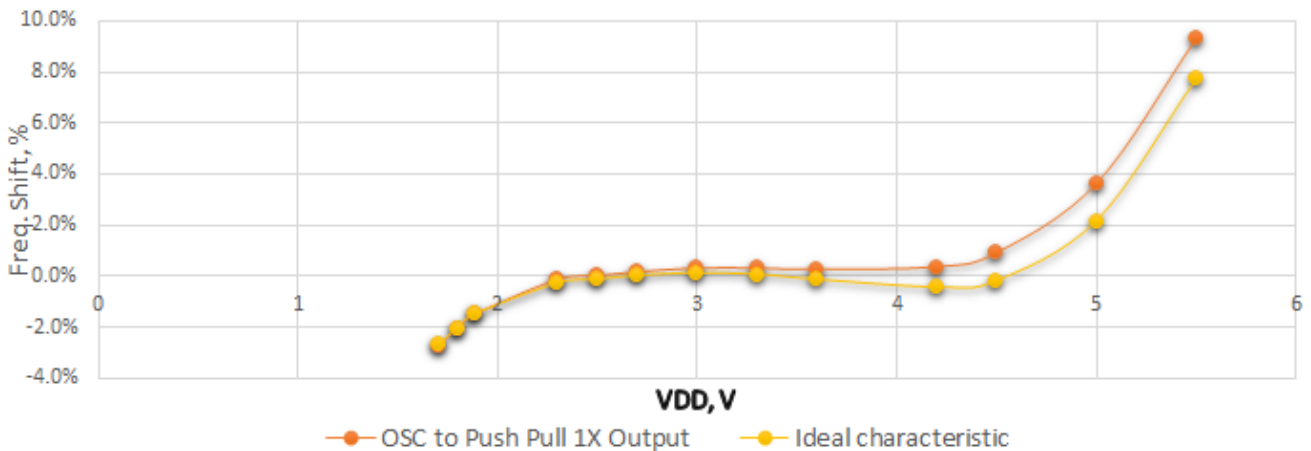
Figure 4. OSC Frequency vs. V_{DD}

While applying some high-frequency noise to the V_{DD}, OSC inaccuracy may increase. The same behavior is also present in cases where high-frequency switches are outputted from the chip using the Push-Pull type driver. See, the test results in [Table 1](#).

Currently, there are no viable workarounds for this issue. However, the issue can be minimized by doing the following:

- Only use frequencies lower than 2 MHz when switching the output.
- Do not use parallel PIN connections to output high-speed switching signals.

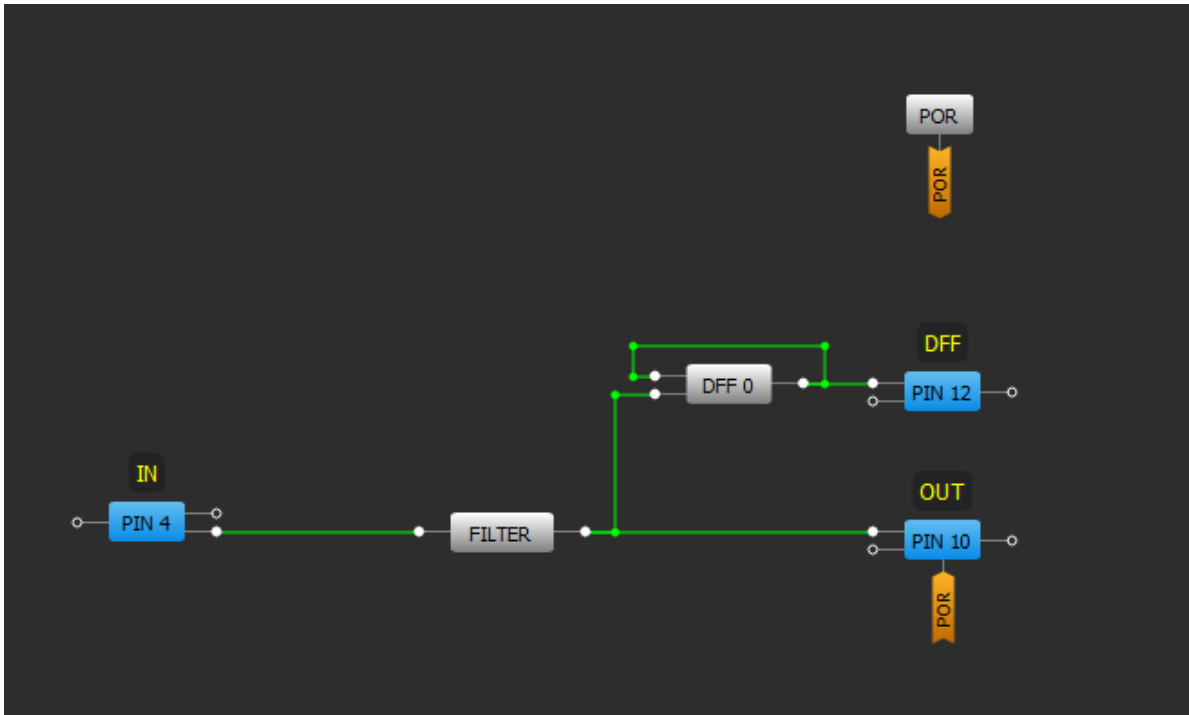
Figure 6. Testing Design

If high-frequency clock input comes in, the FILTER cell may not filter out it. There are several factors like input frequency, duty cycle, and LOW duration in such signal that may lead to its passing through the FILTER block.

Currently, there is no workaround for this issue. Filter block is good at filtering short spontaneous glitches. It is intended to be used in a series connection before the delay cell to avoid its latching.

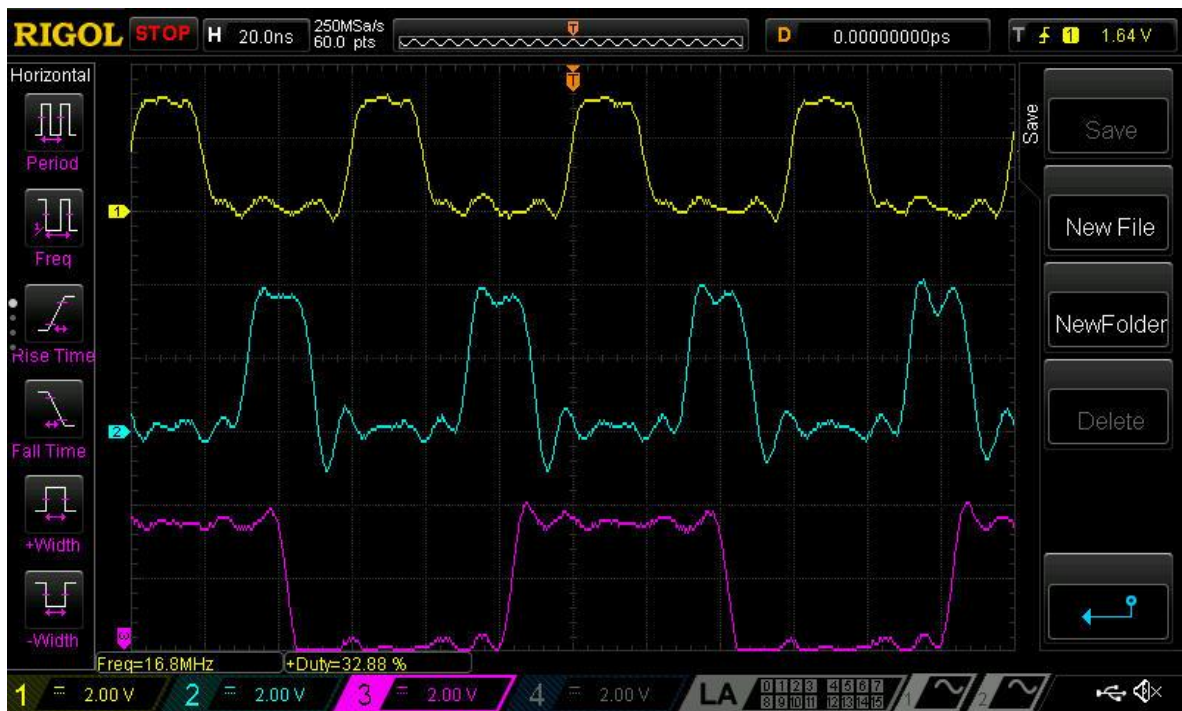
Figure 8. Output Waveforms at Period = 60 ns, Pulse Width = 20 ns, DC = 33.3 % (Incorrect Functionality)

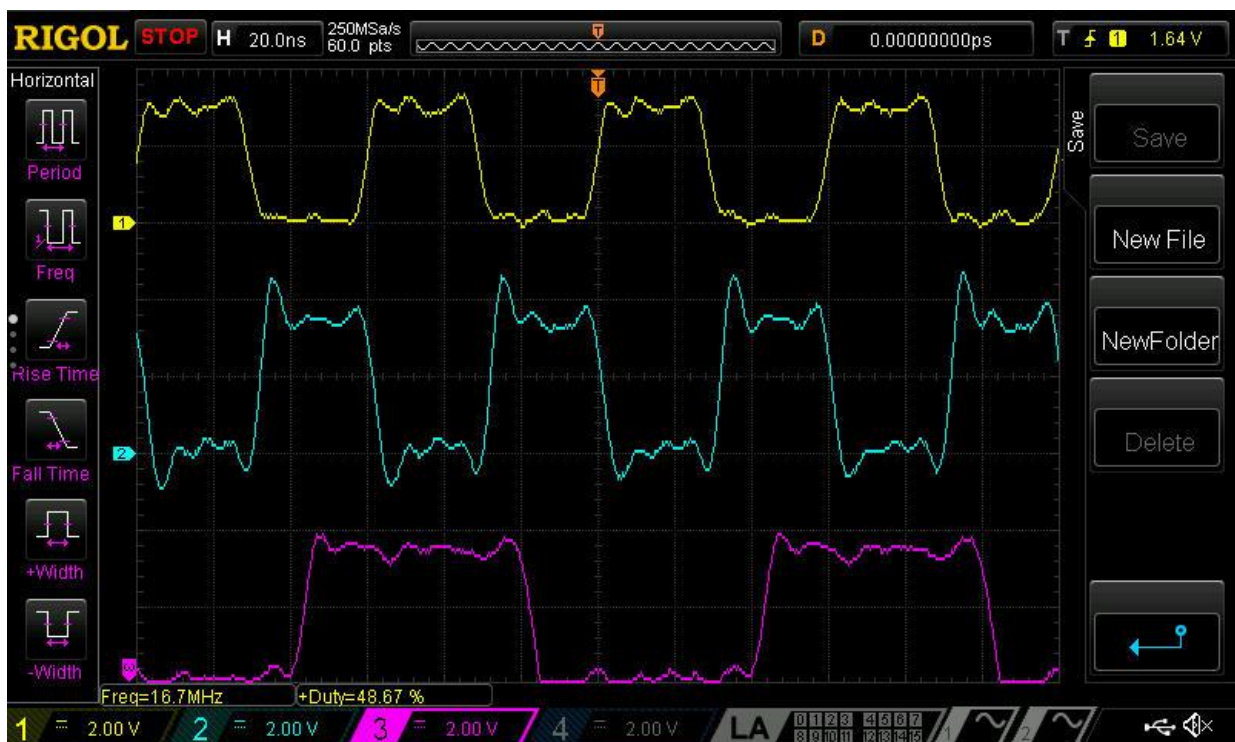
Figure 9. Output Waveforms at Period = 60 ns, Pulse Width = 30 ns, DC = 50 % (Incorrect Functionality)

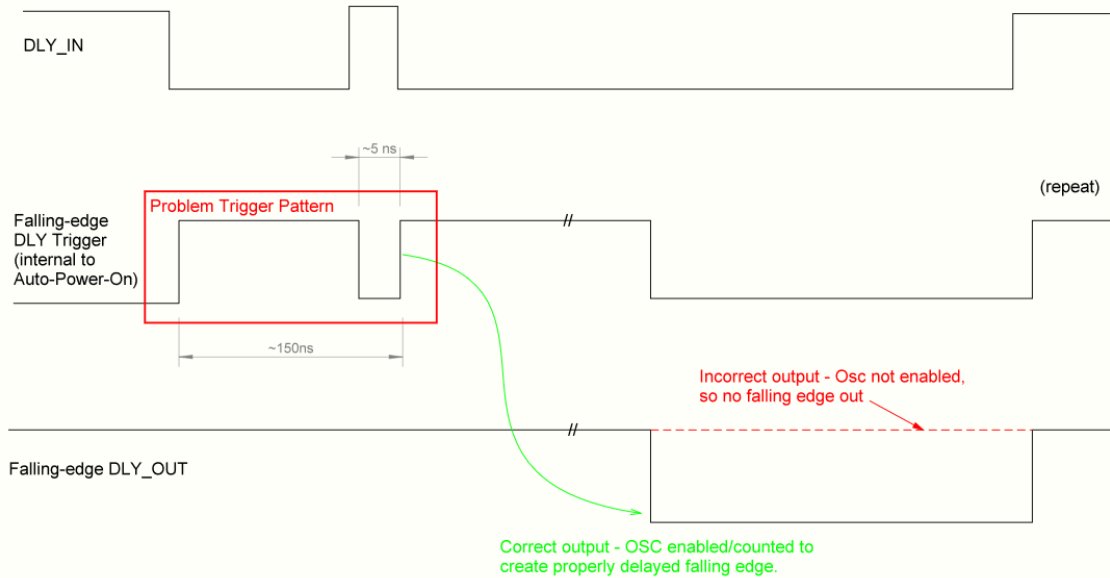
Figure 11: Problem Trigger Pattern

For this chip, the Auto Power On circuitry of the 25 kHz/2 MHz generators contains a circuit errata, which can potentially fail to power on the OSC for a specific pattern and timing of the OR of all related DLY trigger signals. The pattern is shown in Figure 11 (boxed in red) and consists of a relatively longer pulse (~145 ns) followed by a shorter (~5 ns) glitch of opposite polarity.

- Use signal conditioning circuits to prevent glitches on DLY inputs < 200 ns. Examples:
 - ACMP with Hysteresis
 - External RC in front of Digital Input with Schmitt Trigger
 - Filter cell.
- Set OSC power mode to Force Power On mode instead of Auto Power On.
- Use a different oscillator, such as 25 MHz Ring OSC, which does not have Auto Power On issue.

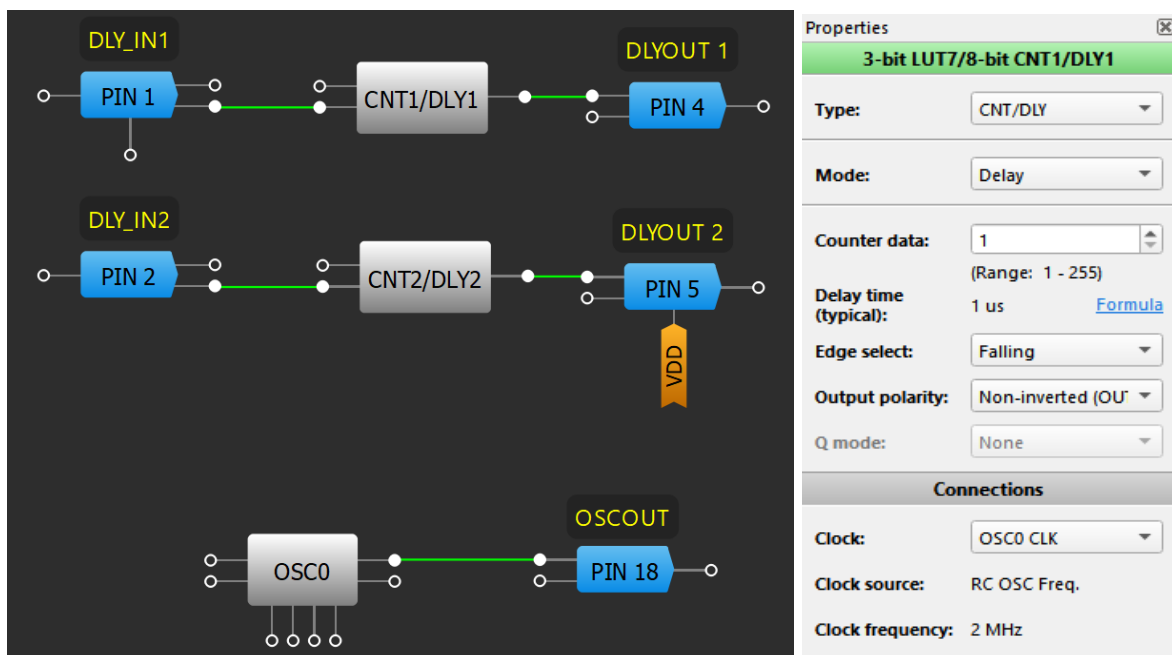
Figure 12: Test Circuit

The error is difficult to capture as the timing must be exact within ns, and short (ns) pulses are difficult to generate glitches precise enough to induce the problem. GPIO naturally filters out ns pulses, so for purposes of errata capture, two simultaneous falling-edge DLY circuits (as shown in Figure 12) were used. By lining up two delays precisely at a particular timing relationship, we can use the internal Auto Power On (OR logic) to generate the glitch pattern necessary to cause the error.

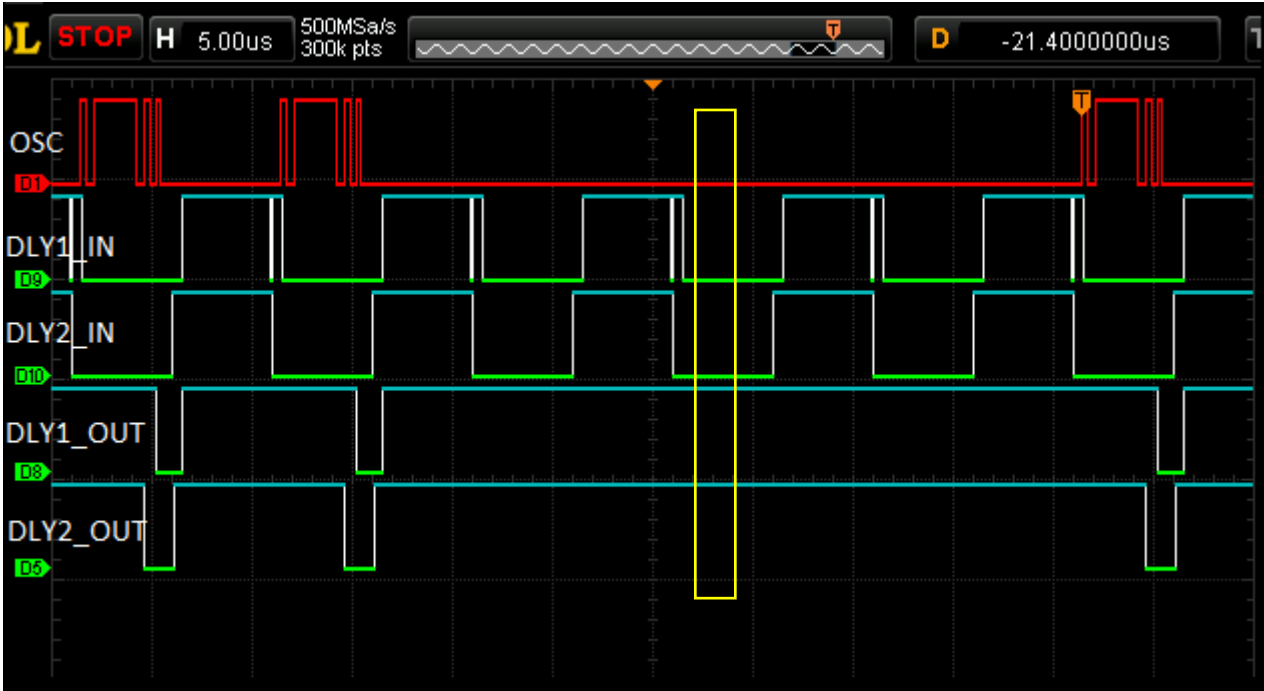
Figure 13: Errata Capture (Zoom Out)

Figure 13 shows a series of DLY output events are missing, where the OSC is correspondingly not triggering when it was supposed to. Figure 14 is a zoom-in of the boxed region from Figure 13. The total glitch/chatter time was measured in this case at 152 ns. By using the composite OR of the two delay channels, we can asynchronously strobe with tiny frequency variations, and so tune the timing to induce this errata. Note that the error is not persistent – the system is recovered when all DLYs are returned to inactive state, such as when input of falling edge DLY goes high, thus canceling delay, or after DLY out finishes.
