Errata

SLG46117

CE-GP-012

This document contains the known errata for SLG46117 and the recommended workarounds.

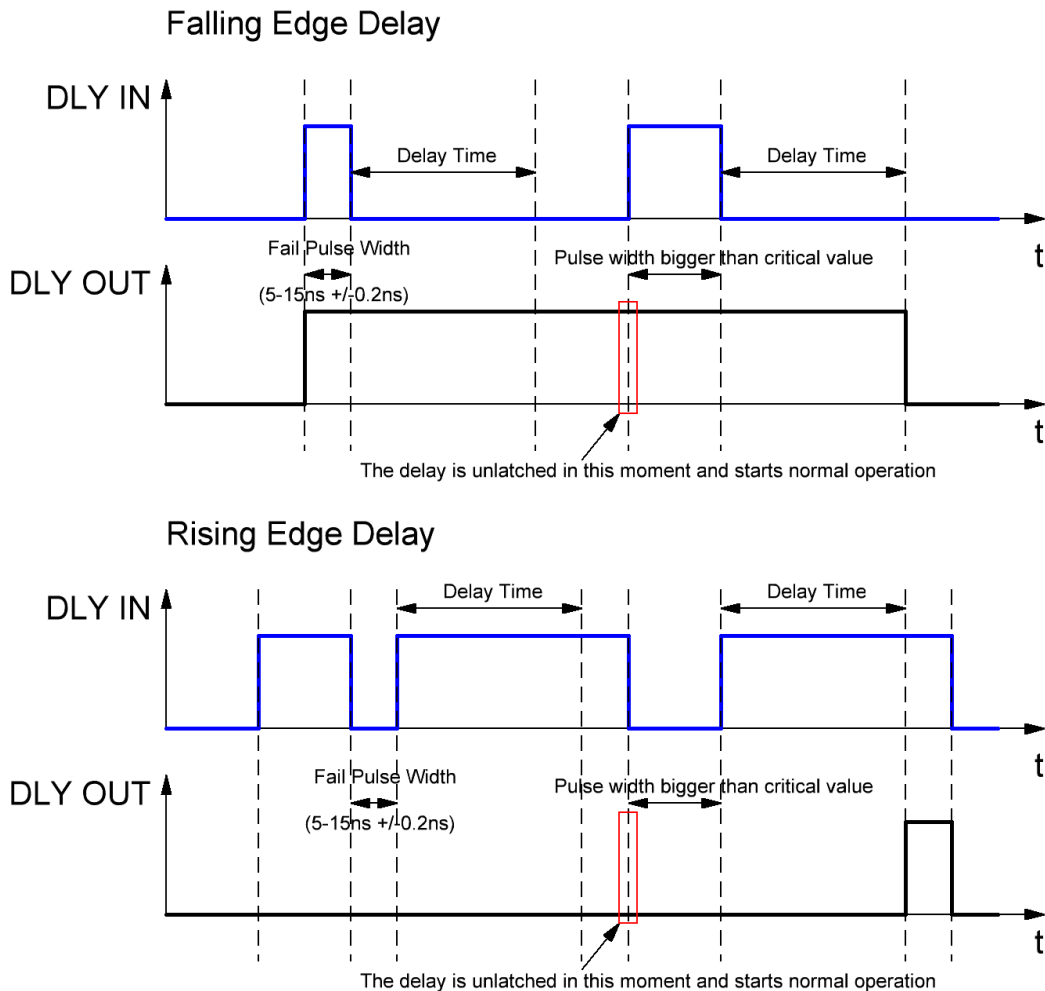
The delay output could be latched despite the input change when a short pulse is input. For example, if the delay cell is configured as a falling edge delay, the short pulse (see NOTE) appears on its input the delay cell output will switch from LOW to HIGH but may not switch from HIGH to LOW even after the delay time has passed.

NOTE: The pulse width varies from chip to chip and with different V_{DD} voltage. It is in range of 5-15ns and in the window $\pm 0.2ns$, so it should be very precise for issue happen.

Use P DLY/FILTER block configured as a both edge delay or FILTER.
