Errata

SLG46121

CE-GP-019

This document contains the known errata for SLG46121 and the recommended workarounds.

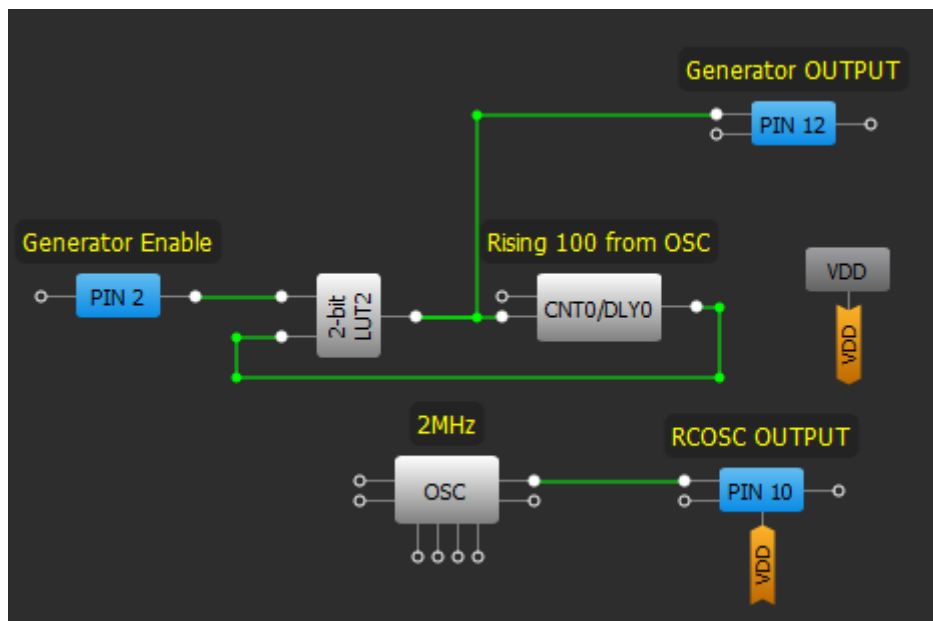
An example of such issue is in the following configuration:

The RC OSC has a longer settling time when configured as 2 MHz with Auto Power On in the designs that have very short RC OSC disable time.

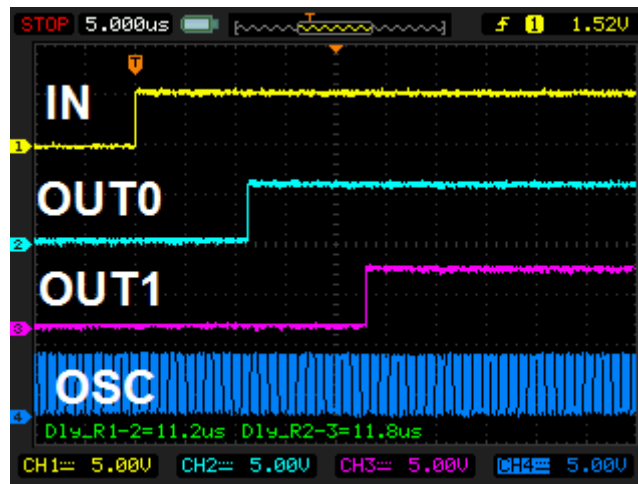
If there are some inner blocks which use RC OSC at the moment or RC OSC is forced power on when such error appears, RC OSC will be operational and delay value will be proper.

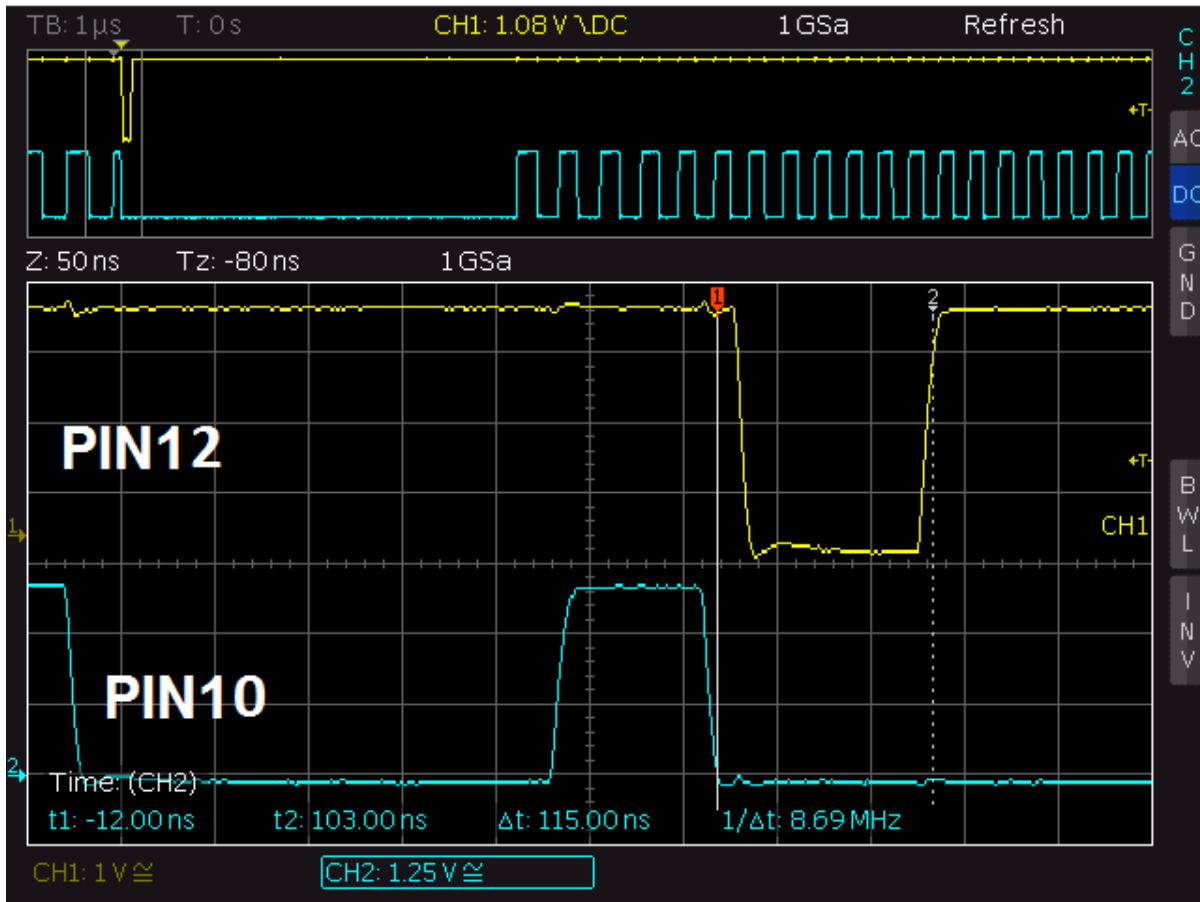
Channel 1 – 2-bit LUT0 output; Channel 2 – RC OSC output

- In first case use block with longer propagation time.

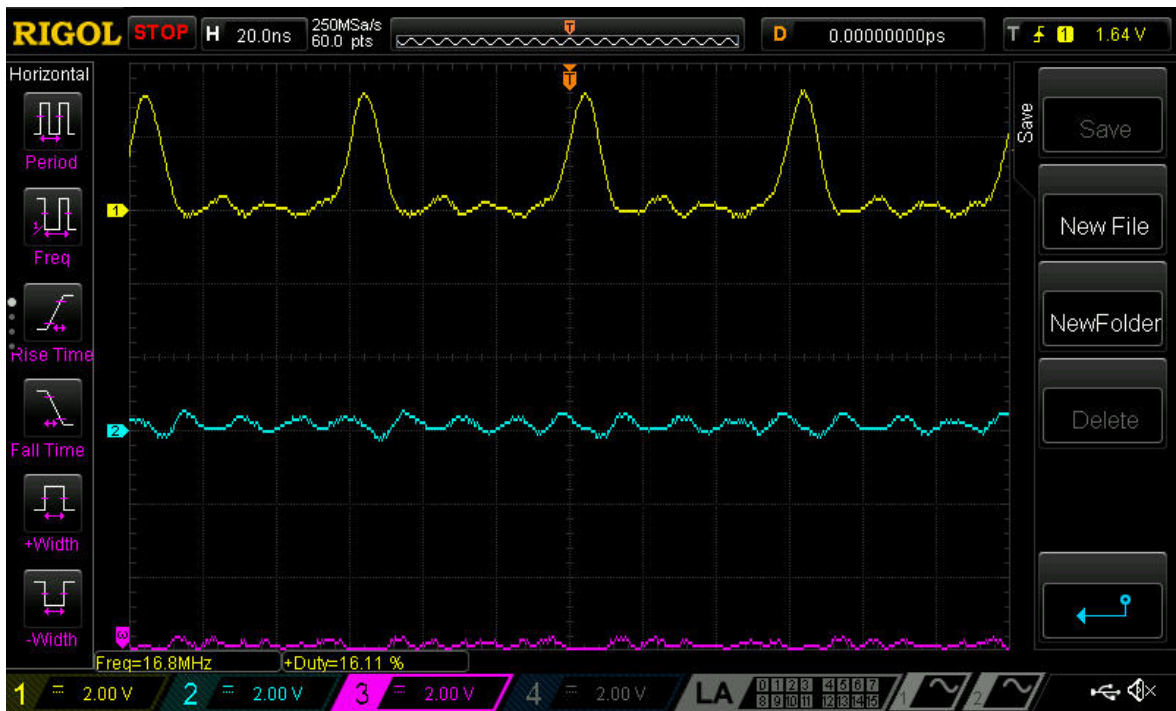
1. Period is 60ns. Pulse width is 10ns DC=16.7% (Correct functionality)

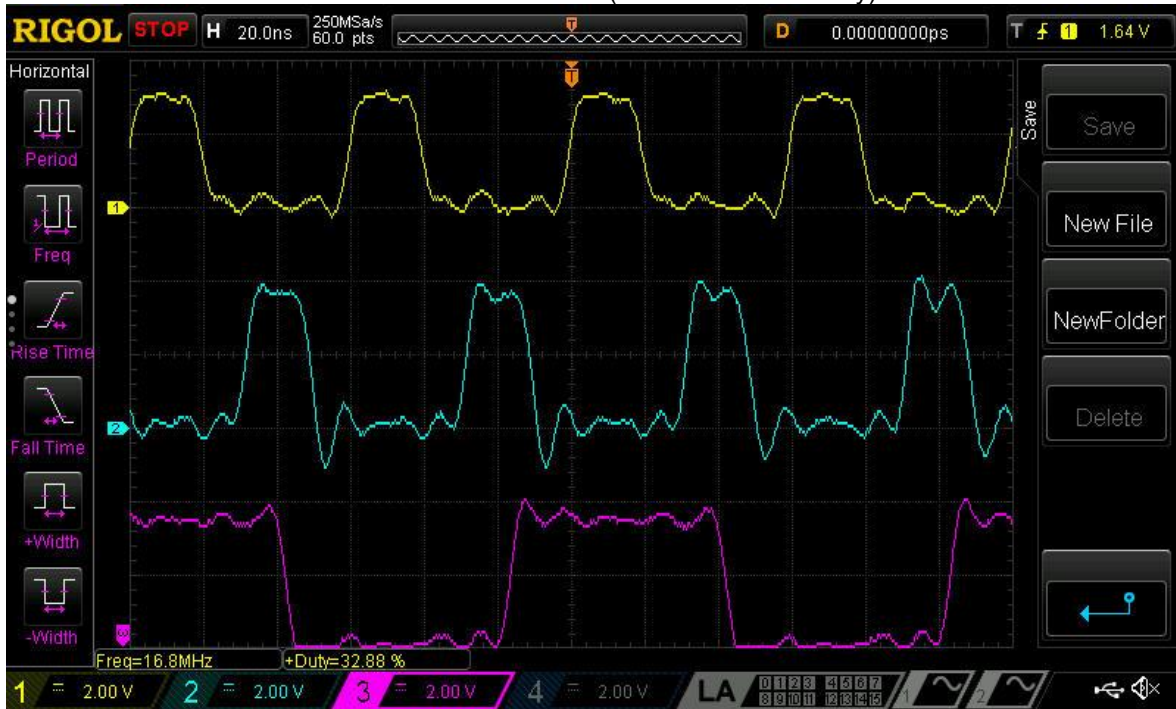
2. Period is 60ns. Pulse width is 20ns DC = 33.3% (Incorrect functionality)

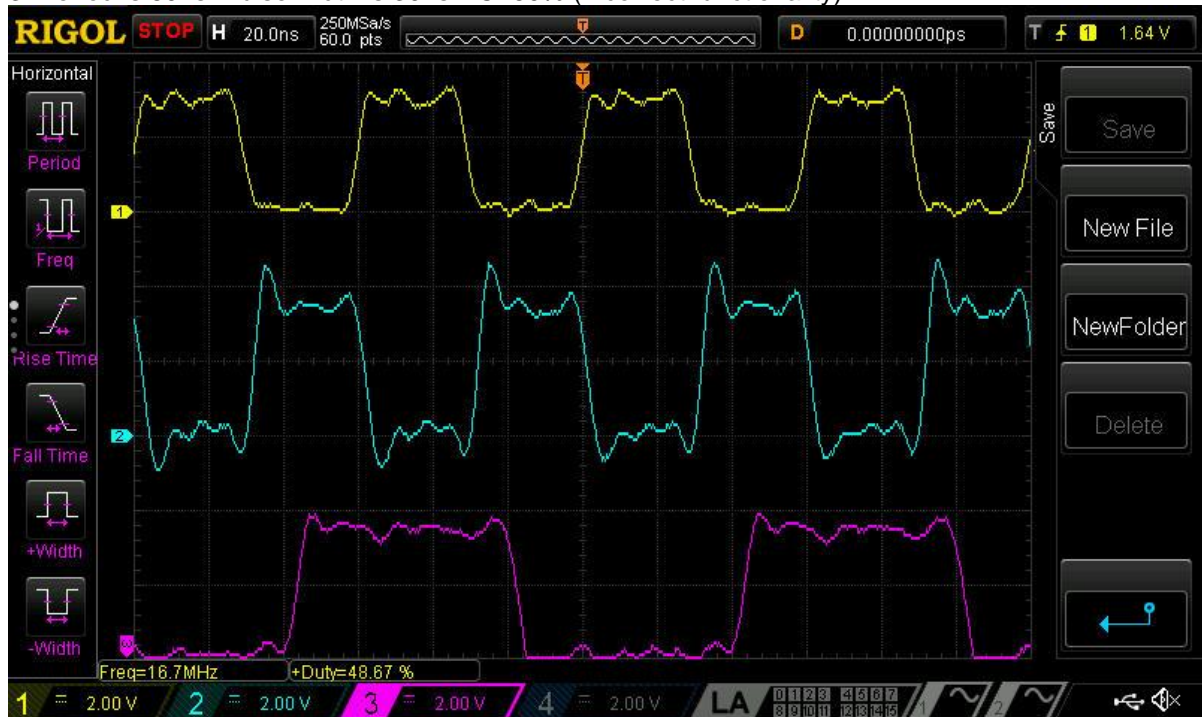
3. Period is 60ns. Pulse width is 30ns DC=50% (Incorrect functionality)

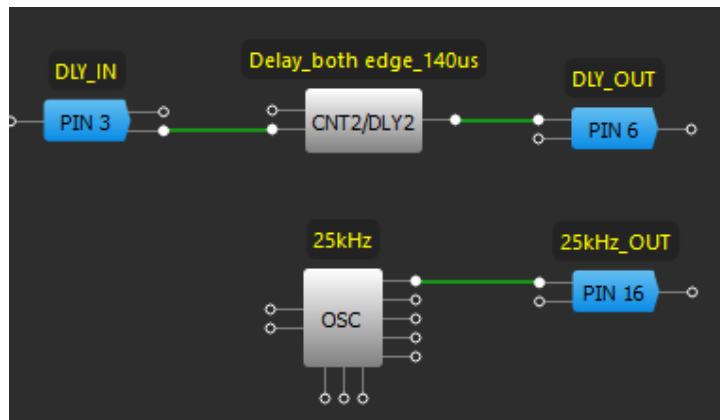
The first period of the RC OSC can be very short when OSC configured as 25 kHz with Auto Power On in the designs. This can be occurred when V_{DD} is above 4.0 V. Critical for CNT/DLY with a low counter data (less than 10) or if it is necessary to use the frequency of the OSC to clock external elements.

An example of such issue is in the following configuration:

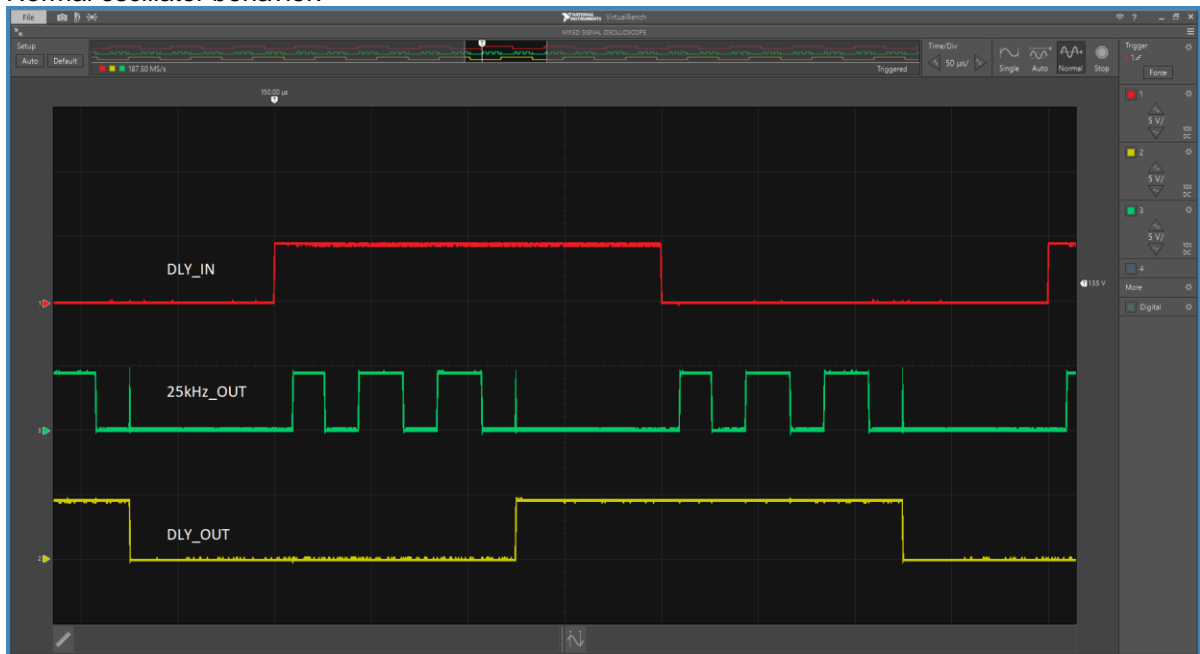
Normal oscillator behavior.
