Errata

SLG46121

CE-GP-019

This document contains the known errata for SLG46121 and the recommended workarounds.

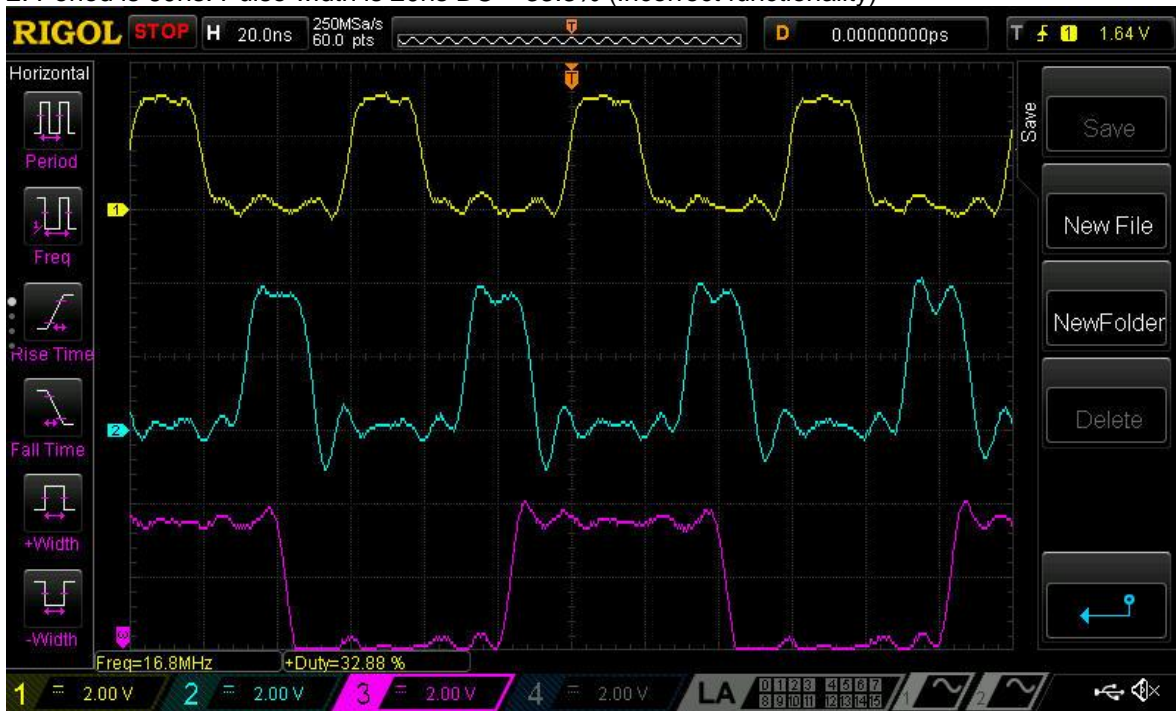
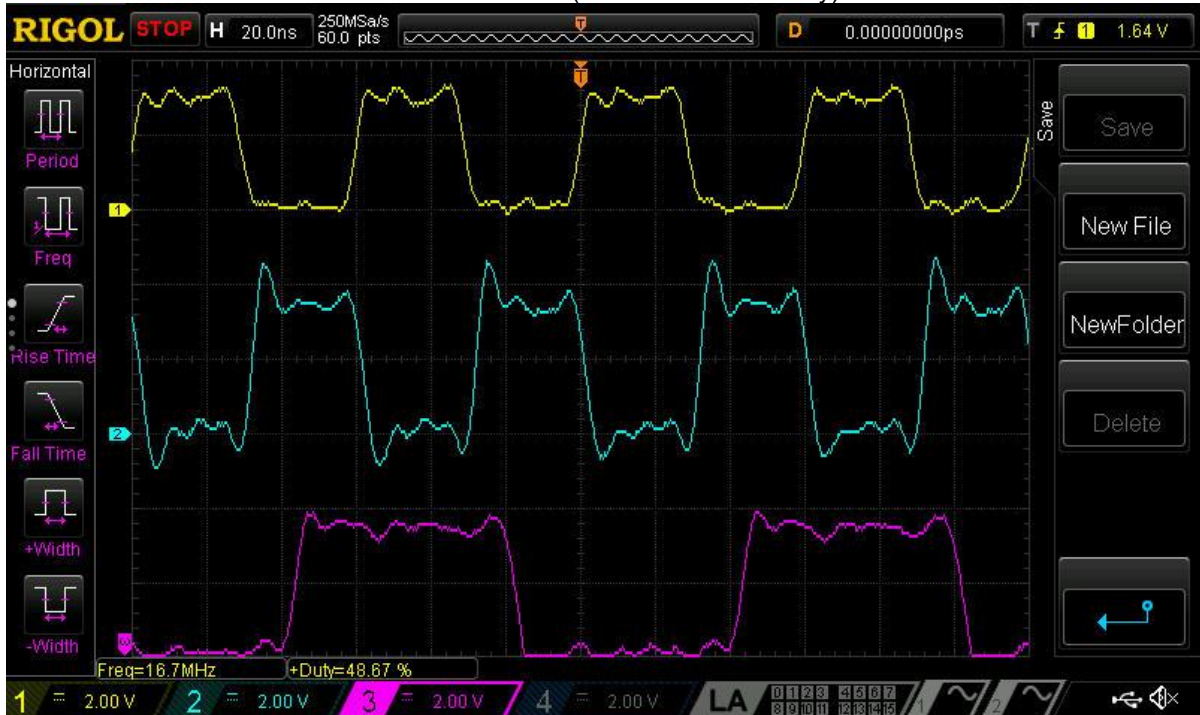
3. Period is 60ns. Pulse width is 30ns DC=50% (Incorrect functionality)

Currently there is no workaround for this issue. Filter block is good at filtering short spontaneous glitches. It is intended to be used in series connection before the delay cell to avoid its latching (see issue #5).

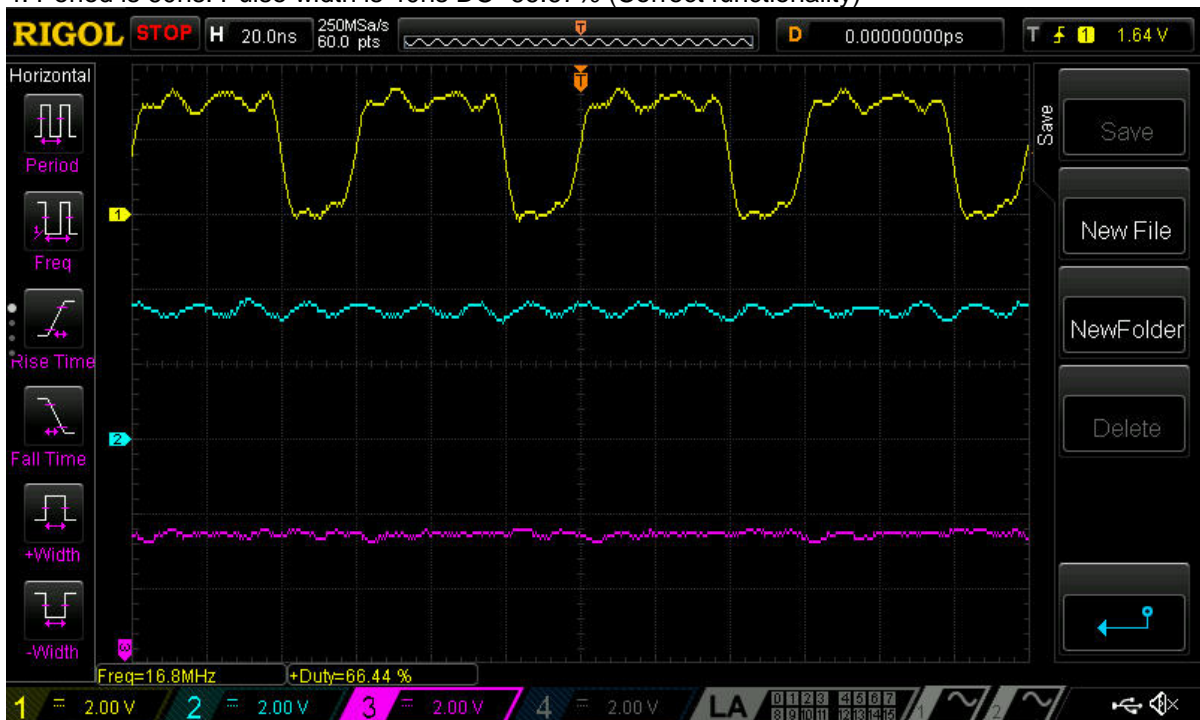
4. Period is 60ns. Pulse width is 40ns DC=66.67% (Correct functionality)

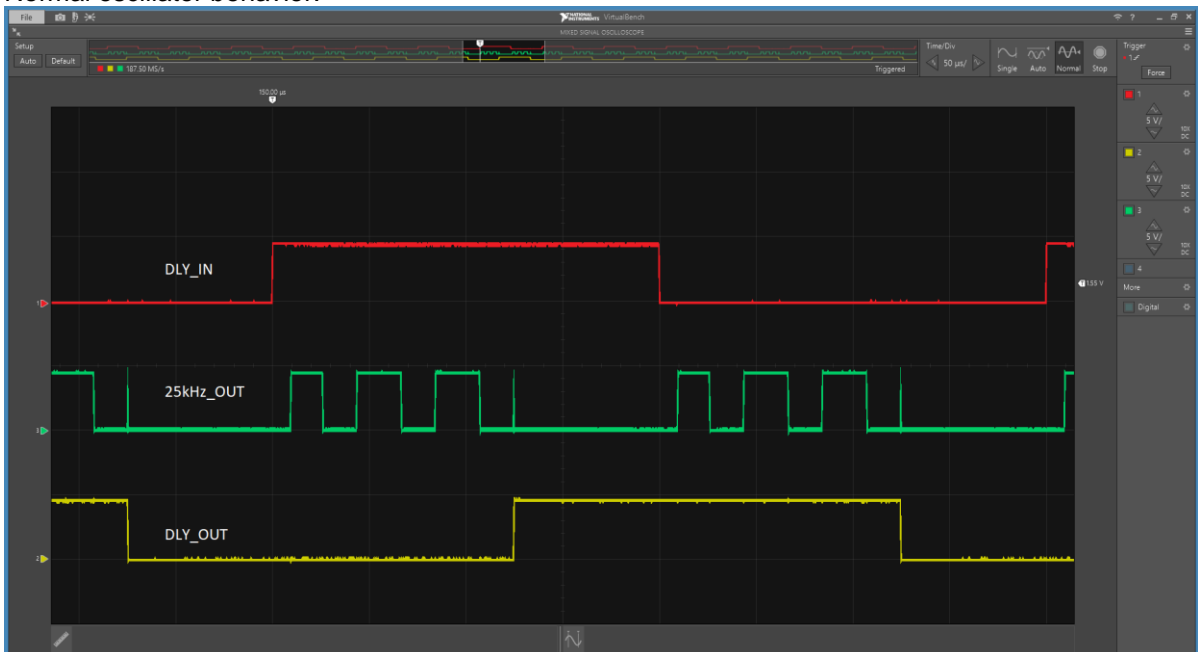
Normal oscillator behavior.

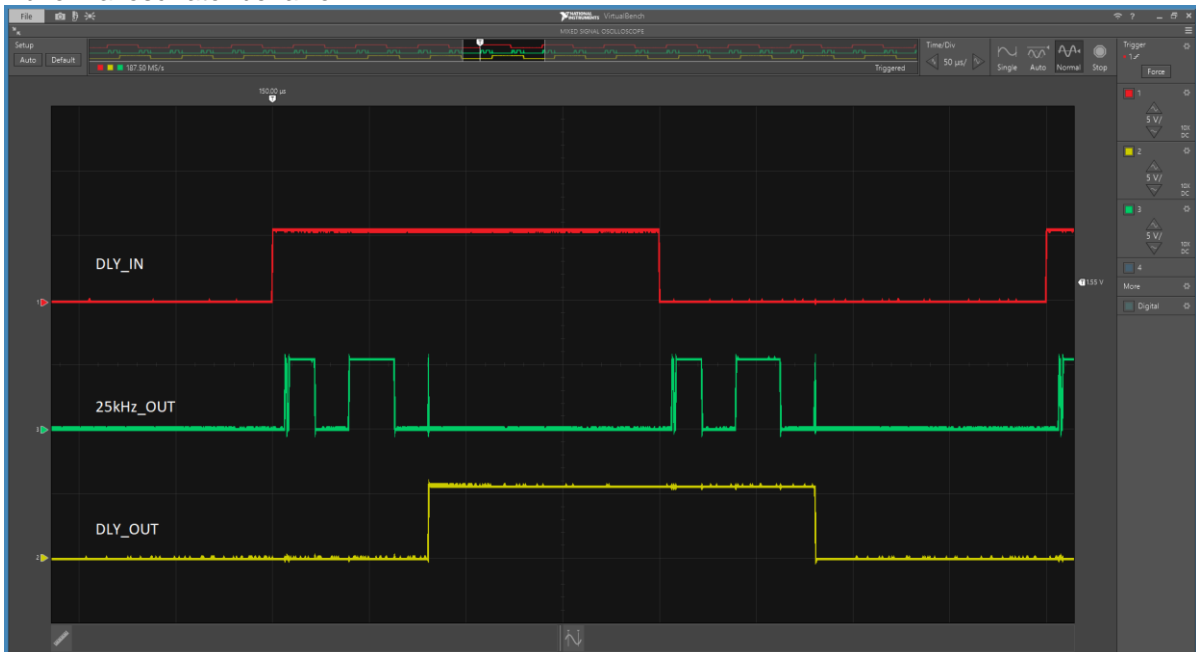
Abnormal oscillator behavior.

- Avoid V_{DD} higher than 4 V
- Force ON OSC
