Errata

SLG46517

CE-GP-001

This document contains the known errata for SLG46517 and the recommended workarounds.

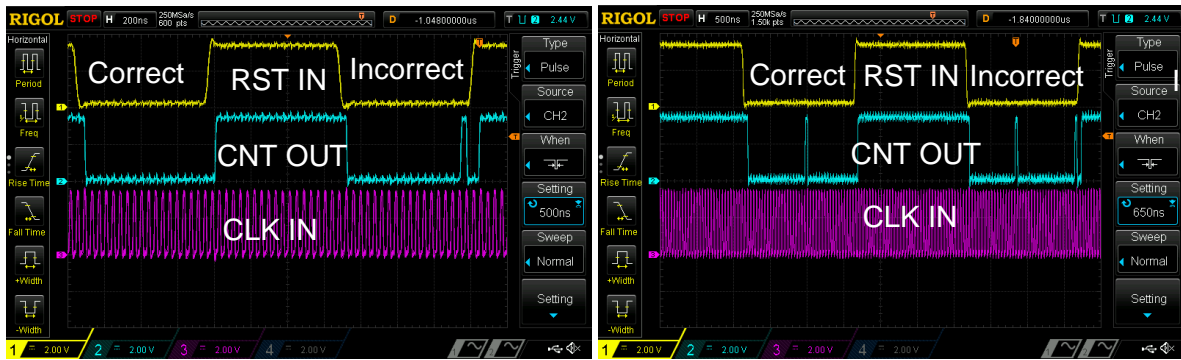
If the Counter Reset is asserted at the same time as a rising clock edge, it is possible that the Counter Data will be reset incorrectly and the counter output may appear faster than expected. This phenomenon appears more often as the clock frequency increases.

Synchronize RESET input of the Counter with its CLK using 2 DFF cells as shown on Figure 3.

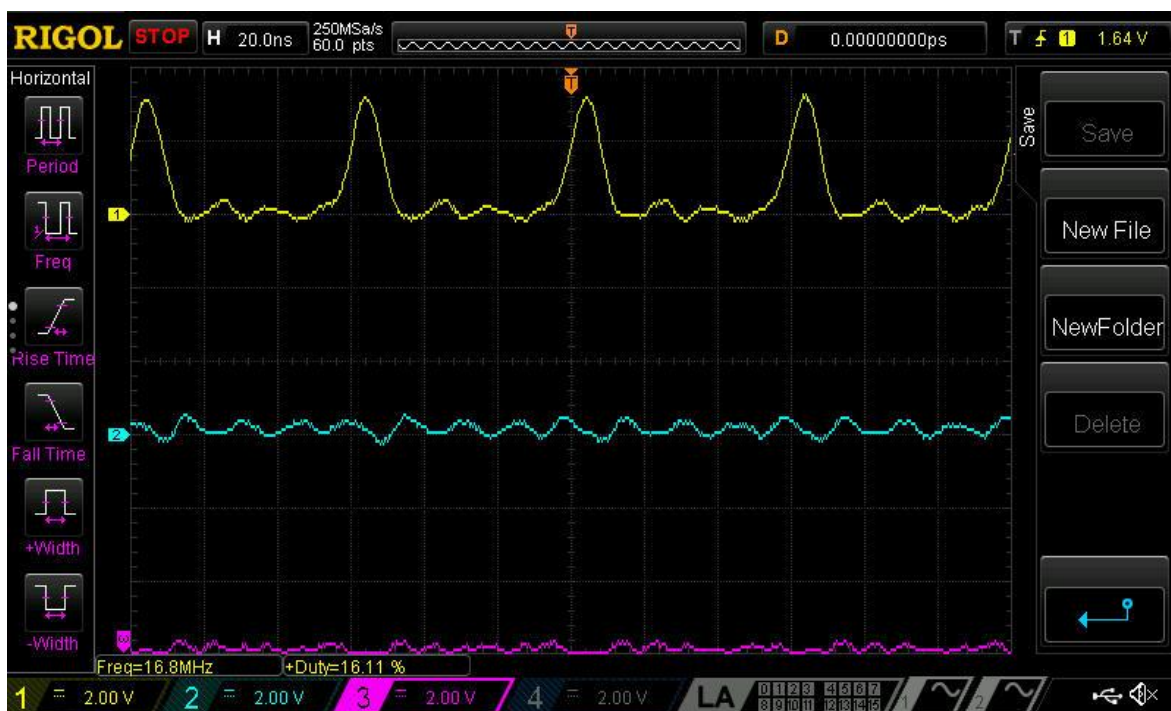
Figure 5

2. Period is 60ns. Pulse width is 20ns DC = 33.3% (Incorrect functionality)

Currently there is no workaround for this issue. Filter block is good at filtering short spontaneous glitches. It is intended to be used in series connection before the delay cell to avoid its latching.

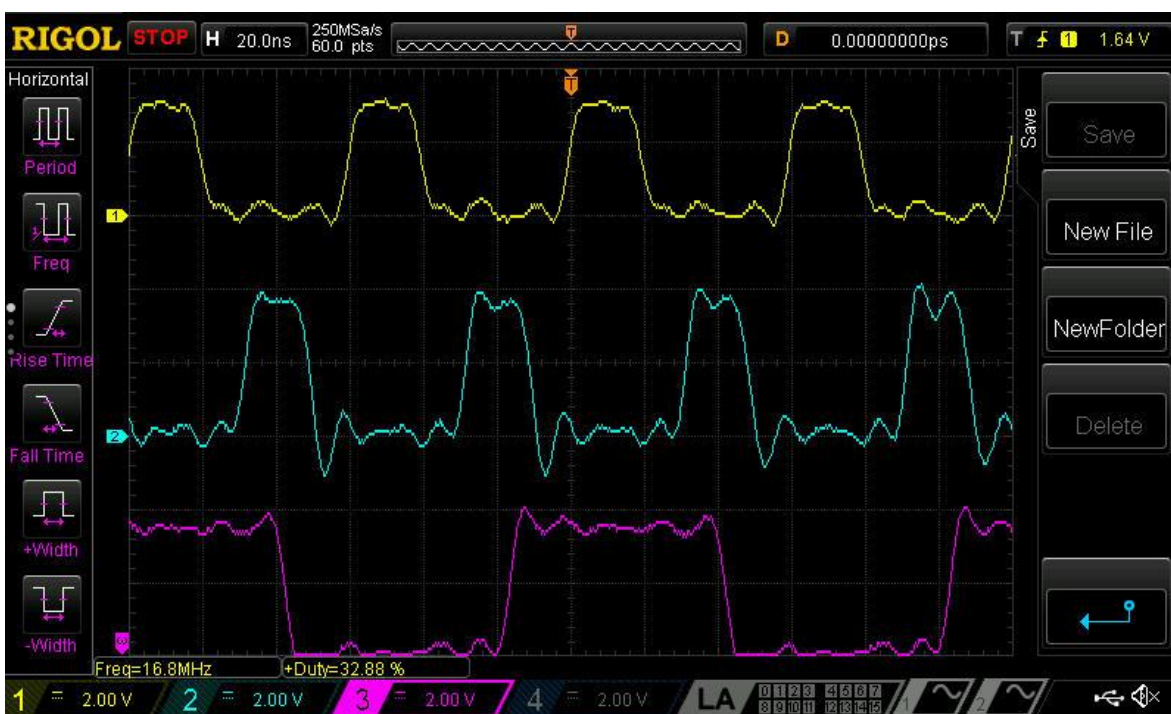
Figure 6

3. Period is 60ns. Pulse width is 30ns DC=50% (Incorrect functionality)

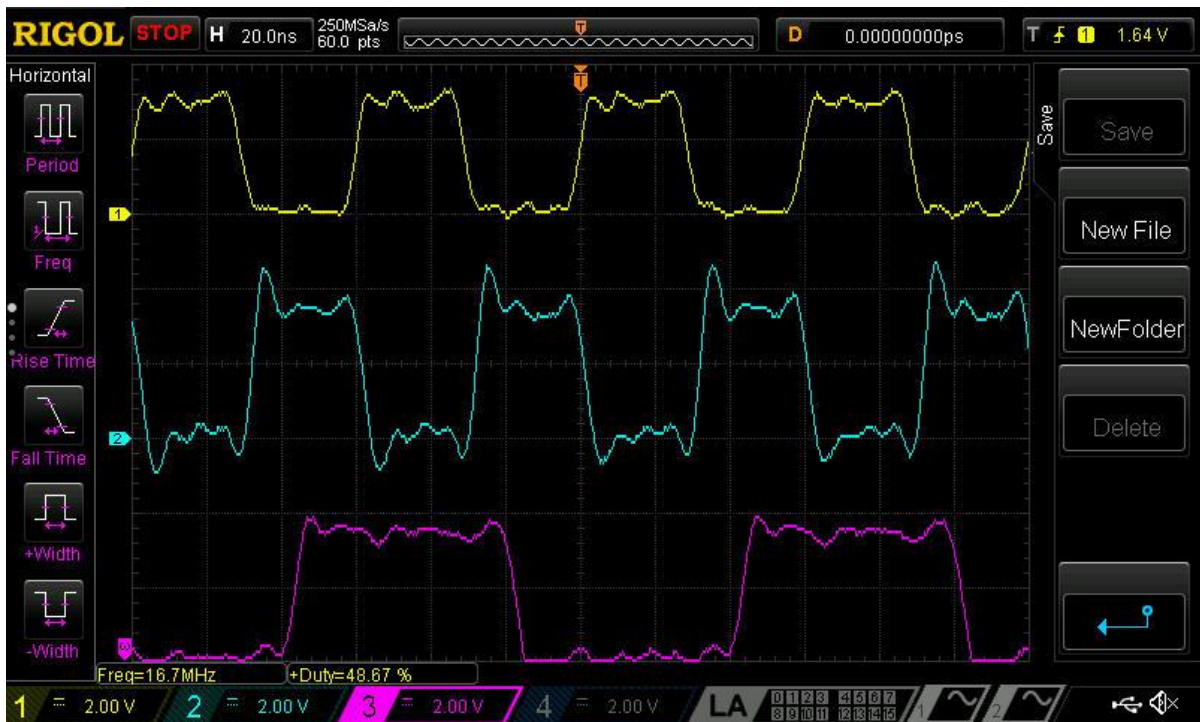
Figure 7

4. Period is 60ns. Pulse width is 40ns DC=66.67% (Correct functionality)

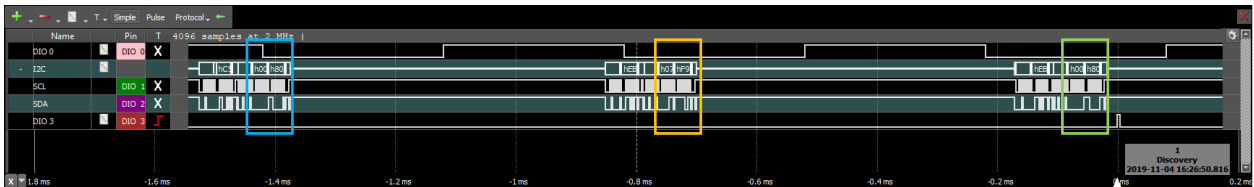
Figure 12: Counter Behavior

For the following condition, the Counter Data register contents are unexpectedly loaded into the counter's DFF chain. This behavior occurs when there is a falling edge on the counter block's clock input during the data return portion of an I2C read of the Counter Data registers. Figure 10 shows this falling edge boxed in light blue followed by two I2C reads of the Current Count Value registers.

As you can see by the MCU data log below, the Current Count Value gradually increases from 0xF904 to 0xF907 but is unexpectedly reset to 0x8000. Please note that the colored HEX values in the MCU Log correspond to the boxed I2C read commands shown in the waveform above. As previously described, this reset occurs because there is a falling edge on the counter's clock input while the GreenPAK device is responding to an I2C read request to 0xC5 and 0xC6. (Note that 0xC5/0xC6 are the Counter Data registers and 0xEB/0xEC are the Current Count Value registers for CNT0.)

The reason that the counter isn't set to 0x8000 on the I2C read immediately following the Counter Data query is because the counter requires two rising edges on its clock input to load the data from the Counter Data registers into the DFF chain. Note that all rising edges during T_{stop} will be gated internally by the "Stop and Restart" feature.

I2C Read of Counter Data: Avoid reading Counter Data via I2C while the counter is being clocked.

Within the MCU, we recommend saving the Counter Data register configuration as a software variable so that the Counter Data register doesn't need to be read during counter operation.
