SLG4653x Errata

CE-GP-002

This document contains the known errata for SLG46533, SLG46534, SLG46535, SLG46536, SLG46537, SLG46538 and the recommended workarounds.

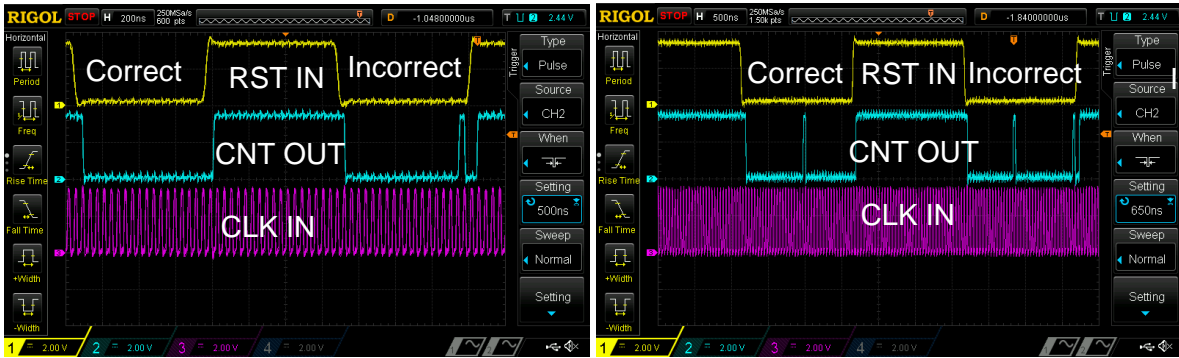
If the Counter Reset is asserted at the same time as a rising clock edge, it is possible that the Counter Data will be reset incorrectly and the counter output may appear faster than expected. This phenomenon appears more often as the clock frequency increases.

Synchronize RESET input of the Counter with its CLK using 2 DFF cells as shown on [Figure 3](#).

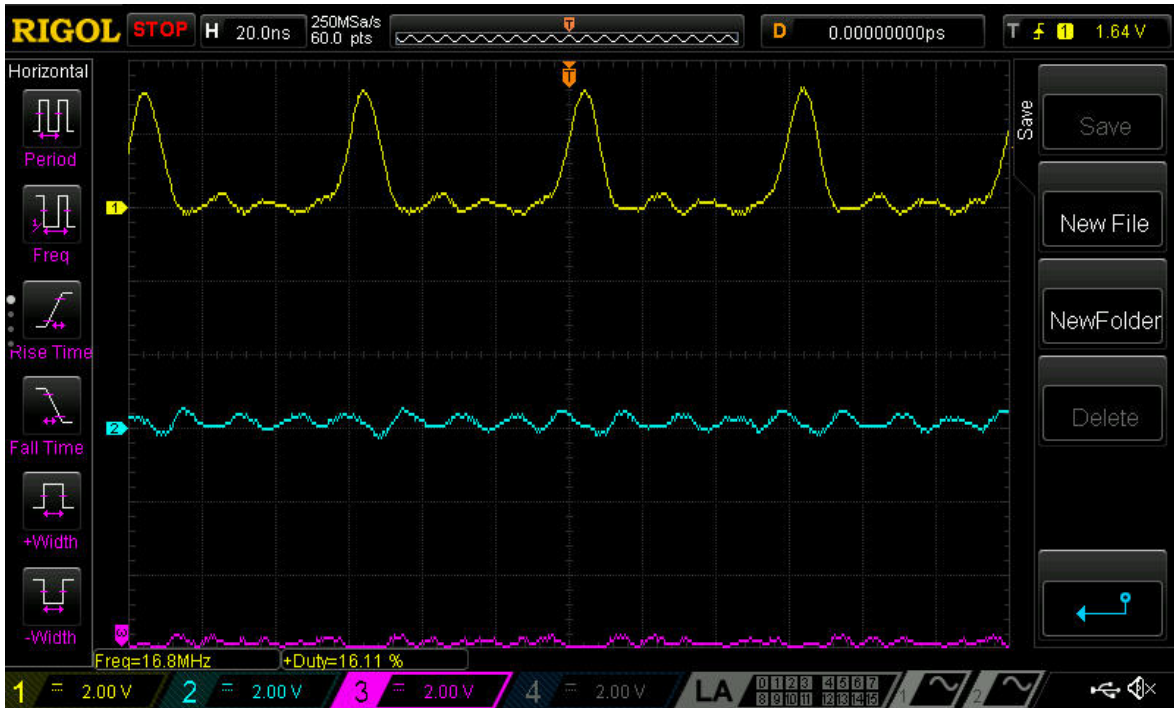
Figure 5

- 1. Period is 60 ns. Pulse width is 10 ns, DC = 16.7 % (correct functionality).

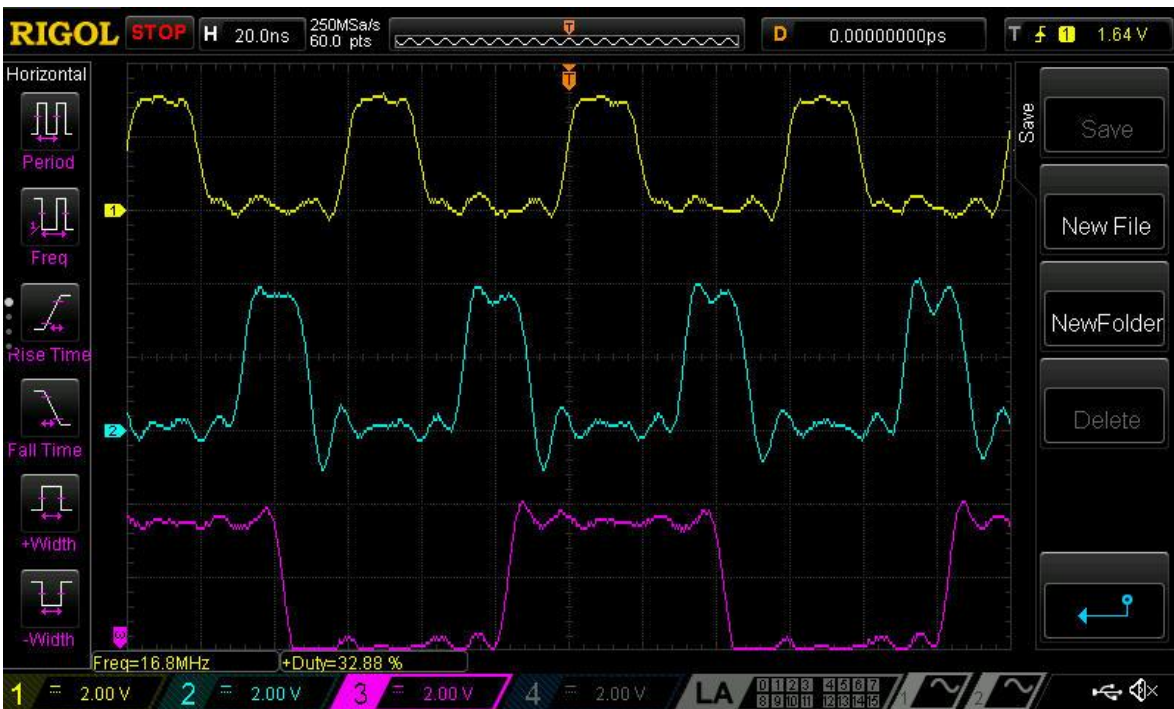
Figure 6

- 2. Period is 60 ns. Pulse width is 20 ns, DC = 33.3 % (incorrect functionality).

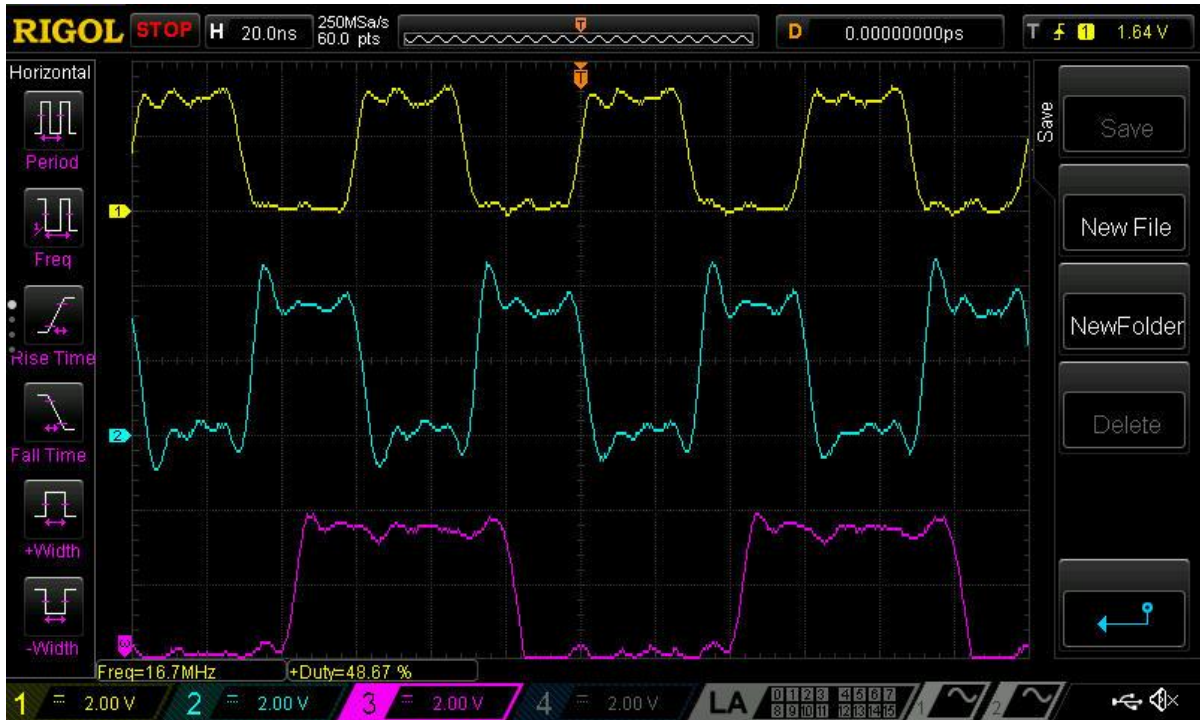
Figure 7

3. Period is 60 ns. Pulse width is 30 ns, DC = 50 % (incorrect functionality).

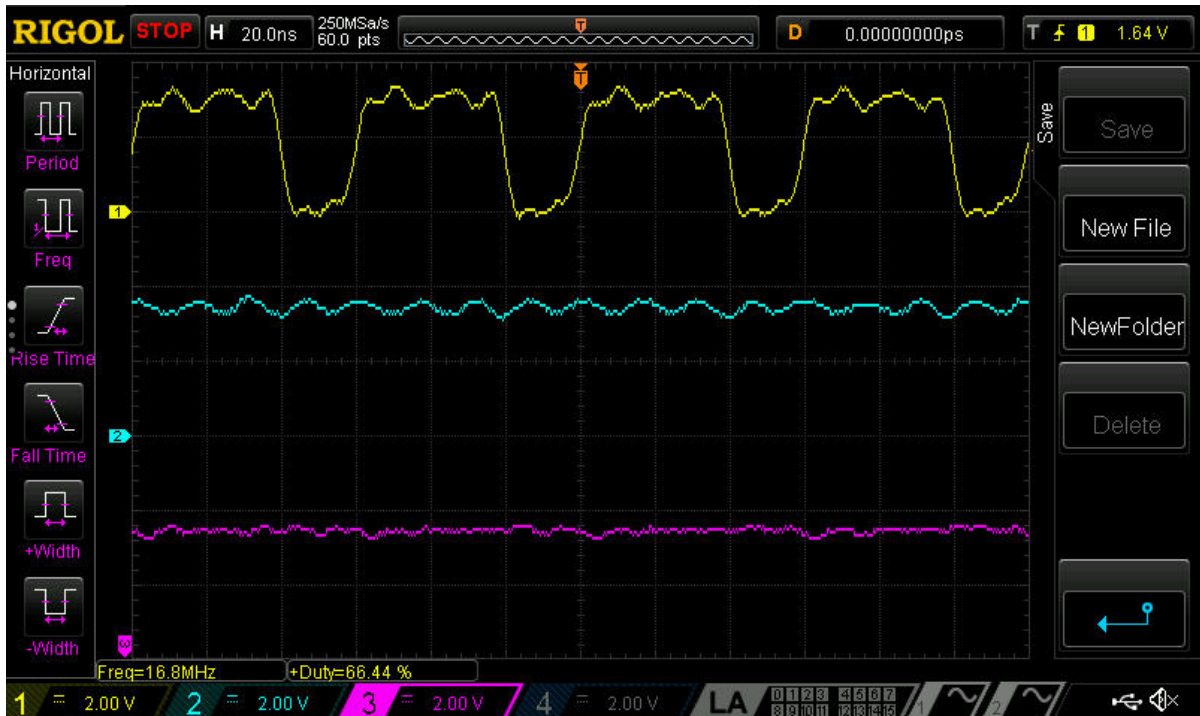
Figure 8

4. Period is 60 ns. Pulse width is 40 ns, DC = 66.67 % (correct functionality).

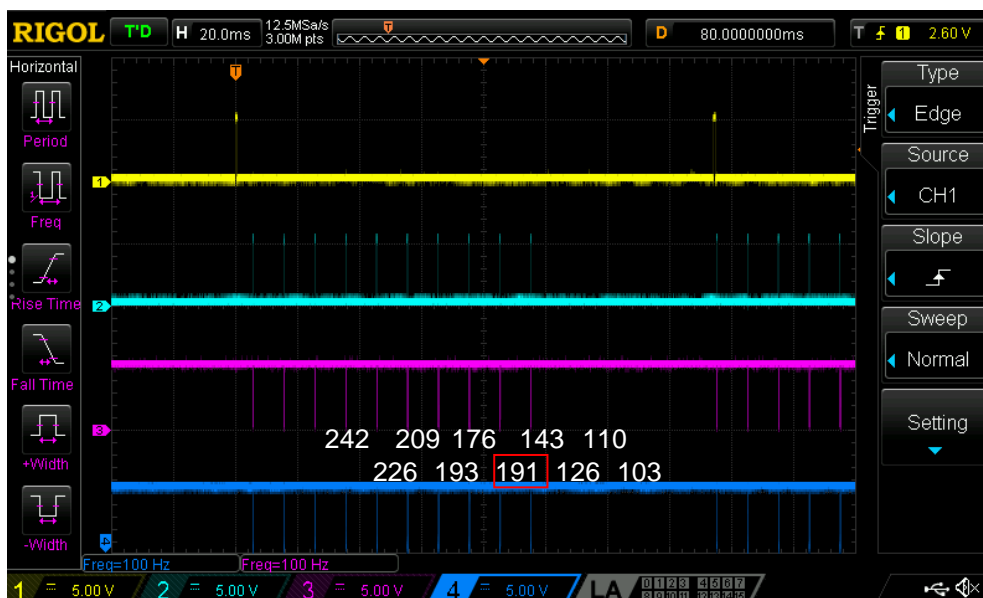
Figure 9

Asynchronous interaction between the CNT/DLY clock input and the I2C latch signal (generated by an I2C read command of the CNT/DLY block's count value) can result in an incorrect I2C data read. The CNT/DLY block will count accurately, but the count value transferred into the block's I2C read register might be loaded incompletely if the I2C latch signal and the clock input occur at about the same time.

The example data capture below shows ten periodic I2C reads of CNT2/DLY2 configured to count down at about 16 clocks per read. The sixth read sample erroneously shows a value greater than that of the fifth. The seventh sample reads as if the previous I2C error never occurred - the difference from the fifth sample (176) to the seventh (143) is 33 clocks or 16 clocks + 17 clocks as expected.

If the possibility of incorrect I2C data reads can't be accommodated for by external software checks, one can guarantee proper operation by stopping the CNT/DLY block's clock during I2C reads through one of the following methods: by disabling the oscillator block, by reconfiguring the CNT/DLY block's clock source, or by gating an external clock using a LUT (Look-up Table) in the signal matrix. After disabling the CNT/DLY block's clock, the count registers can be read without error. Please note that this workaround will add the I2C read and processing time to the counter's overall clock period.

The best workaround depends on the resource constraints of the application. If the oscillator block doesn't clock other logic elements within the design, a matrix output can be used to manually power down the oscillators for the I2C read. When the CNT/DLY block's clock source is routed internally from the oscillator block, I2C commands can temporarily reconfigure the CNT/DLY block's clock source registers to select "Ext. CLK. (From Matrix)." This action will disable the clock by connecting it to ground. If the CNT/DLY block is clocked from the signal matrix, a LUT can be used to gate the clock during an I2C read.

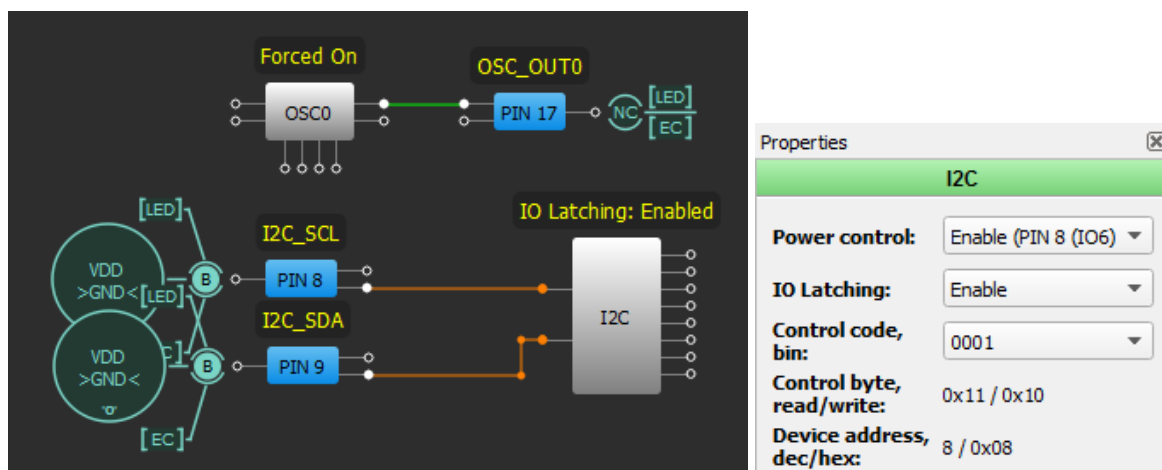
Figure 13

The GreenPAK device does not check for a matching I2C Slave address condition before triggering 'IO Latching'. A Start bit on the I2C bus will trigger IO Latching. A Start bit is when I2C\_SDA goes low first followed by I2C\_SCL going low after.

In the example below, we will be monitoring the OSC output, which is measured by a scope on Channel 3 via PIN17 ("OSC\_OUT0"). The I2C bus will be forced low to create a START bit.

Disable IO Latching in programmed OTP. This register is I2C-write locked during normal operation and therefore should be disabled in configuration file.

Do not share I2C bus with other devices and make sure the I2C bus is not powered down while the GreenPAK is still powered through VDD.

If the above cannot be satisfied, then consider using the SLG4658x devices, where this errata has been fixed.

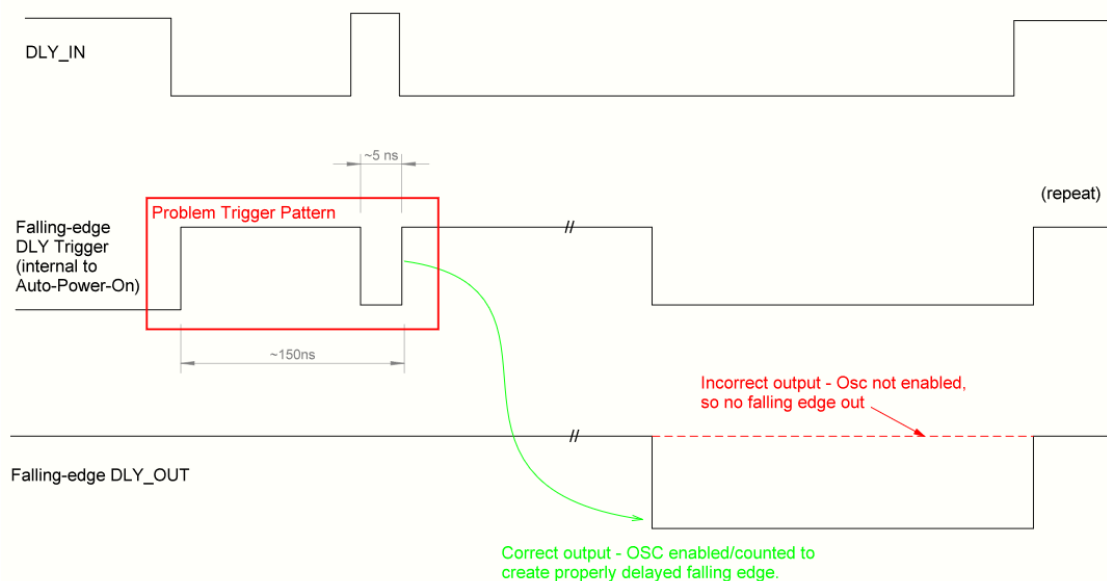
**Figure 15: Problem Trigger Pattern**

For this chip, the Auto Power On circuitry of the 25 kHz/2 MHz generators contains a circuit errata, which can potentially fail to power on the OSC for a specific pattern and timing of the OR of all related DLY trigger signals. The pattern is shown in [Figure 15](#) (boxed in red) and consists of a relatively longer pulse (~145 ns) followed by a shorter (~5 ns) glitch of opposite polarity.

1. Use signal conditioning circuits to prevent glitch on DLY inputs < 200 ns. Examples:
  - a. ACMP with Hysteresis
  - b. External RC in front of Digital Input with Schmitt Trigger
  - c. Filter cell.
2. Set OSC power mode to Force Power On mode instead of Auto Power On.
3. Use different oscillator, such as 25 MHz Ring OSC, which does not have Auto Power On issue.
