SLG46580

ISSUE 1: Long 2 MHz OSC Settling Time Functional Blocks Affected: OSC, Counter, Delay

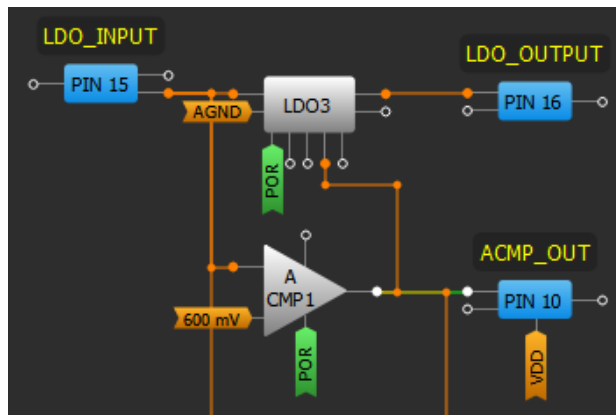
If an LDO's VIN pin (LDO_INPUT) has an internal connection (depicted with an orange wire) to the ACMP's IN+ port, the ACMP's output may give an erroneous result with respect to the LDO's input voltage. The switch between the LDO's VIN pin and the ACMP's IN+ port is implemented using an NMOS-only based transmission gate with its gate controlled by logic supplied from VDD. As a result, this switch is unable to pass LDO input voltages that are close to VDD. This can result in the ACMP's IN+ port seeing a lower voltage than the actual voltage present at LDO_INPUT. This lower input voltage may cause the output of the ACMP to behave unexpectedly.

If the LDO's UVLO feature is enabled, the ACMP's output will cause unexpected LDO behavior that results from the previously described transmission gate voltage drop.

Case 1: proper behavior at VDD = 5 V.

With a 5 V VDD, the NMOS transmission gate passes the 2.25 and 2.75 V LDO_INPUT pin voltages to the ACMP's IN+ port. When the input voltage exceeds the 2.4 V IN- threshold of the ACMP, the LDO is enabled.

Case 2: erroneous behavior at VDD = 2.75 V.

When the VDD is reduced to 2.75 V, the NMOS transmission gate is unable to pass LDO_INPUT's full magnitude to the ACMP's IN+ port. Since the IN+ port of the ACMP doesn't exceed the 2.4 V IN- threshold, the ACMP's output stays low and keeps the LDO disabled.

- If the GreenPAK's VDD is always powered up before the LDO's VIN input, you can externally short the LDO's VIN to another dedicated analog input pin for the desired ACMP.

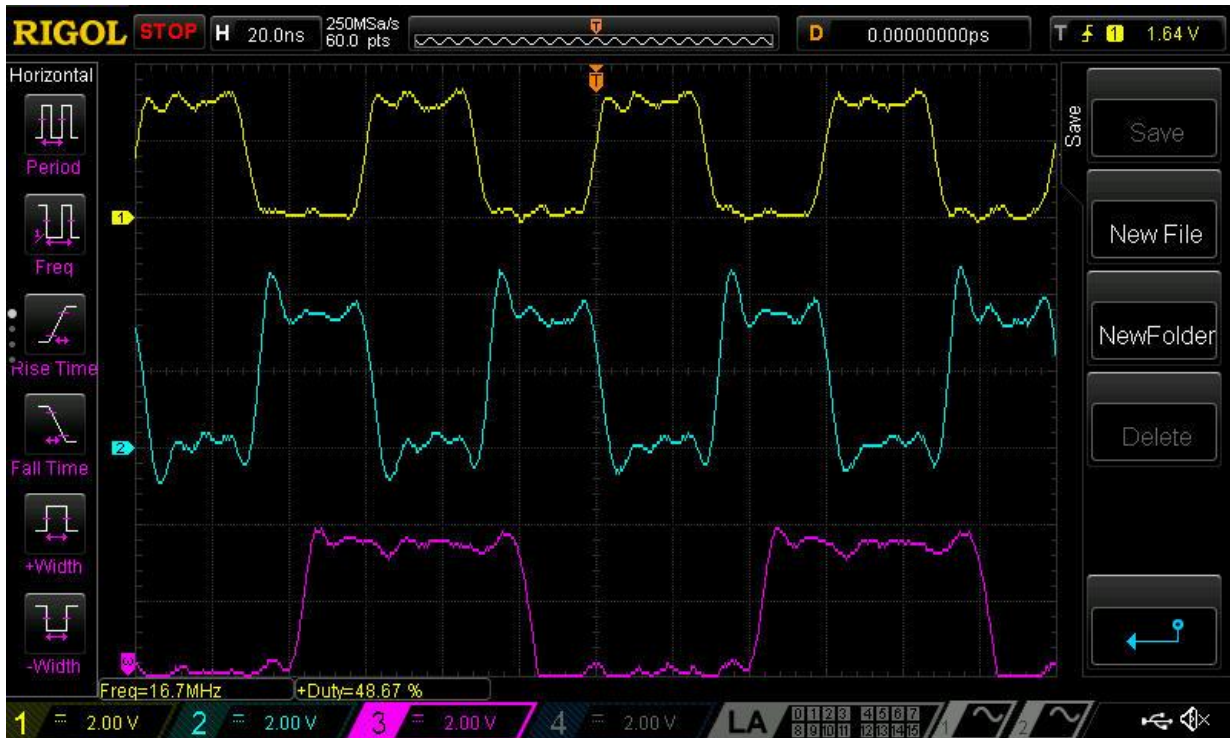
- Period is 60 ns. Pulse width is 30 ns, DC = 50 % (incorrect functionality).

Currently, there is no workaround for this issue. The FILTER block correctly filters isolated glitches, but it shouldn't be used to filter repetitive, high frequency input signals.

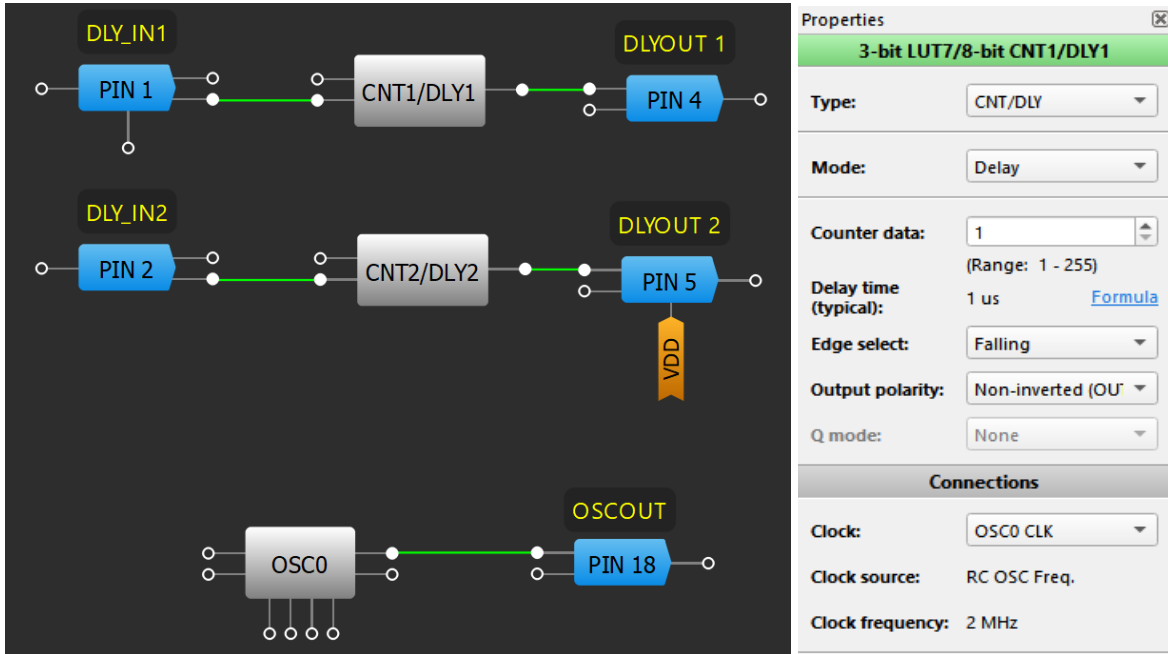
Figure 2: Test Circuit

The error is difficult to capture as the timing must be exact within ns, and short (ns) pulses are difficult to generate glitch precise enough to induce the problem. GPIO naturally filter out ns pulses, so for purposes of errata capture, two simultaneous falling-edge DLY circuits (as shown in Figure 2) were used. By lining up two delays precisely at a particular timing relationship, we can use the internal Auto Power On (OR logic) to generate the glitch pattern necessary to cause the error.
