SLG46582

ISSUE 1: Long 2 MHz OSC Settling Time Functional Blocks Affected: OSC, Counter, Delay

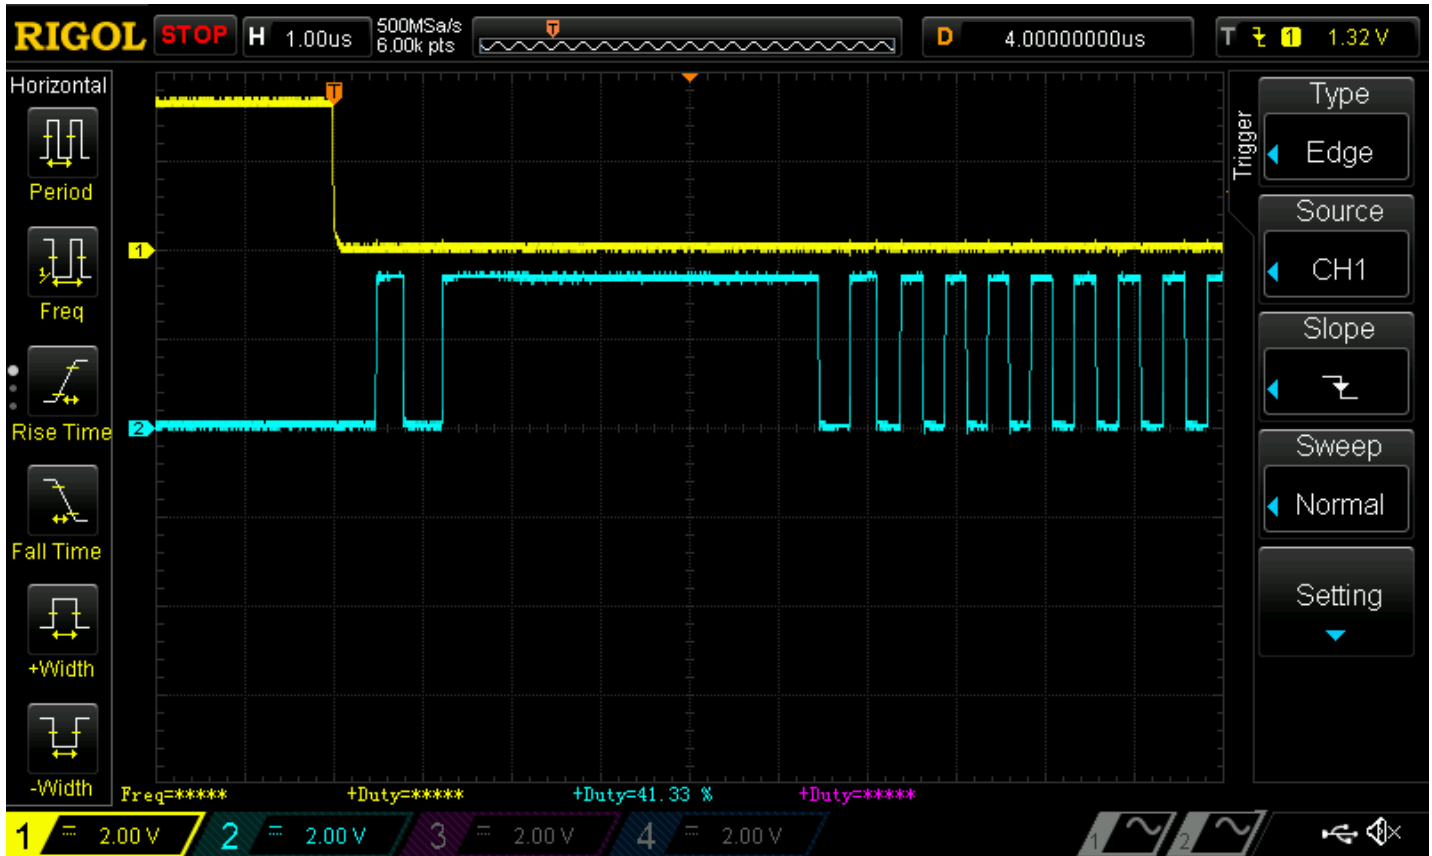
2 MHz OSC has an additional ~ 9 cycles settling period. Higher VDD shows longer settling time.

Channel 1 – OSC Power Down; Channel 2 –OSC output

Such behavior will lead to substantial error in period calculations if the delay time is relatively small.

- Enable Fast Start-up option. Fast Start-up means forcing bias ready at the power-up instead of automatic enabling at OSC event. The standby current consumption difference between Fast start-up disabled and enabled is only an additional 300 nA.
- Use the “Force power on” OSC power control option to make the OSC operate at all times. However, this will cause increased constant current consumption.

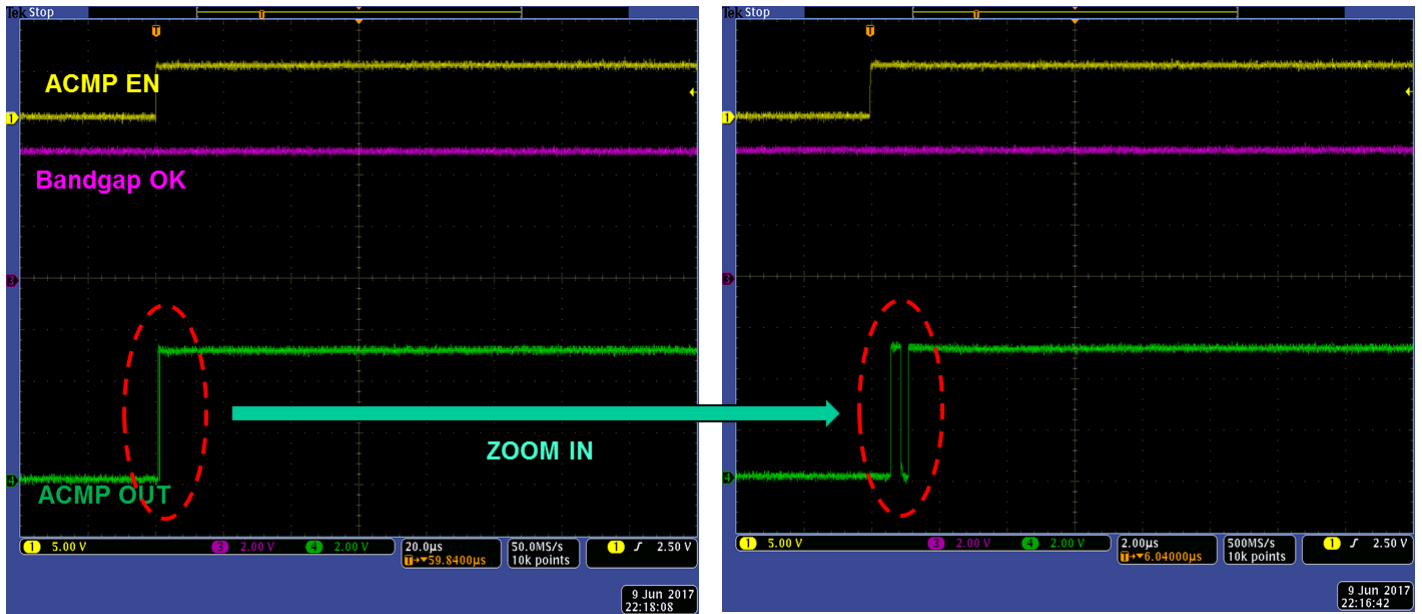
After power-up, if LDO is enabled earlier than ACMP, its output may generate a glitch.

VDD = 5.0 V, ACMP IN+ > IN-, one of LDOs enabled.

Because BG_OK is already released by LDO, there is no gating signal. Depending on the ACMP VREF condition & the positive input value, it is possible for the ACMP to have a glitch. Subsequently, the other ACMP will not have an issue unless the customer repeats LDO enable first and ACMP later during power stable.

- Use both edge delay on the output to filter out the glitch.

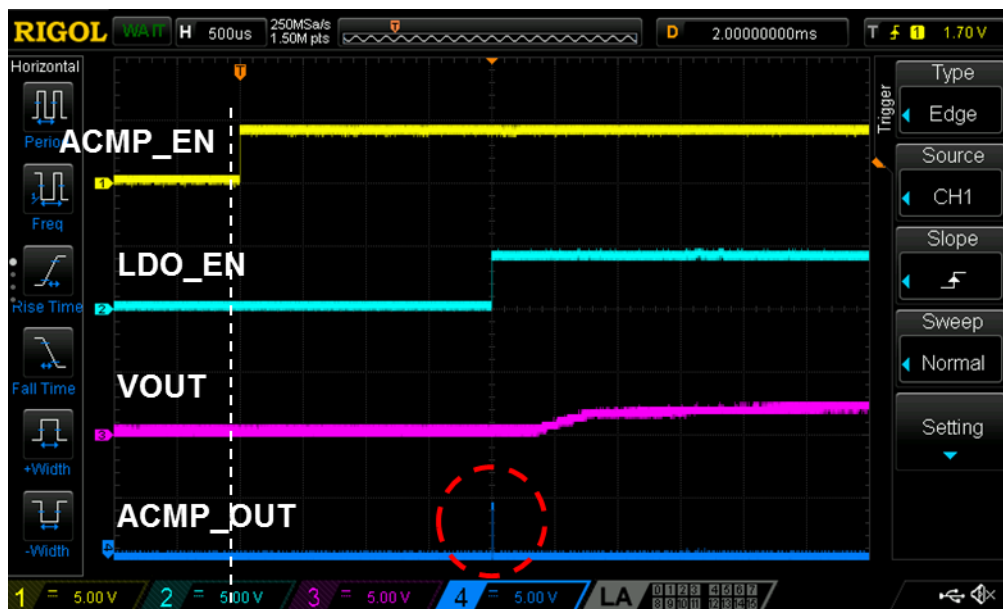
If an LDO's Low Power Mode is selected (for example tied to VDD) a glitch may appear on the ACMP's output after the first LDO is enabled. When the first LDO is turned on, the Low Power Mode switch causes a drop in the internal bandgap voltage that is used to derive the ACMP reference voltages.

- Use both edge delay on the output to filter out the glitch.
- Use some logic to avoid turning on Low Power Mode before enabling LDO and powering up the ACMP. Example is shown below.

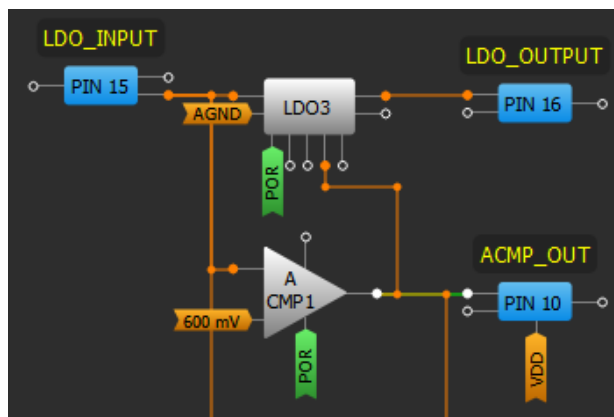
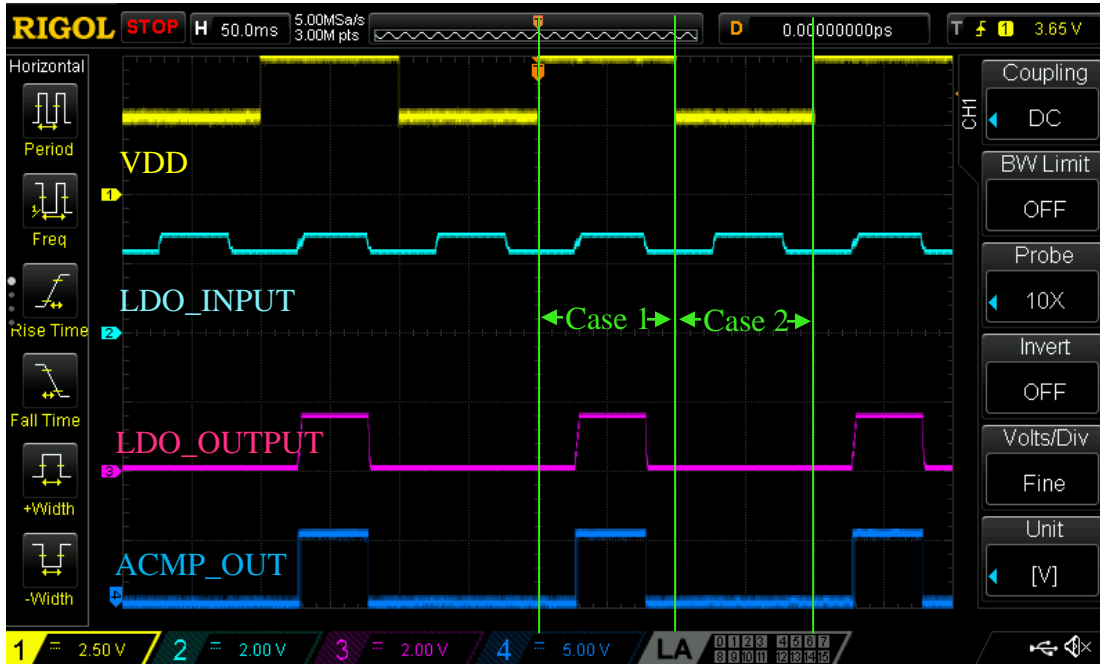
If an LDO's VIN pin (LDO_INPUT) has an internal connection (depicted with an orange wire) to the ACMP's IN+ port, the ACMP's output may give an erroneous result with respect to the LDO's input voltage. The switch between the LDO's VIN pin and the ACMP's IN+ port is implemented using an NMOS-only based transmission gate with its gate controlled by logic supplied from VDD. As a result, this switch is unable to pass LDO input voltages that are close to VDD. This can result in the ACMP's IN+ port seeing a lower voltage than the actual voltage present at LDO_INPUT. This lower input voltage may cause the output of the ACMP to behave unexpectedly.

If the LDO's UVLO feature is enabled, the ACMP's output will cause unexpected LDO behavior that results from the previously described transmission gate voltage drop.

Case 1: proper behavior at VDD = 5 V.

With a 5 V VDD, the NMOS transmission gate passes the 2.25 and 2.75 V LDO_INPUT pin voltages to the ACMP's IN+ port. When the input voltage exceeds the 2.4 V IN- threshold of the ACMP, the LDO is enabled.

Case 2: erroneous behavior at VDD = 2.75 V.

When the VDD is reduced to 2.75 V, the NMOS transmission gate is unable to pass LDO_INPUT's full magnitude to the ACMP's IN+ port. Since the IN+ port of the ACMP doesn't exceed the 2.4 V IN- threshold, the ACMP's output stays low and keeps the LDO disabled.

- If the GreenPAK's VDD is always powered up before the LDO's VIN input, you can externally short the LDO's VIN to another dedicated analog input pin for the desired ACMP.

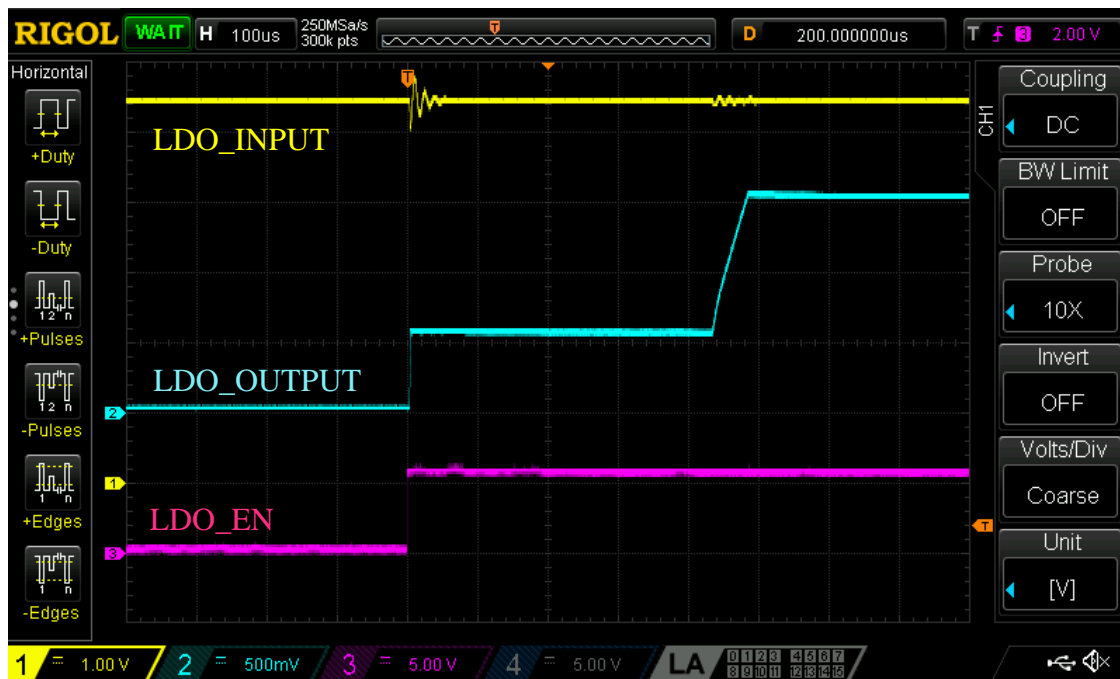
When a GreenPAK's first LDO is enabled, the LDO's VOUT will step to a non-zero voltage during its 500 μ s wait time. The magnitude of this step is directly proportional to the LDO's VIN and the GreenPAK's VDD. With a large LDO input voltage and VDD, this step can exceed 500 mV.

VDD = 5.5 V, LDO_INPUT = 5.5 V, all other LDOs disabled.

- If your GreenPAK design has an unused LDO, you can reduce the magnitude of this voltage step by keeping an unused LDO enabled in high power mode.

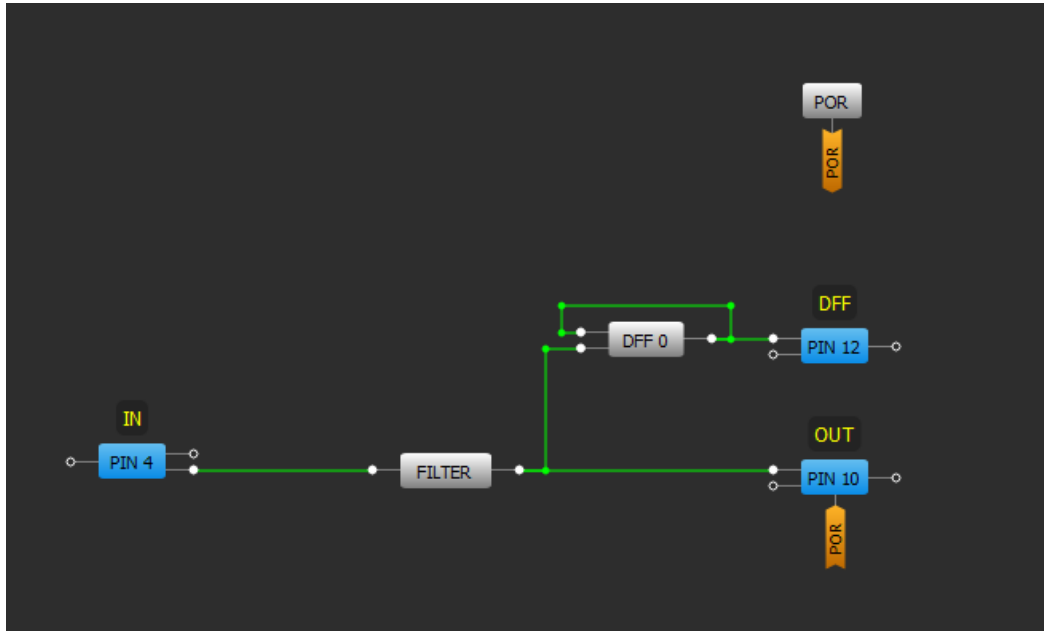
If the FILTER cell's input signal contains multiple consecutive pulses within short time intervals, the FILTER cell may not filter the input pulses as expected. The errant behavior applies only to repeated input pulses and depends on both their frequency and duty cycle.

Channel 1 (yellow/top line) – PIN#4 (IN).
 Channel 2 (light blue/2nd line) – PIN#10 (OUT).
 Channel 3 (magenta /3rd line) – PIN#12 (DFF).

Currently, there is no workaround for this issue. The FILTER block correctly filters isolated glitches, but it shouldn't be used to filter repetitive, high frequency input signals.

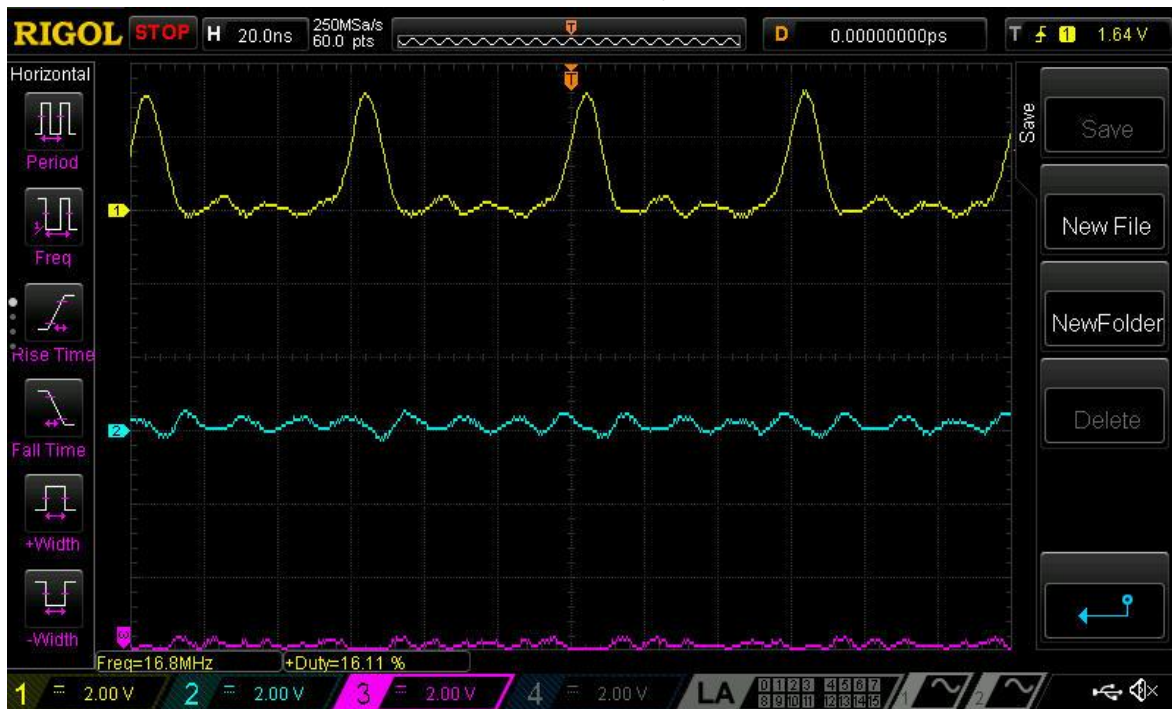
1. Period is 60 ns. Pulse width is 10 ns, DC = 16.7 % (correct functionality).

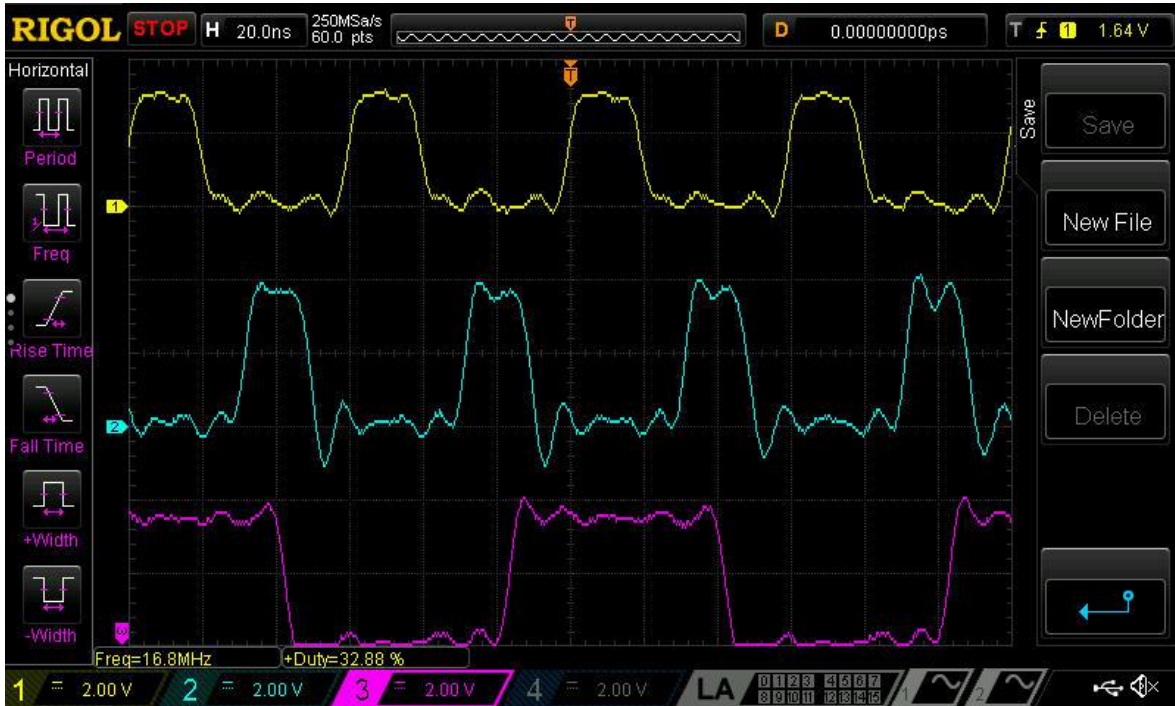
- Period is 60 ns. Pulse width is 20 ns, DC = 33.3 % (incorrect functionality).

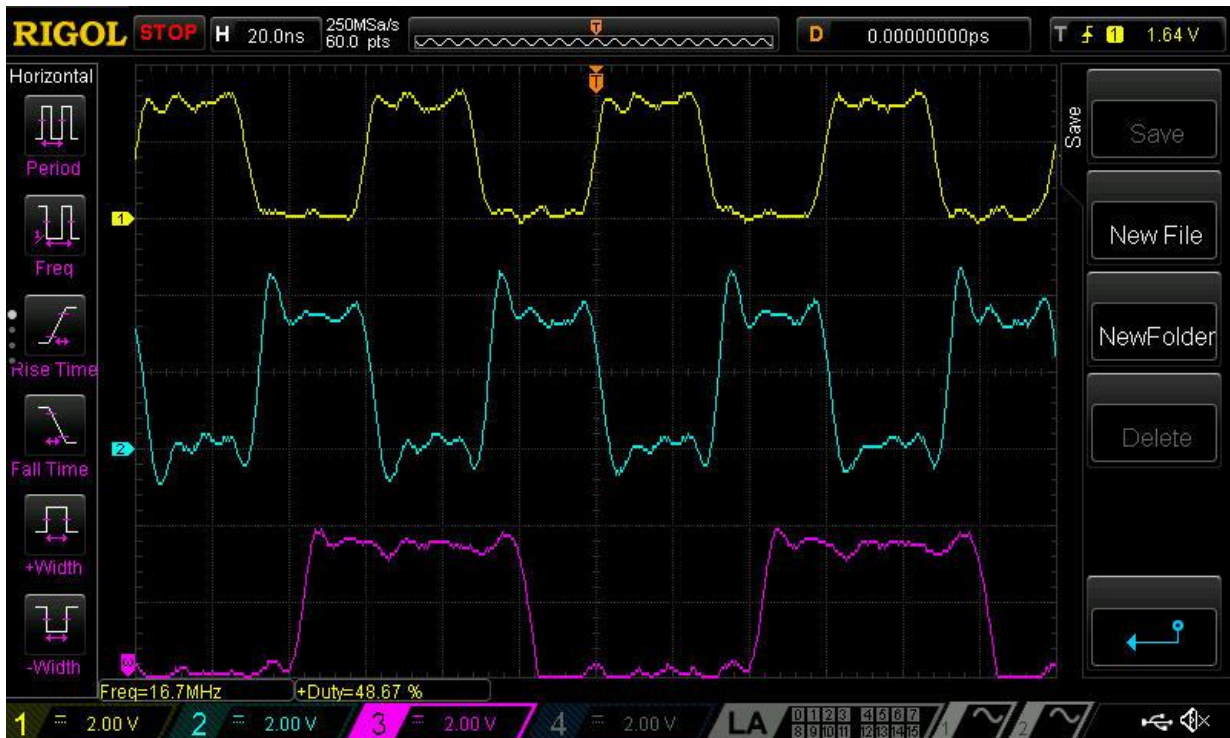
- Period is 60 ns. Pulse width is 30 ns, DC = 50 % (incorrect functionality).

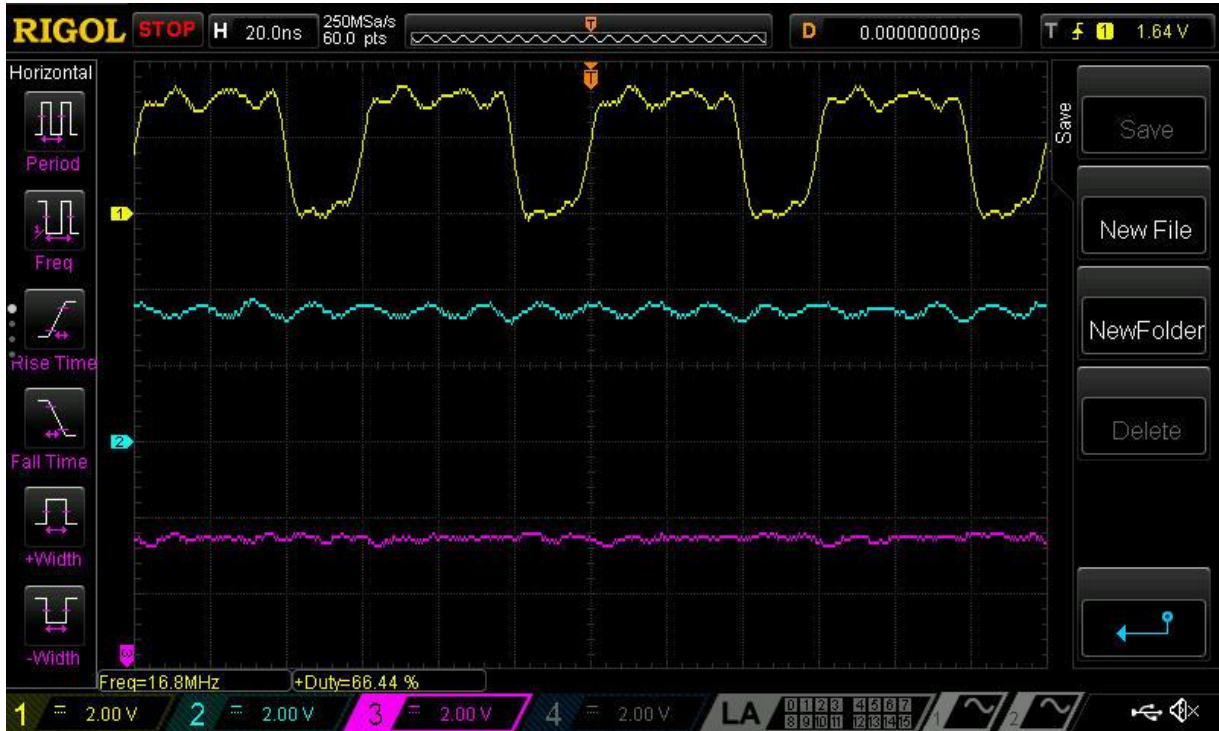
4. Period is 60 ns. Pulse width is 40 ns, DC = 66.67 % (correct functionality).

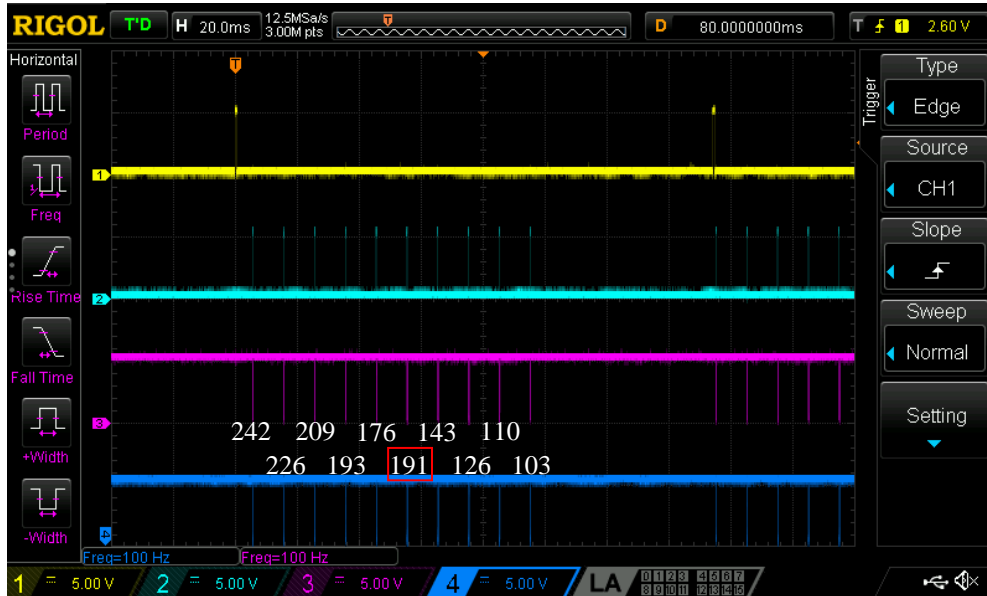
Asynchronous interaction between the CNT/DLY clock input and the I²C latch signal (generated by an I²C read command of the CNT/DLY block's count value) can result in an incorrect I²C data read. The CNT/DLY block will count accurately, but the count value transferred into the block's I²C read register might be loaded incompletely if the I²C latch signal and the clock input occur at about the same time.

The example data capture below shows ten periodic I²C reads of CNT2/DLY2 configured to count down at about 16 clocks per read. The sixth read sample erroneously shows a value greater than that of the fifth. The seventh sample reads as if the previous I²C error never occurred - the difference from the fifth sample (176) to the seventh (143) is 33 clocks or 16 clocks + 17 clocks as expected.

- Channel 1 (yellow/top line) – PIN#2 (CNT2/DLY2 Out).
- Channel 2 (light blue/2nd line) – PIN#1 (I²C Read Triggers).
- Channel 3 (magenta /3rd line) – PIN#8 (I²C SCL).
- Channel 3 (dark blue /4th line) – PIN#9 (I²C SDA).

If the possibility of incorrect I²C data reads can't be accommodated for by external software checks, one can guarantee proper operation by stopping the CNT/DLY block's clock during I²C reads through one of the following methods: by disabling the oscillator block, by reconfiguring the CNT/DLY block's clock source, or by gating an external clock using a LUT (Look-up Table) in the signal matrix. After disabling the CNT/DLY block's clock, the count registers can be read without error. Please note that this workaround will add the I²C read and processing time to the counter's overall clock period.

The best workaround depends on the resource constraints of the application. If the oscillator block doesn't clock other logic elements within the design, a matrix output can be used to manually power down the oscillators for the I²C read. When the CNT/DLY block's clock source is routed internally from the oscillator block, I²C commands can temporarily reconfigure the CNT/DLY block's clock source registers to select "Ext. CLK. (From Matrix)." This action will disable the clock by connecting it to ground. If the CNT/DLY block is clocked from the signal matrix, a LUT can be used to gate the clock during an I²C read.

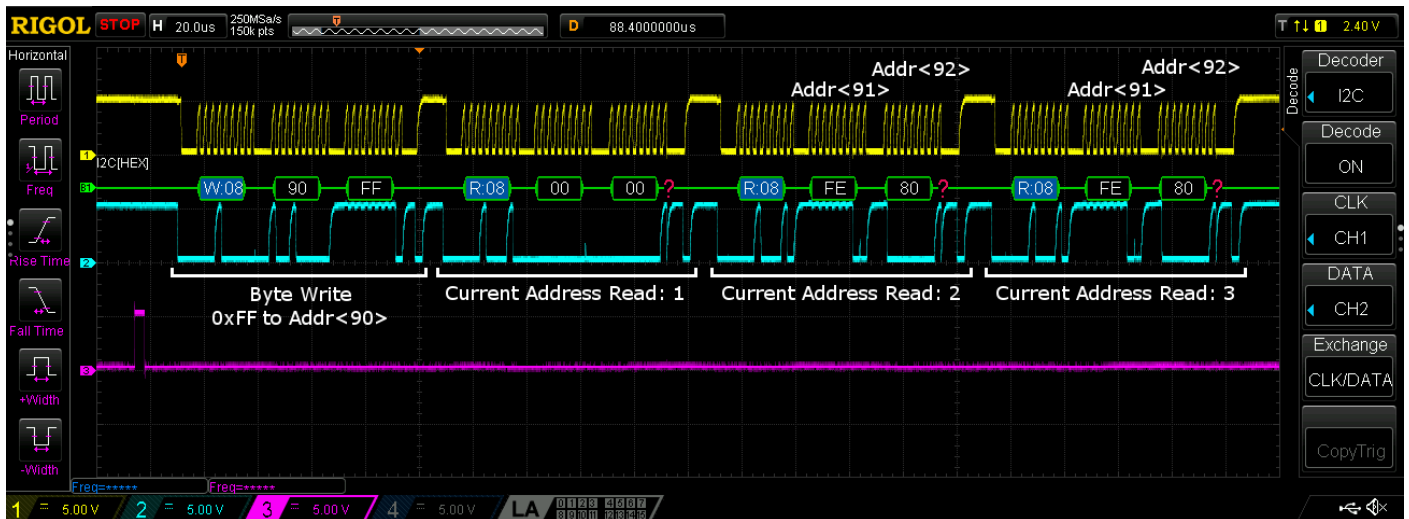
The first “Current Address Read” or “Sequential Read” command following an I²C “Byte Write” or a “Sequential Write” command will produce incorrect data. Additional read commands will return the expected data. See the waveform below for more information.

Channel 1 (yellow/top line) – PIN#8 (SCL).

Channel 2 (light blue/2nd line) – PIN#9 (SDA).

Channel 3 (magenta/3rd line) – I²C Software Trigger.

Note: In the GreenPAK test design, Addr<91> and Addr<92> expect FE and 80 respectively.

If possible, use the “Random Read” command as described in the datasheet for SLG46582. This command will output the correct data.

If you expect consecutive reads of the same register, we recommend sending a “Random Read” command to the register preceding the register of interest. After the “Random Read” command finishes, the chip’s register pointer will increment to the desired register and the following “Current Address Read” or “Sequential Read” commands will produce the correct data. Note that the “Current Address Read” and “Sequential Read” commands don’t increment the GreenPAK’s register pointer.

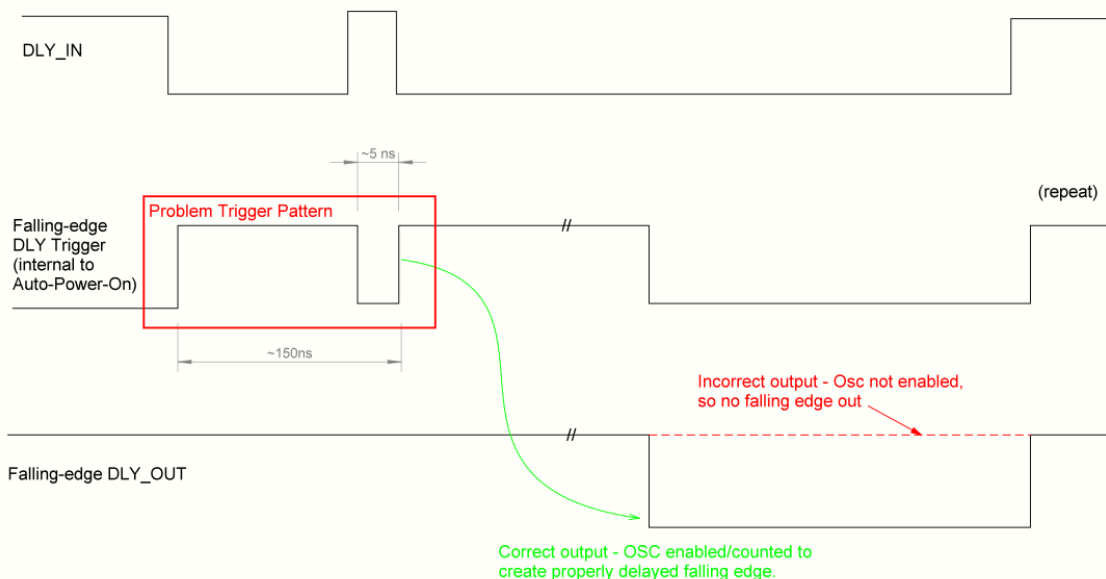
Figure 1: Problem Trigger Pattern

For this chip, the Auto Power On circuitry of the 25 kHz/2 MHz generators contains a circuit errata, which can potentially fail to power on the OSC for a specific pattern and timing of the OR of all related DLY trigger signals. The pattern is shown in [Figure 1](#) (boxed in red) and consists of a relatively longer pulse (~145 ns) followed by a shorter (~5 ns) glitch of opposite polarity.

1. Use signal conditioning circuits to prevent glitch on DLY inputs < 200 ns. Examples:
 - a. ACMP with Hysteresis
 - b. External RC in front of Digital Input with Schmitt Trigger
 - c. Filter cell.
2. Set OSC power mode to Force Power On mode instead of Auto Power On.

3. Use different oscillator, such as 25 MHz Ring OSC, which does not have Auto Power On issue.

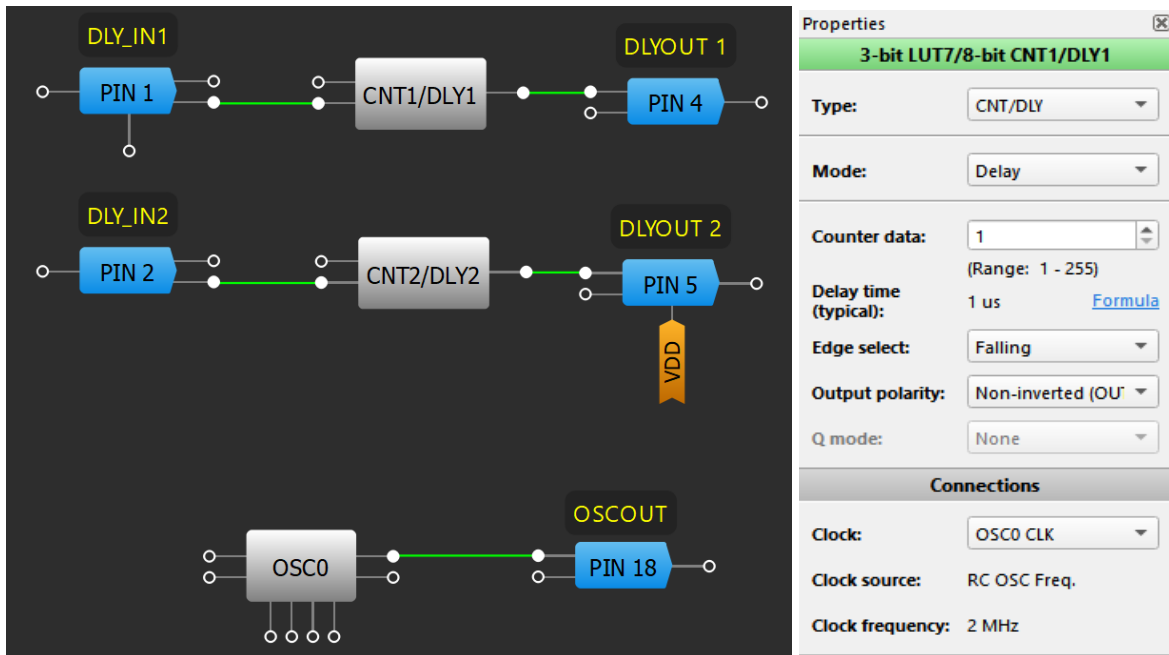
Figure 2: Test Circuit

The error is difficult to capture as the timing must be exact within ns, and short (ns) pulses are difficult to generate glitch precise enough to induce the problem. GPIO naturally filter out ns pulses, so for purposes of errata capture, two simultaneous falling-edge DLY circuits (as shown in Figure 2) were used. By lining up two delays precisely at a particular timing relationship, we can use the internal Auto Power On (OR logic) to generate the glitch pattern necessary to cause the error.

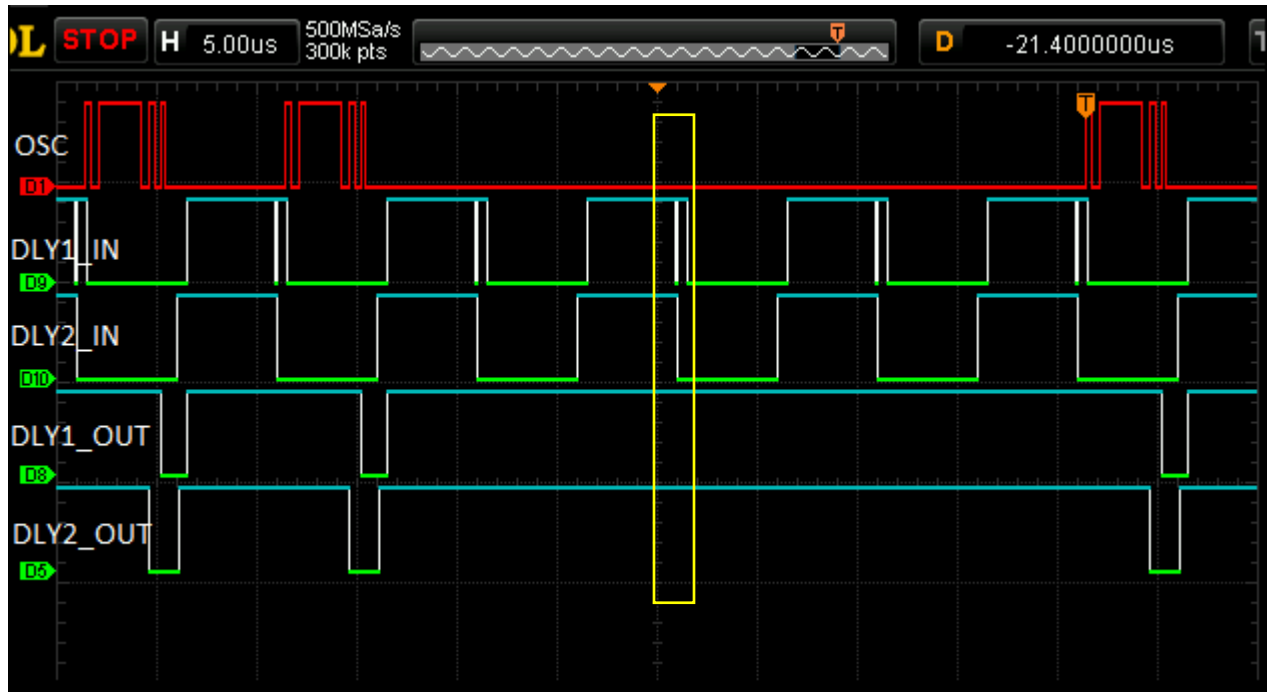
Figure 3: Errata Capture (Zoom Out)

Figure 3 shows a series of DLY output events are missing, where the OSC is correspondingly not triggering when it was supposed to. Figure 4 is a zoom in of the boxed region from Figure 3. The total glitch/chatter time was measured in this case at 152 ns. By using the composite OR of the two delay channels, we can asynchronously strobe with tiny frequency variations, and so tune the timing to induce this errata. Note that the error is not persistent – the system is recovered when all DLYs are returned to inactive state, such as when input of falling edge DLY goes high, thus canceling delay, or after DLY out finishes.
