SLG46583

ISSUE 1: Long 2 MHz OSC Settling Time Functional Blocks Affected: OSC, Counter, Delay

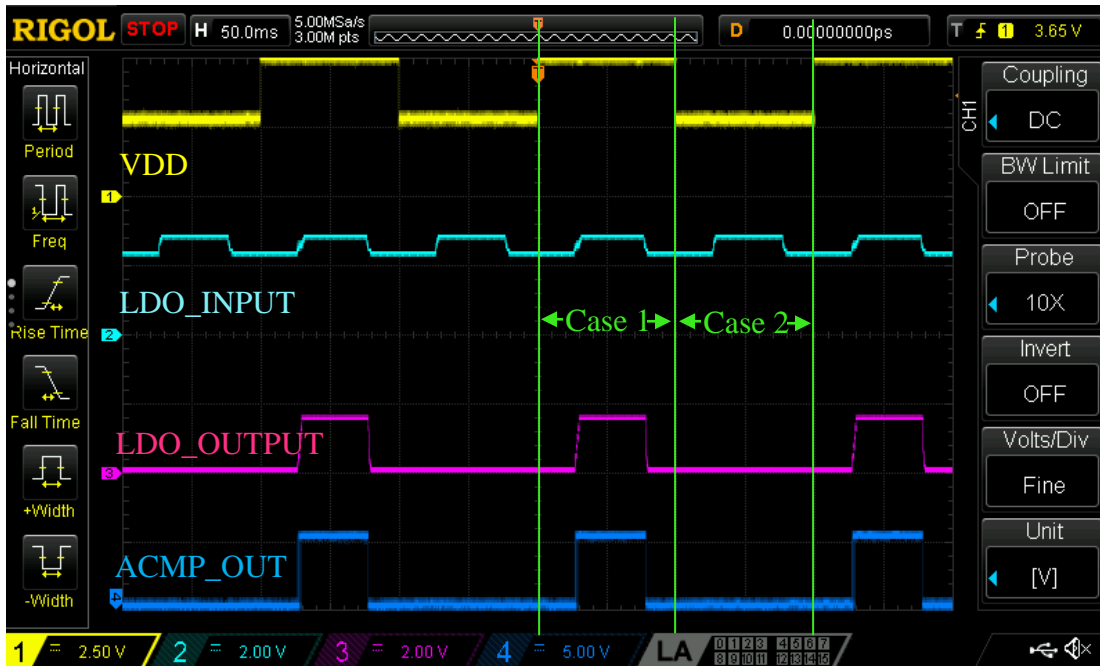
If an LDO's VIN pin (LDO_INPUT) has an internal connection (depicted with an orange wire) to the ACMP's IN+ port, the ACMP's output may give an erroneous result with respect to the LDO's input voltage. The switch between the LDO's VIN pin and the ACMP's IN+ port is implemented using an NMOS-only based transmission gate with its gate controlled by logic supplied from VDD. As a result, this switch is unable to pass LDO input voltages that are close to VDD. This can result in the ACMP's IN+ port seeing a lower voltage than the actual voltage present at LDO_INPUT. This lower input voltage may cause the output of the ACMP to behave unexpectedly.

If the LDO's UVLO feature is enabled, the ACMP's output will cause unexpected LDO behavior that results from the previously described transmission gate voltage drop.

Case 1: proper behavior at VDD = 5 V.

With a 5 V VDD, the NMOS transmission gate passes the 2.25 and 2.75 V LDO_INPUT pin voltages to the ACMP's IN+ port. When the input voltage exceeds the 2.4 V IN- threshold of the ACMP, the LDO is enabled.

Case 2: erroneous behavior at VDD = 2.75 V.

When the VDD is reduced to 2.75 V, the NMOS transmission gate is unable to pass LDO_INPUT's full magnitude to the ACMP's IN+ port. Since the IN+ port of the ACMP doesn't exceed the 2.4 V IN- threshold, the ACMP's output stays low and keeps the LDO disabled.

- If the GreenPAK's VDD is always powered up before the LDO's VIN input, you can externally short the LDO's VIN to another dedicated analog input pin for the desired ACMP.

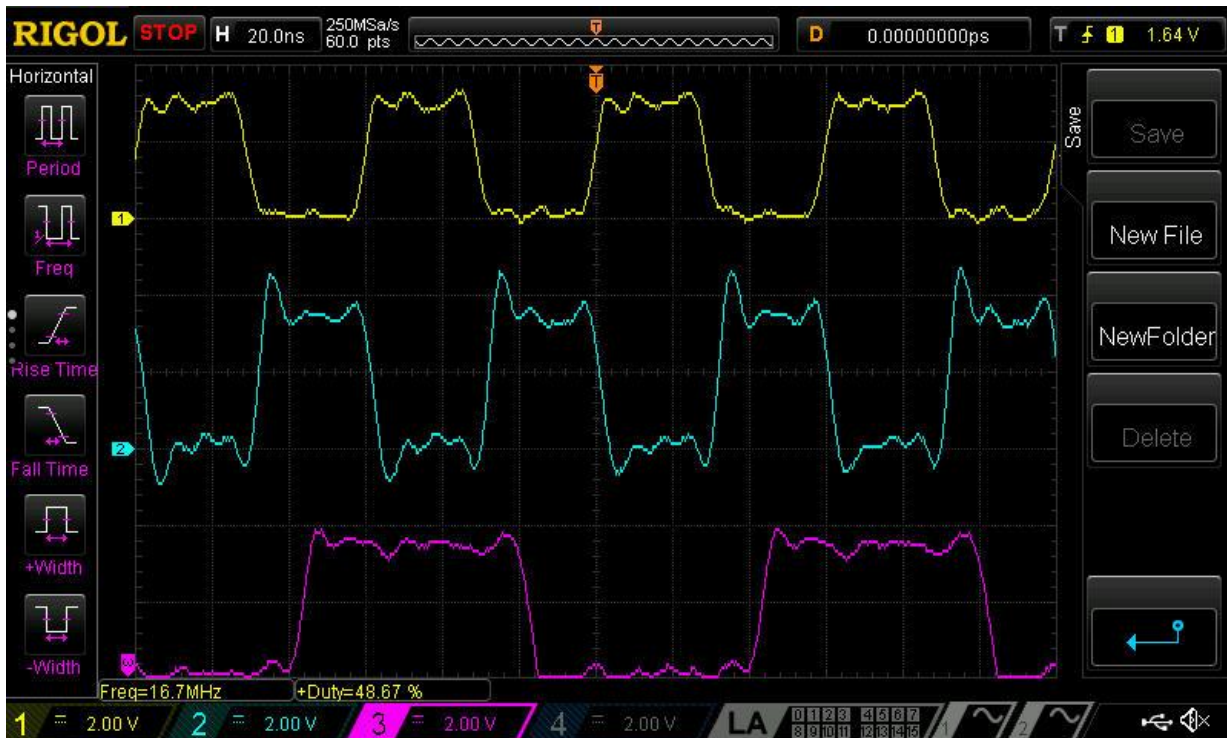
- Period is 60 ns. Pulse width is 30 ns, DC = 50 % (incorrect functionality).

Currently, there is no workaround for this issue. The FILTER block correctly filters isolated glitches, but it shouldn't be used to filter repetitive, high frequency input signals.

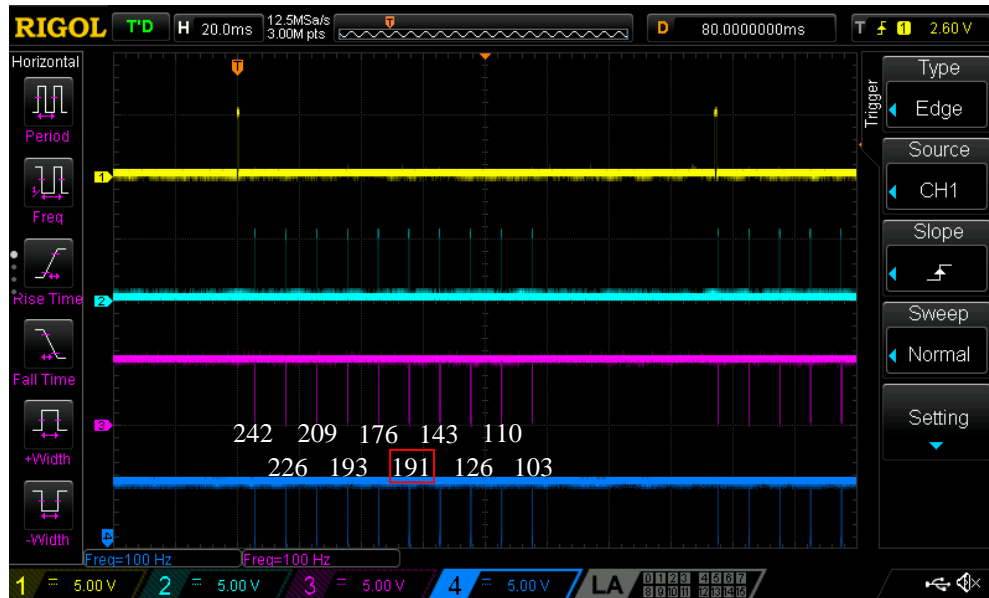
Asynchronous interaction between the CNT/DLY clock input and the I²C latch signal (generated by an I²C read command of the CNT/DLY block's count value) can result in an incorrect I²C data read. The CNT/DLY block will count accurately, but the count value transferred into the block's I²C read register might be loaded incompletely if the I²C latch signal and the clock input occur at about the same time.

The example data capture below shows ten periodic I²C reads of CNT2/DLY2 configured to count down at about 16 clocks per read. The sixth read sample erroneously shows a value greater than that of the fifth. The seventh sample reads as if the previous I²C error never occurred - the difference from the fifth sample (176) to the seventh (143) is 33 clocks or 16 clocks + 17 clocks as expected.

- Channel 1 (yellow/top line) – PIN#2 (CNT2/DLY2 Out).
- Channel 2 (light blue/2nd line) – PIN#1 (I²C Read Triggers).
- Channel 3 (magenta /3rd line) – PIN#8 (I²C SCL).
- Channel 3 (dark blue /4th line) – PIN#9 (I²C SDA).

If the possibility of incorrect I²C data reads can't be accommodated for by external software checks, one can guarantee proper operation by stopping the CNT/DLY block's clock during I²C reads through one of the following methods: by disabling the oscillator block, by reconfiguring the CNT/DLY block's clock source, or by gating an external clock using a LUT (Look-up Table) in the signal matrix. After disabling the CNT/DLY block's clock, the count registers can be read without error. Please note that this workaround will add the I²C read and processing time to the counter's overall clock period.

The best workaround depends on the resource constraints of the application. If the oscillator block doesn't clock other logic elements within the design, a matrix output can be used to manually power down the oscillators for the I²C read. When the CNT/DLY block's clock source is routed internally from the oscillator block, I²C commands can temporarily reconfigure the CNT/DLY block's clock source registers to select "Ext. CLK. (From Matrix)." This action will disable the clock by connecting it to ground. If the CNT/DLY block is clocked from the signal matrix, a LUT can be used to gate the clock during an I²C read.

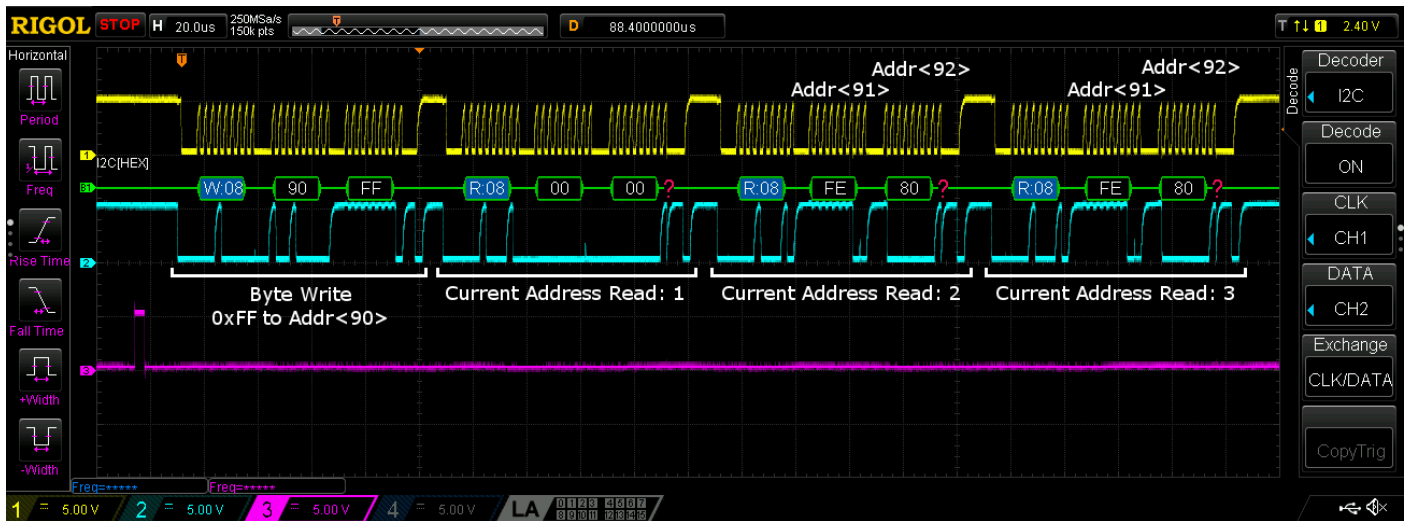
The first “Current Address Read” or “Sequential Read” command following an I²C “Byte Write” or a “Sequential Write” command will produce incorrect data. Additional read commands will return the expected data. See the waveform below for more information.

Channel 1 (yellow/top line) – PIN#8 (SCL).

Channel 2 (light blue/2nd line) – PIN#9 (SDA).

Channel 3 (magenta/3rd line) – I²C Software Trigger.

Note: In the GreenPAK test design, Addr<91> and Addr<92> expect FE and 80 respectively.

If possible, use the “Random Read” command as described in the datasheet for SLG46583. This command will output the correct data.

If you expect consecutive reads of the same register, we recommend sending a “Random Read” command to the register preceding the register of interest. After the “Random Read” command finishes, the chip’s register pointer will increment to the desired register and the following “Current Address Read” or “Sequential Read” commands will produce the correct data. Note that the “Current Address Read” and “Sequential Read” commands don’t increment the GreenPAK’s register pointer.

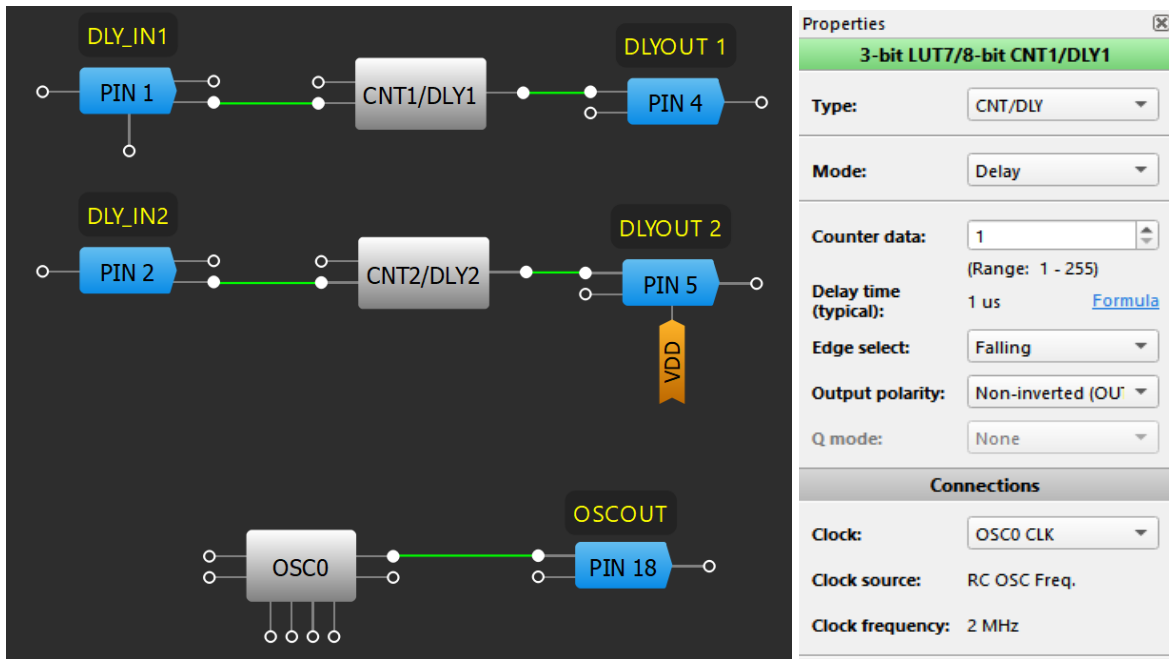
Figure 2: Test Circuit

The error is difficult to capture as the timing must be exact within ns, and short (ns) pulses are difficult to generate glitch precise enough to induce the problem. GPIO naturally filter out ns pulses, so for purposes of errata capture, two simultaneous falling-edge DLY circuits (as shown in Figure 2) were used. By lining up two delays precisely at a particular timing relationship, we can use the internal Auto Power On (OR logic) to generate the glitch pattern necessary to cause the error.

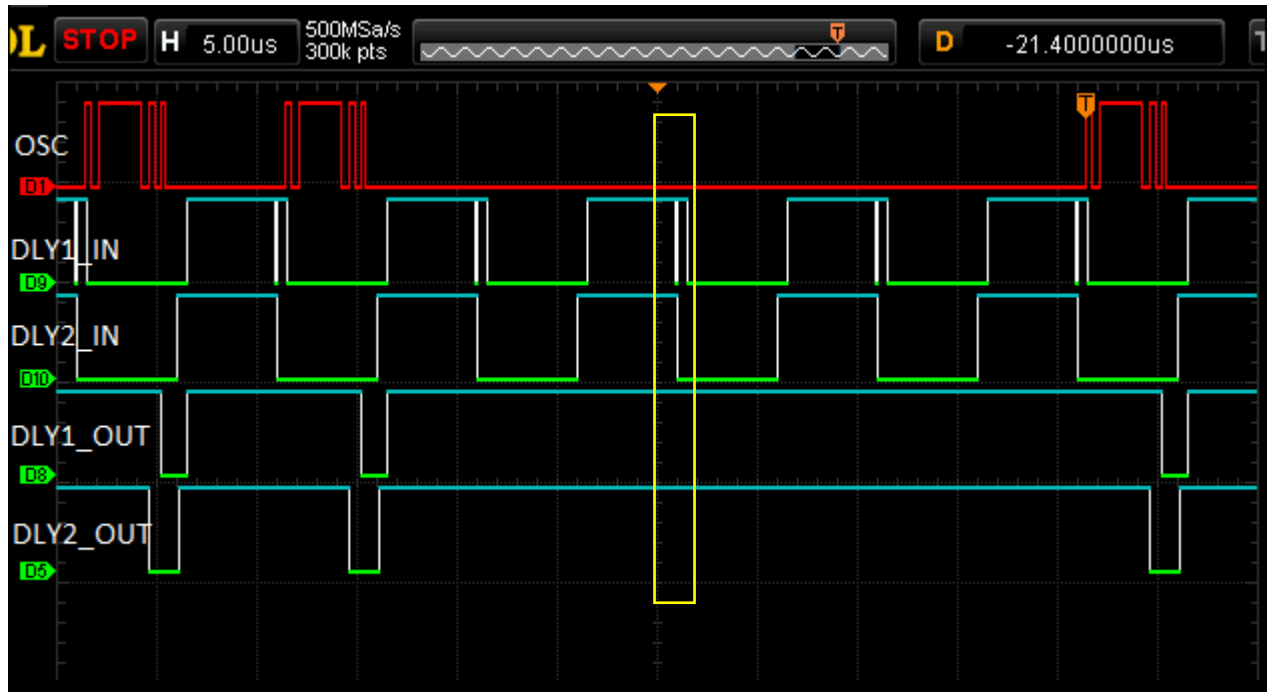
Figure 3: Errata Capture (Zoom Out)

Figure 3 shows a series of DLY output events are missing, where the OSC is correspondingly not triggering when it was supposed to. Figure 4 is a zoom in of the boxed region from Figure 3. The total glitch/chatter time was measured in this case at 152 ns. By using the composite OR of the two delay channels, we can asynchronously strobe with tiny frequency variations, and so tune the timing to induce this errata. Note that the error is not persistent – the system is recovered when all DLYs are returned to inactive state, such as when input of falling edge DLY goes high, thus canceling delay, or after DLY out finishes.
