ISSUE 1: FILTER Cell does not Filter Out Repetitive Glitches

SLG46585

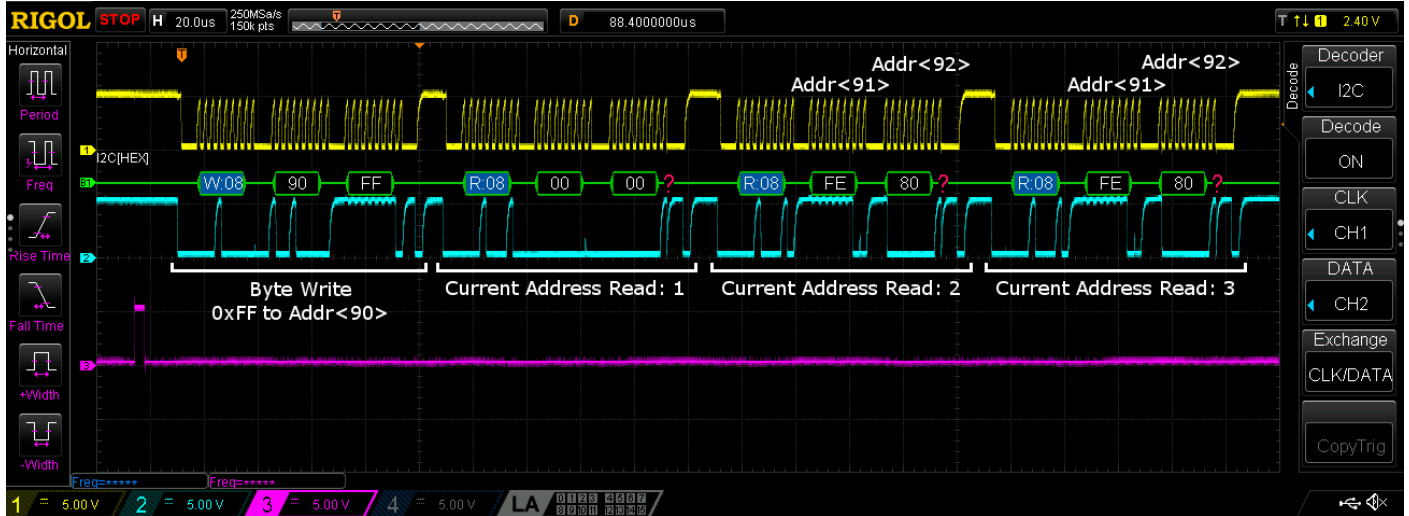
The first “Current Address Read” or “Sequential Read” command following an I²C “Byte Write” or a “Sequential Write” command will produce incorrect data. Additional read commands will return the expected data. See the waveform below for more information.

Note: In the GreenPAK test design, Addr<91> and Addr<92> expect FE and 80 respectively.

If possible, use the “Random Read” command as described in the datasheet for SLG46585. This command will output the correct data.

If you expect consecutive reads of the same register, we recommend sending a “Random Read” command to the register preceding the register of interest. After the “Random Read” command finishes, the chip’s register pointer will increment to the desired register and the following “Current Address Read” or “Sequential Read” commands will produce the correct data. Note that the “Current Address Read” and “Sequential Read” commands don’t increment the GreenPAK’s register pointer.

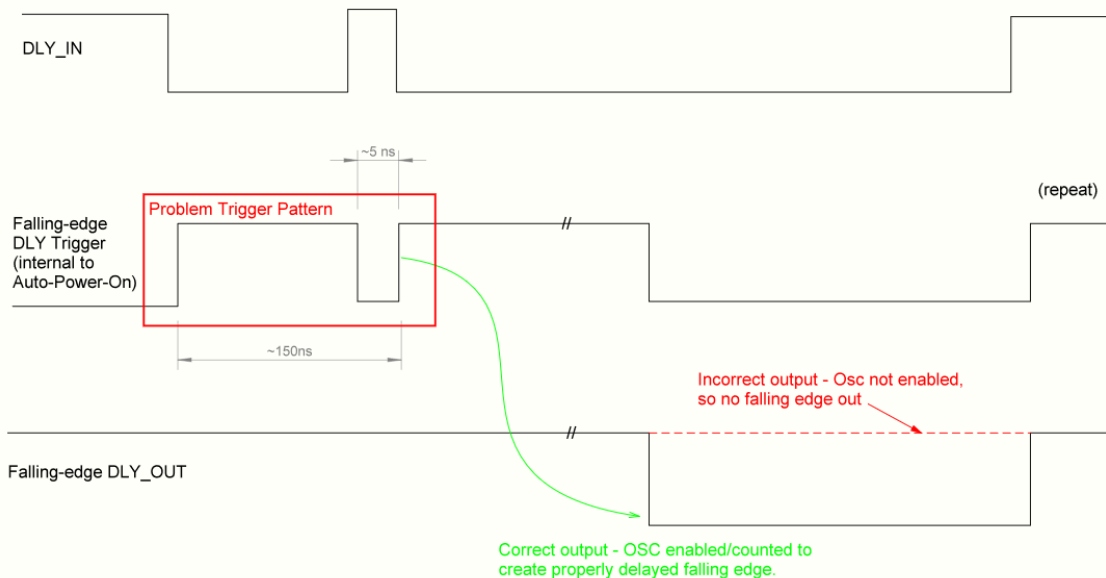
Figure 1: Problem Trigger Pattern

For this chip, the Auto Power On circuitry of the 25 kHz/2 MHz generators contains a circuit errata, which can potentially fail to power on the OSC for a specific pattern and timing of the OR of all related DLY trigger signals. The pattern is shown in [Figure 1](#) (boxed in red) and consists of a relatively longer pulse (~145 ns) followed by a shorter (~5 ns) glitch of opposite polarity.

1. Use signal conditioning circuits to prevent glitch on DLY inputs < 200 ns. Examples:
 - a. ACMP with Hysteresis
 - b. External RC in front of Digital Input with Schmitt Trigger
 - c. Filter cell.
2. Set OSC power mode to Force Power On mode instead of Auto Power On.
3. Use different oscillator, such as 25 MHz Ring OSC, which does not have Auto Power On issue.

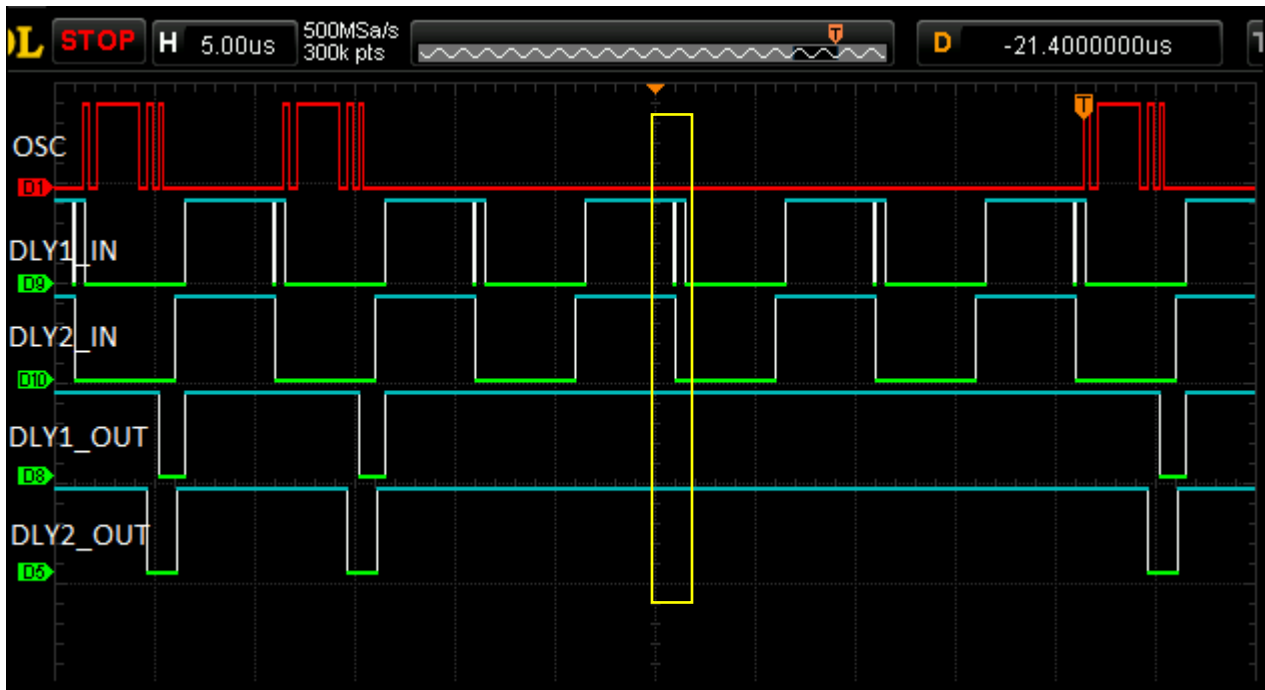
Figure 3: Errata Capture (Zoom Out)

Figure 3 shows a series of DLY output events are missing, where the OSC is correspondingly not triggering when it was supposed to. Figure 4 is a zoom in of the boxed region from Figure 3. The total glitch/chatter time was measured in this case at 152 ns. By using the composite OR of the two delay channels, we can asynchronously strobe with tiny frequency variations, and so tune the timing to induce this errata. Note that the error is not persistent – the system is recovered when all DLYs are returned to inactive state, such as when input of falling edge DLY goes high, thus canceling delay, or after DLY out finishes.
