SLG47525/28 Errata Note

This document contains the known errata for SLG47525/28 and the recommended workarounds.

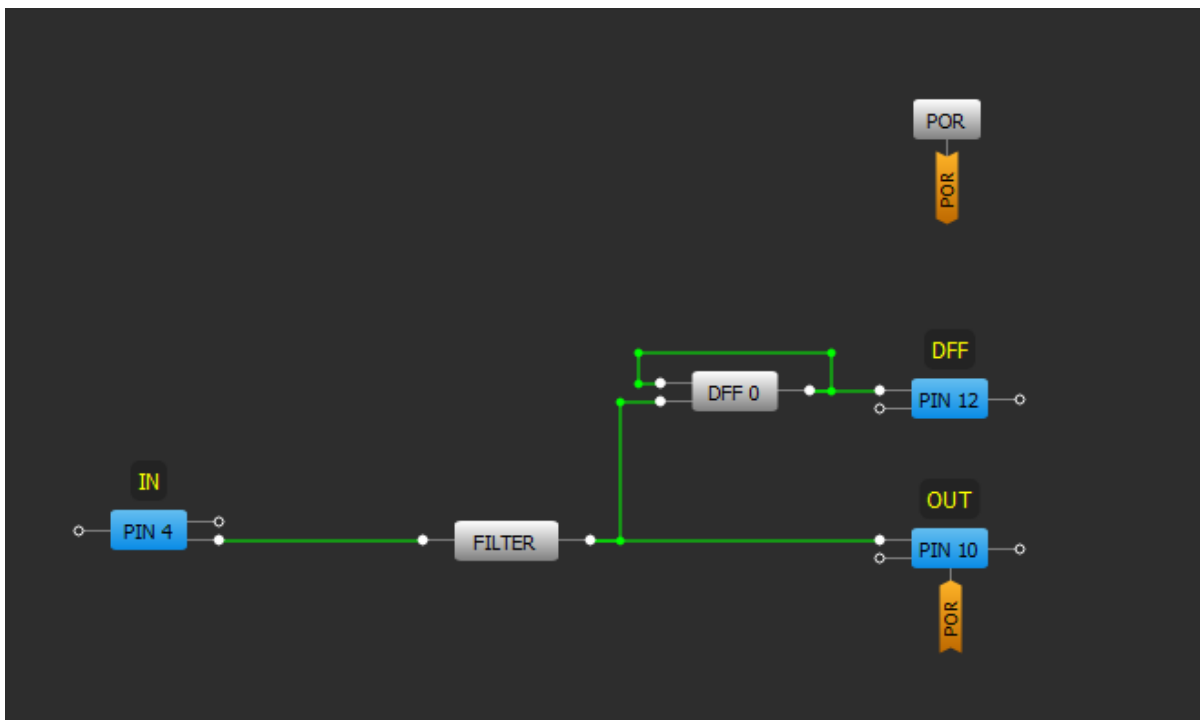
Figure 4

If clock type high frequency input comes in, the FILTER cell may not filter it out. There are several factors like input frequency, duty cycle, and LOW duration in such signal that may lead to its passing through FILTER block.

1. Period is 60 ns. Pulse width is 10 ns, DC = 16.7 % (correct functionality).

Currently there is no workaround for this issue. Filter block is good at filtering short spontaneous glitches. It is intended to be used in series connection before the delay cell to avoid its latching.

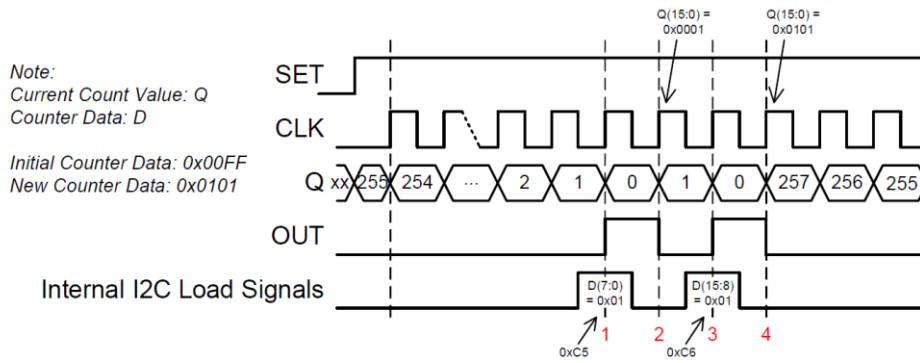
Figure 10. I²C Write of 16-Bit Counter Data Example

The timing diagram in [Figure 10](#) sets up a case where an improper output will be seen on the counter. In this example, the initial Counter Data value (D) is set up as 0x00FF. As you can see, the Current Count Value (Q) decrements from 255 down to 0 with rising edges on CLK. At time "1" denoted by a red number 1, an I²C command (not shown) has just been sent to the GreenPAK device to reconfigure the Counter Data value to 0x0101.

As previously mentioned, the 16-bit value is loaded from the I²C buffers to the Counter Data registers in 8-bit chunks. Right at time “1”, the LSB byte (0x01) is loaded into the Counter Data registers. This makes the Counter Data value temporarily equal to 0x0001. At time “2” between the internal I²C load signals, the counter receives a rising edge on its clock input. This causes the Current Count Value to underflow and to be loaded with the Counter Data value which is 0x0001. At time “3”, the MSB byte (0x01) is loaded into the Counter Data registers setting the Counter Data value to 0x0101. At time “4”, the Current Count Value underflows again and is set to the Counter Data value of 0x0101.

This behavior results in two output pulses on OUT when only one pulse is expected. Observing this behavior depends upon the asynchronous timing between the counter’s clock and an I²C write command to the Counter Data registers. For some applications, the extra pulse on OUT can be ignored and the counter will self-correct after underflowing, overflowing, or being SET/RESET through the GreenPAK connection matrix.

For applications where the application processor needs to read the Current Count Value while the counter is clocking, disable the “Stop and Restart Bit.” When this bit is disabled, the counter’s clock will not be gated internally which avoids the loss of count values during T_{stop}. In order to guarantee the current count value after the I²C write to the Counter Data registers, the clock should be manually stopped for the I²C write or a SET/RESET command should be generated after the I²C write (Case 1).
