1 Purpose of Document

This document summarizes the changes between the previous SAP5 silicon revision C and the current silicon revision D. These include requested UART design changes. The purpose of the redesign was to correct reported timing errors by the UART in the following modes: Master, Monitor, and Repeater. A problem with slave communication in special network constellations was also fixed.

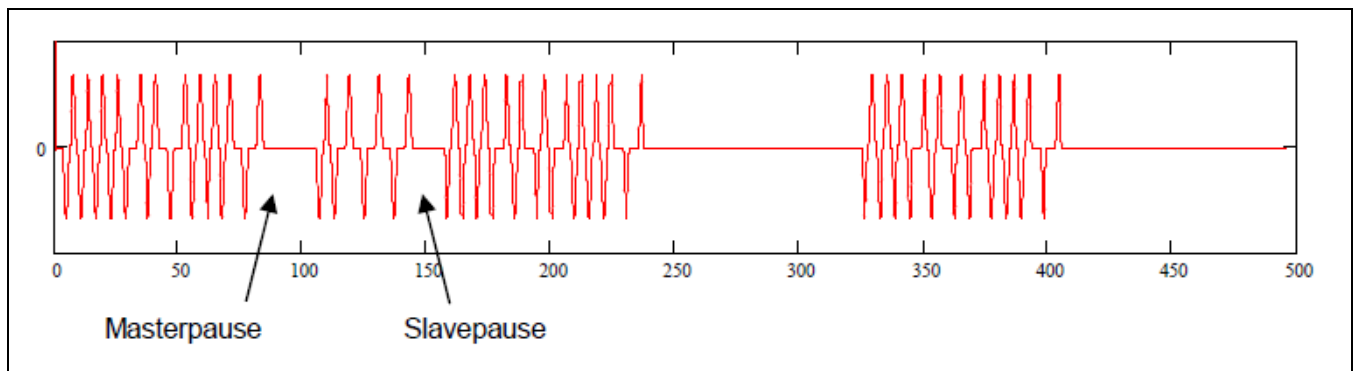
Figure 3.1 Test for SAP5 Revision C Error in Master Pause Detection

If the previous SAP5 revision C is operated in Slave Mode, the UART Master Pause detection does not always function correctly when the UART must listen to slave responses from a different slave. Depending on the actual AS-I line pulse timing, a slave response from a different slave is sometimes not recognized correctly, which results in a UART communication error. This prevents the Slave from understanding the next Master telegram correctly. If the Master telegram addresses the Slave itself, the error leads to a missing slave response and the Slave replies on a second repetition of the Master Call to its own address in asynchronous mode.

This behavior was mostly observed in mixed networks that used modules with the ASI4U, SAP5, and SAP4.1.

Figure 3.1 shows a telegram test case to reproduce the error. The AS-I signals shown in Figure 3.1 were generated by a signal generator that allowed sweeping the Master Pause and Slave Pause duration over the allowed specification limit. The first Master Call contains a different slave address than the tested slave. The second and third master calls address the tested slave. The tested slave replied with the erroneous behavior for certain Master pause and Slave pause scenarios only. The majority of the test cases were passed without error.

A new principle of AS-i telegram pause detection was implemented in SAP5 silicon revision D that is more precise and able to cover all valid timing scenarios for Master and Slave pauses. The new principle is now independent of the internal timing constraints of the UART state machine.
