SLG46625-A Errata Note

This document contains the known errata for SLG46625-A and the recommended workarounds.

Package(s)	20-pin TQFN: 3.5 mm x 3.5 mm x 0.75 mm, 0.5 mm pitch
-------------------	--

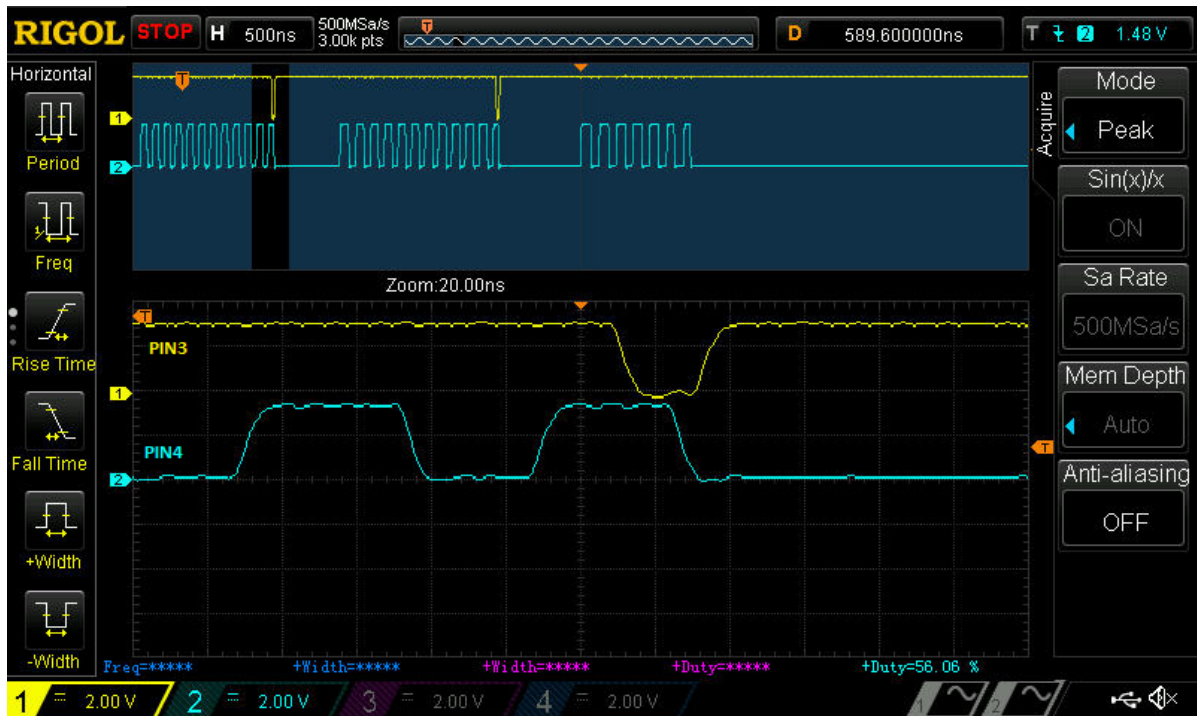
Figure 4. Ring OSC Output

The configuration shown above generates a periodical signal with a frequency defined by the Delay cell and started by a high signal on PIN2. The issue becomes apparent in a longer settling time when the scheme generates short pulses (Delay is configured as a rising edge delay only). See the waveform in [Figure 4](#).

Channel 1 – 2-bit LUT0 output

Channel 2 – Ring OSC output

Such behavior will lead to substantial error in period calculations if the delay time is relatively small.

Set Ring OSC power mode to “Force Power On” or Set Turn on by register option in BG (Band Gap) block as “Enable”.
