Errata

SLG46117

CE-GP-012

This document contains the known errata for SLG46117 and the recommended workarounds.

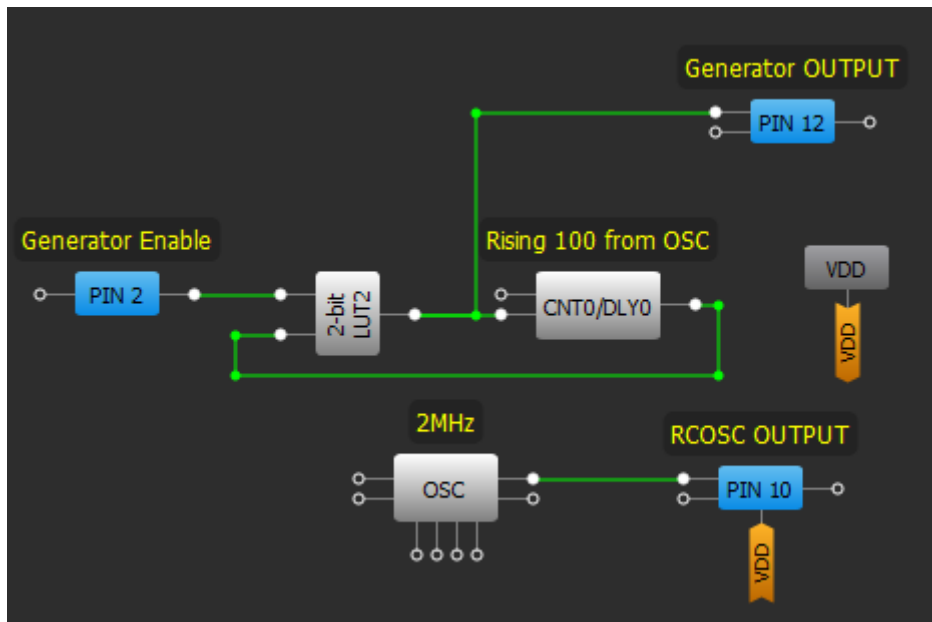
An example of such issue is in the following configuration:

The RC OSC has a longer settling time when configured as 2 MHz with Auto Power On in the designs that have very short RC OSC disable time.

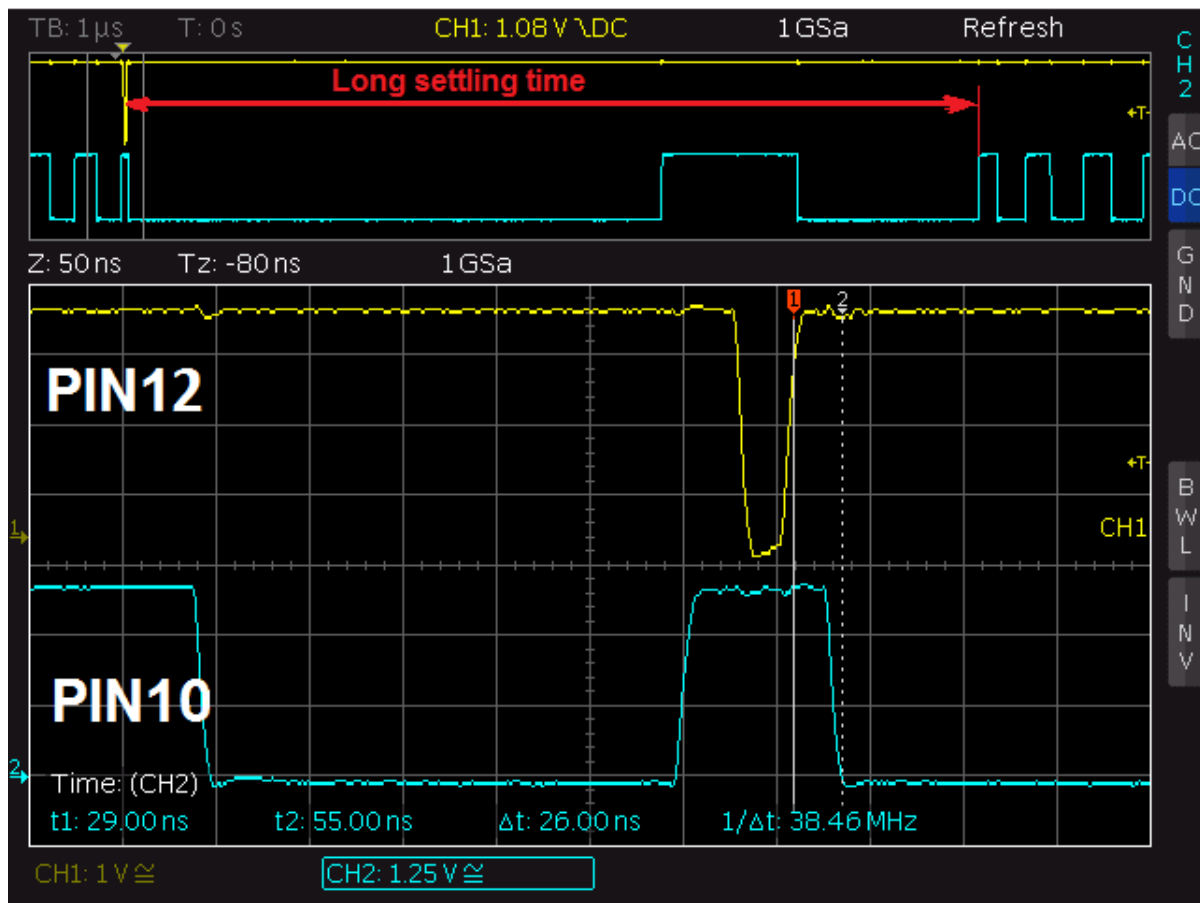
The configuration shown above generates a periodical signal with a frequency defined by the Delay cell and started by a HIGH signal on PIN2. The issue becomes apparent in a longer settling time when the scheme generates short pulses (Delay is configured as a rising edge delay only). See waveform below.

Channel 1 – 2-bit LUT0 output; Channel 2 – RC OSC output

Such behavior will lead to substantial error in period calculations if the delay time is relatively small.

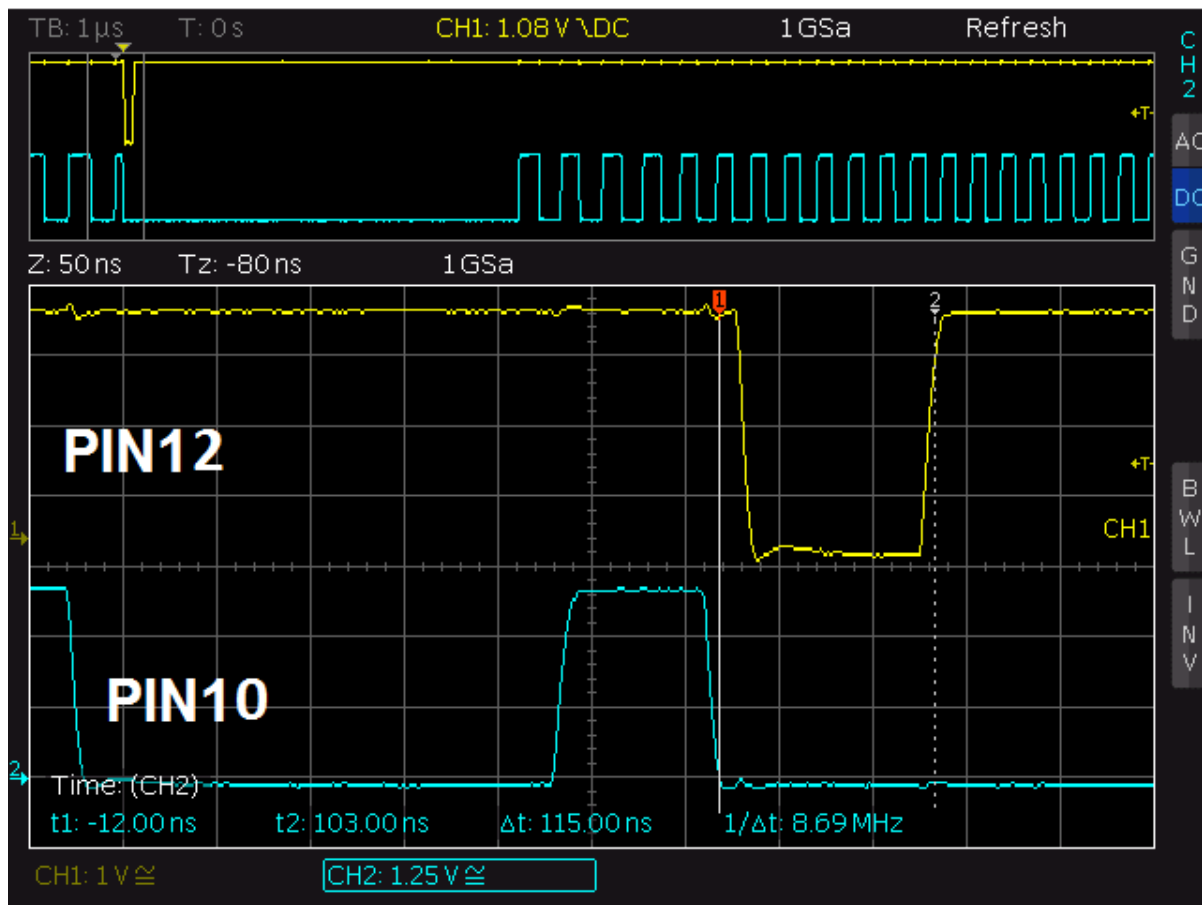
Channel 1 – 2-bit LUT0 output; Channel 2 – RC OSC output

- In first case use block with longer propagation time.

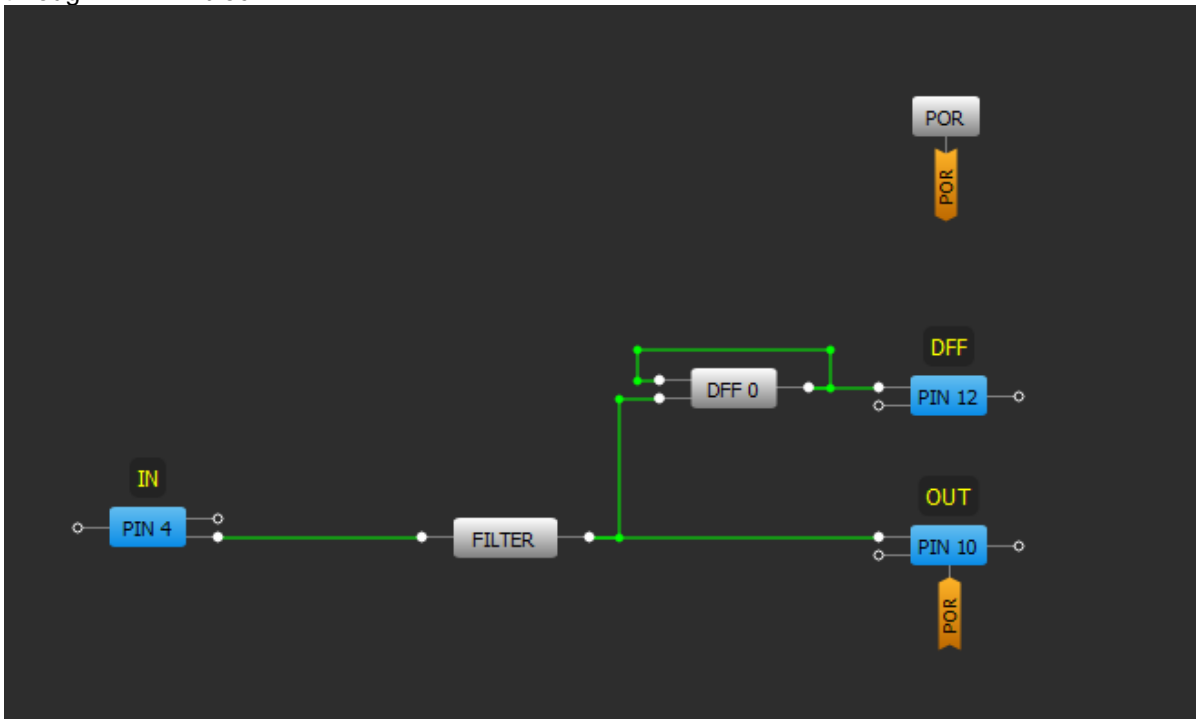
If clock type high frequency input comes in, the FILTER cell may not filter out it. There are several factors like input frequency, duty cycle and LOW duration in such signal that may lead to its passing through FILTER block.

Channel 1 (yellow/top line) – PIN#4 (IN)
 Channel 2 (light blue/2nd line) – PIN#10 (OUT)
 Channel 3 (magenta /3rd line) – PIN#12 (DFF)

Currently there is no workaround for this issue. Filter block is good at filtering short spontaneous glitches. It is intended to be used in series connection before the delay cell to avoid its latching (see issue #5).

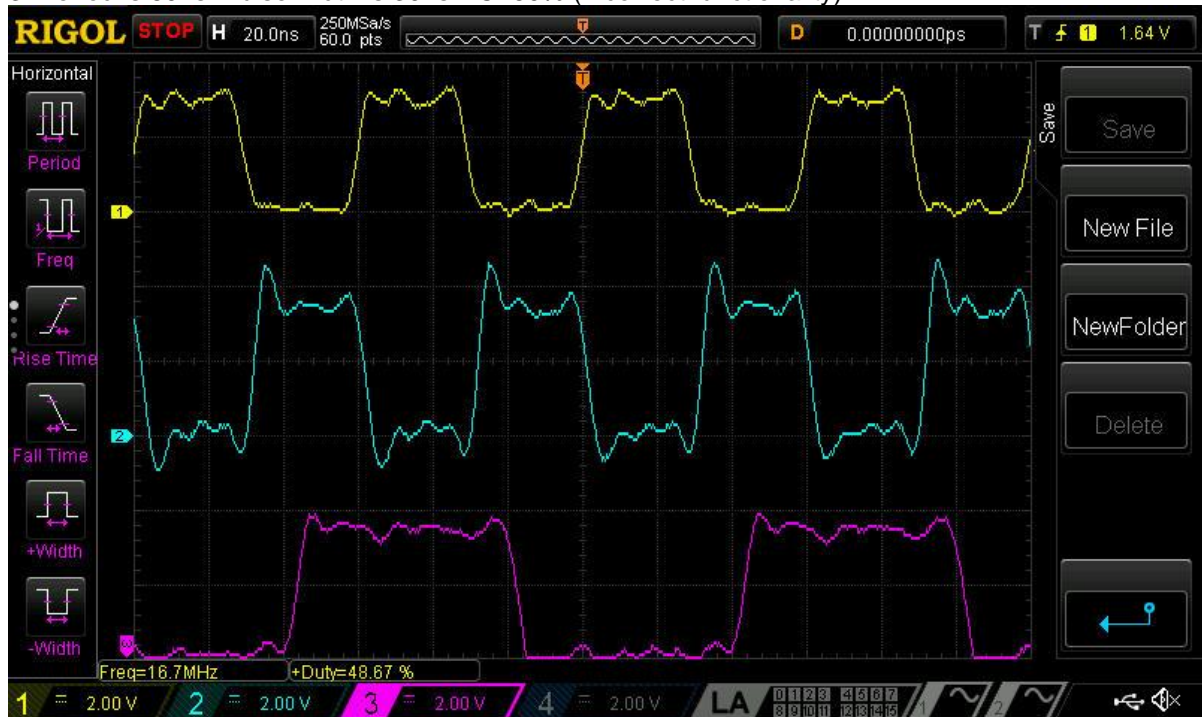
3. Period is 60ns. Pulse width is 30ns DC=50% (Incorrect functionality)

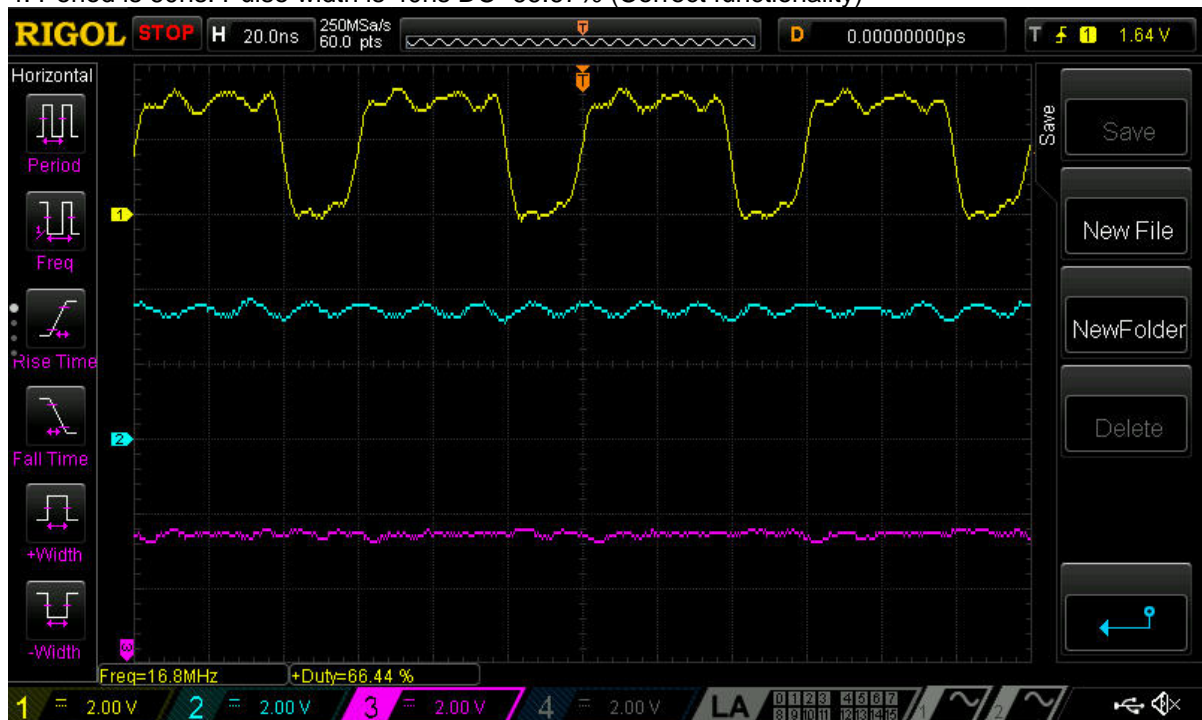
4. Period is 60ns. Pulse width is 40ns DC=66.67% (Correct functionality)

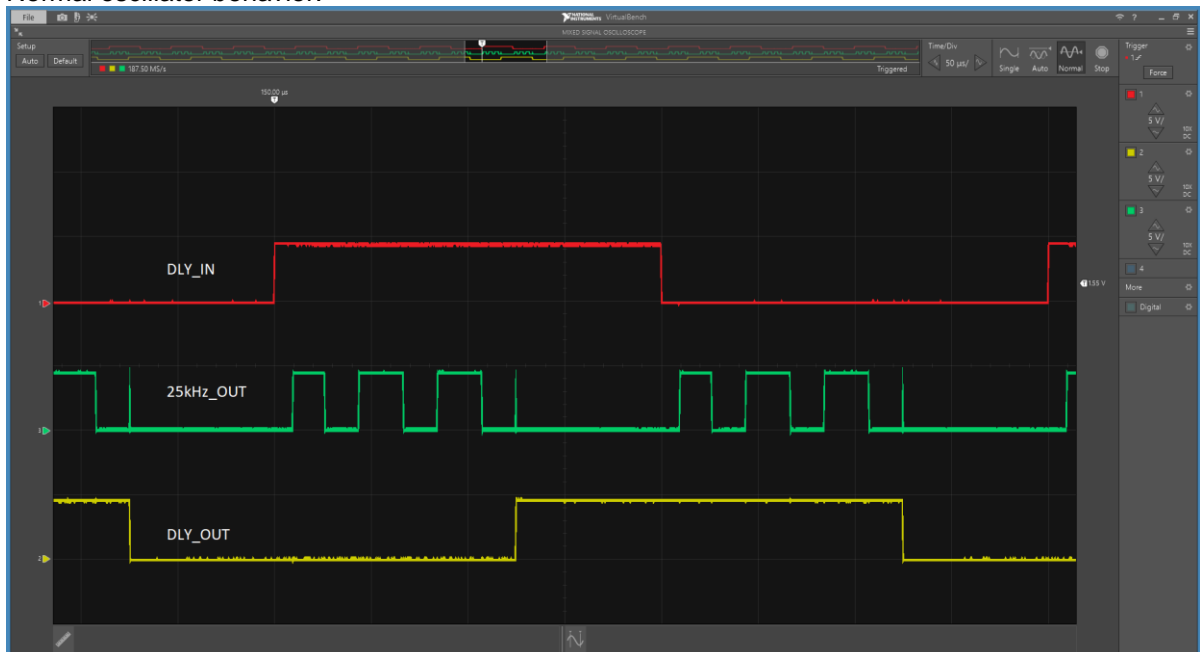
Normal oscillator behavior.

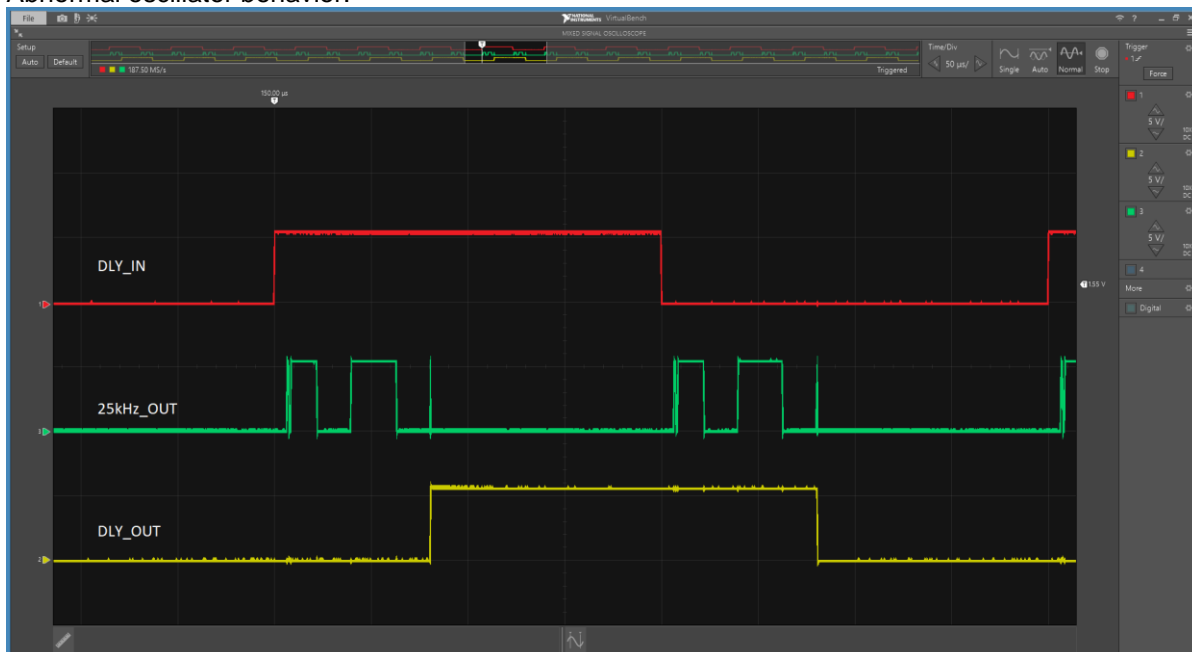
The first period of the RC OSC can be very short when OSC configured as 25 kHz with Auto Power On in the designs. This can be occurred when V_{DD} is above 4.0 V. Critical for CNT/DLY with a low counter data (less than 10) or if it is necessary to use the frequency of the OSC to clock external elements.

Abnormal oscillator behavior.

- Avoid V_{DD} higher than 4 V
- Force ON OSC
