## SLG46620-EV Errata Note

This document contains the known errata for SLG46620-EV and the recommended workarounds.

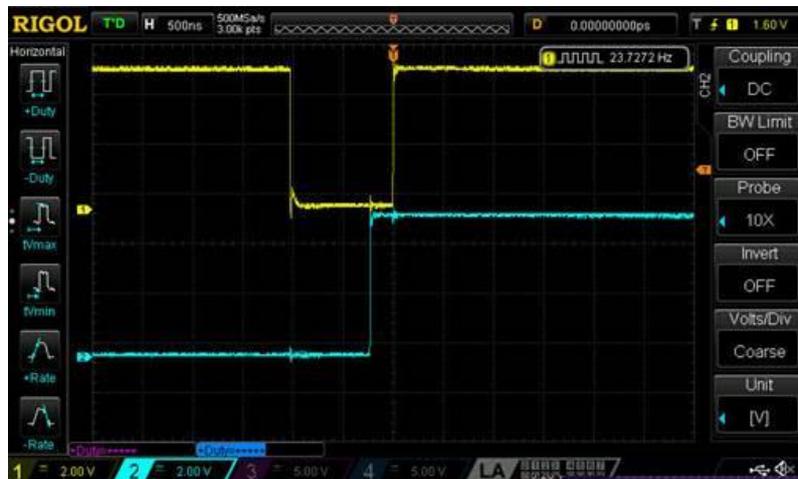
The output of the ACMP incorrectly goes low even when IN+ is greater than IN- if the RING OSC is active when the WS signal rises.

Channel 1 – ACMP out

Channel 2 – WS\_OUT

Avoid using the RING OSC with the WS Controller, or add a filtering block on the ACMP output to filter out the glitch.

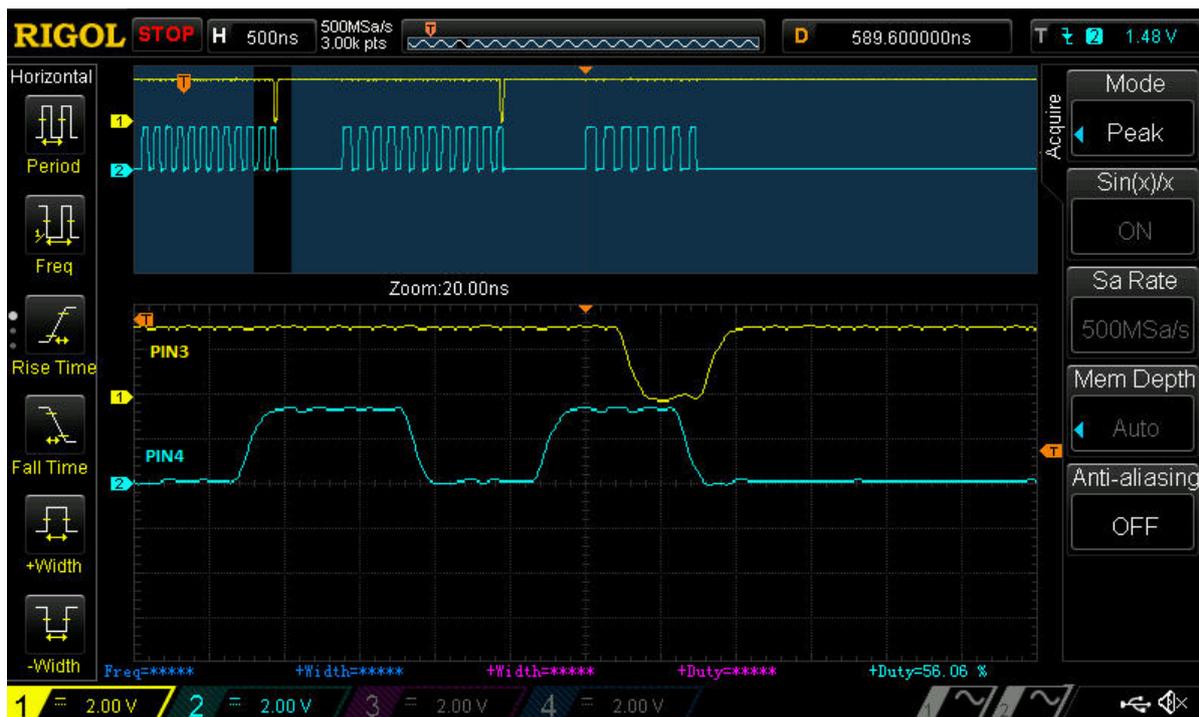
Channel 1 – 2-bit LUT0 output; Channel 2 – Ring OSC output

Such behavior will lead to substantial error in period calculations if the delay time is relatively small.

- Set Ring OSC power mode to “Force Power On”
- or, Set Turn on by register option in BG (Band Gap) block as “Enable”

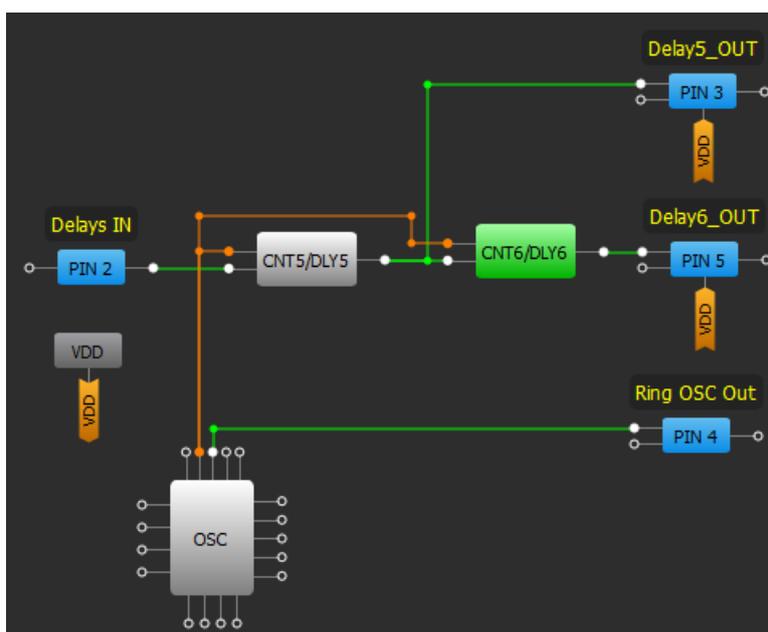
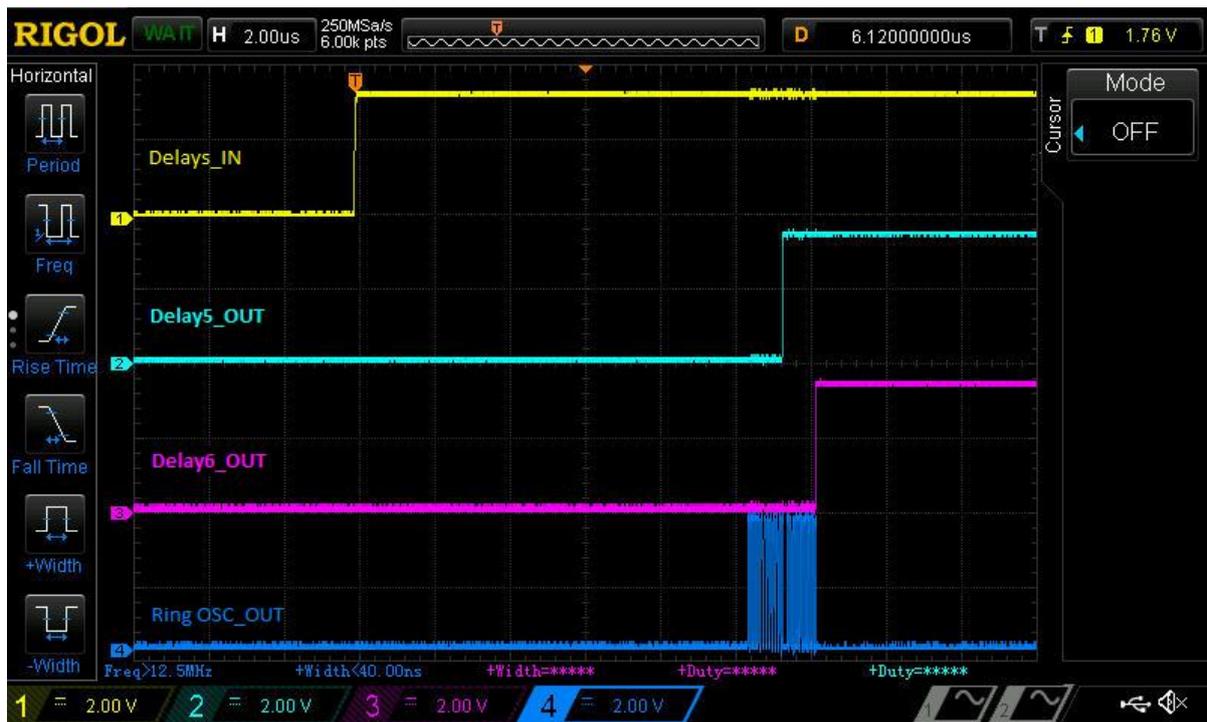
A similar situation can occur while using two connected delays (all edge detect types except for a pair “Rising edge DLY – Falling edge DLY”).

In the following example, Delay5 and Delay6 are configured in the same way. However, Delay5 time is 11.4us instead of expected 0.4us (Delay5 time).

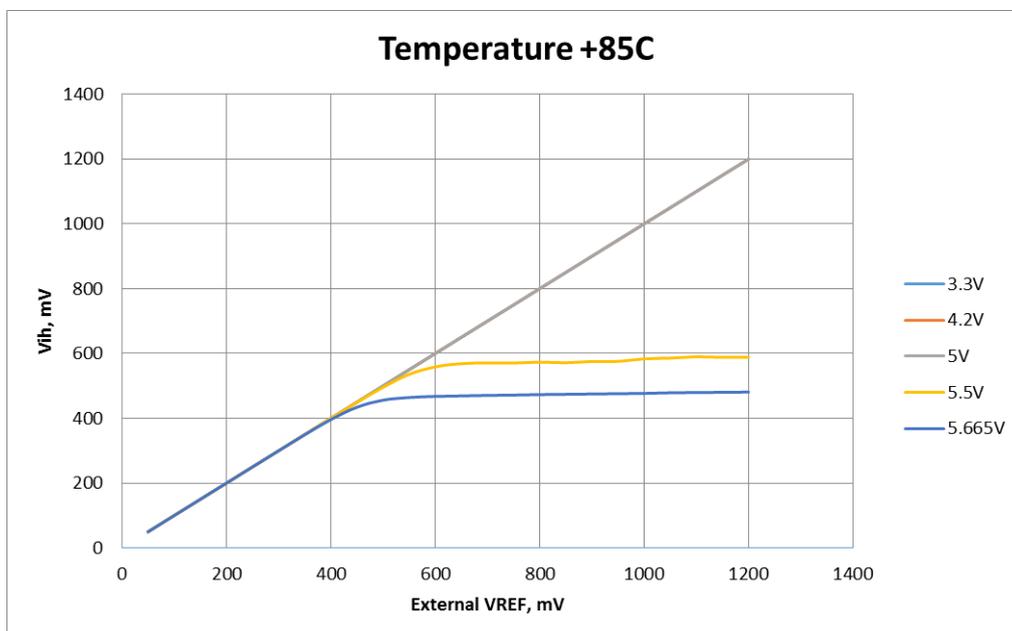
When using external Vref source, the ACMP comparison may happen at wrong threshold if the external Vref voltage is higher than a particular value (please see figure below) at high VDD values (> 5V) and high temperature.

Avoid using ACMPs in such conditions.

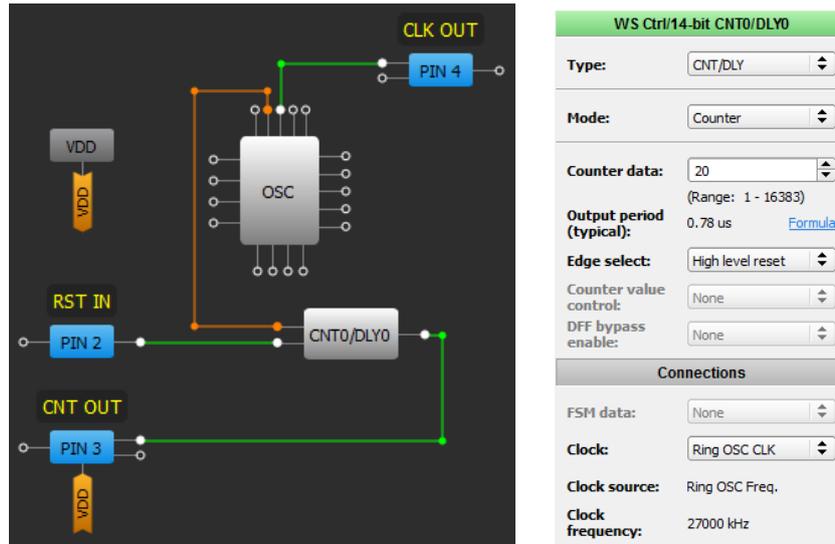
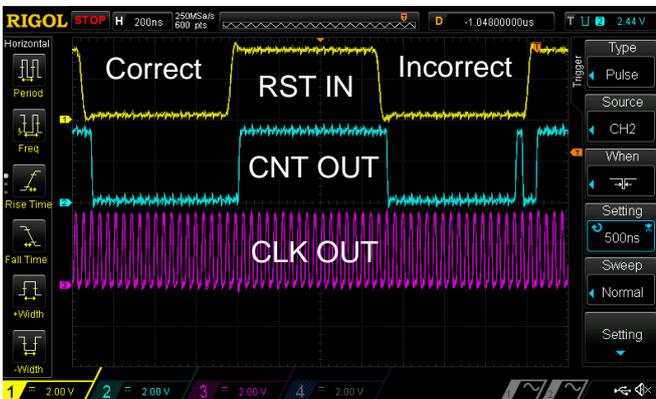
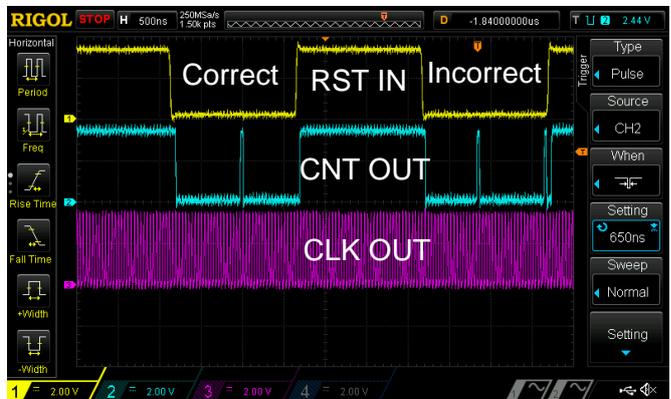
If the Counter Reset occurs at a time very close to a rising edge of the clock signal during clock signal generation (for example OSC operation), there is a possibility that the Counter Data of the Counter is reset incorrectly and the counter end signal (HIGH pulse) may appear faster than expected. This phenomena appears more frequently the higher the clock frequency is.

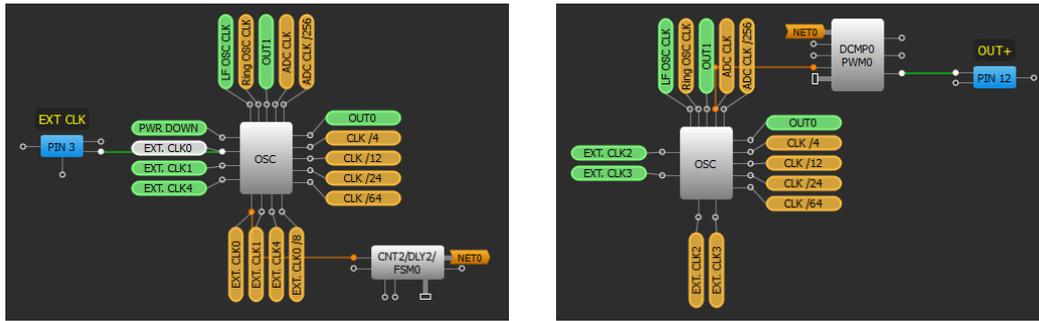
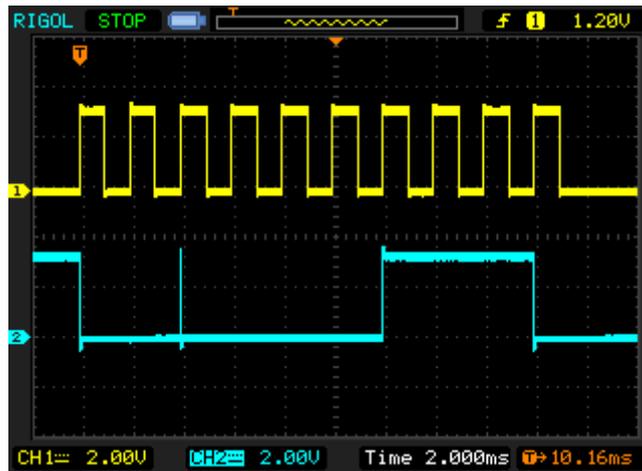
DCMP's OUT+ output may have a glitch when the input data is changed. This issue appears more frequently the higher DCMP clock is.

For example, DCMP IN+ sources from FSM0 and IN- from Register0. DCMP is clocked from the Ring OSC.
