SLG47525/28 Errata Note

This document contains the known errata for SLG47525/28 and the recommended workarounds.

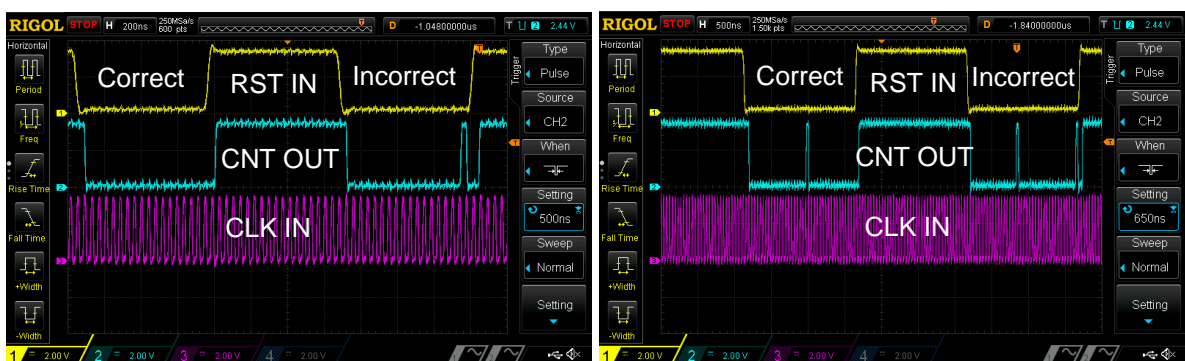
Figure 1

If the Counter Reset is asserted at the same time as a rising clock edge, it is possible that the Counter Data will be reset incorrectly and the counter output may appear faster than expected. This phenomenon appears more often as the clock frequency increases.

Synchronize RESET input of the Counter with its CLK using 2 DFF cells as shown on Figure 3.

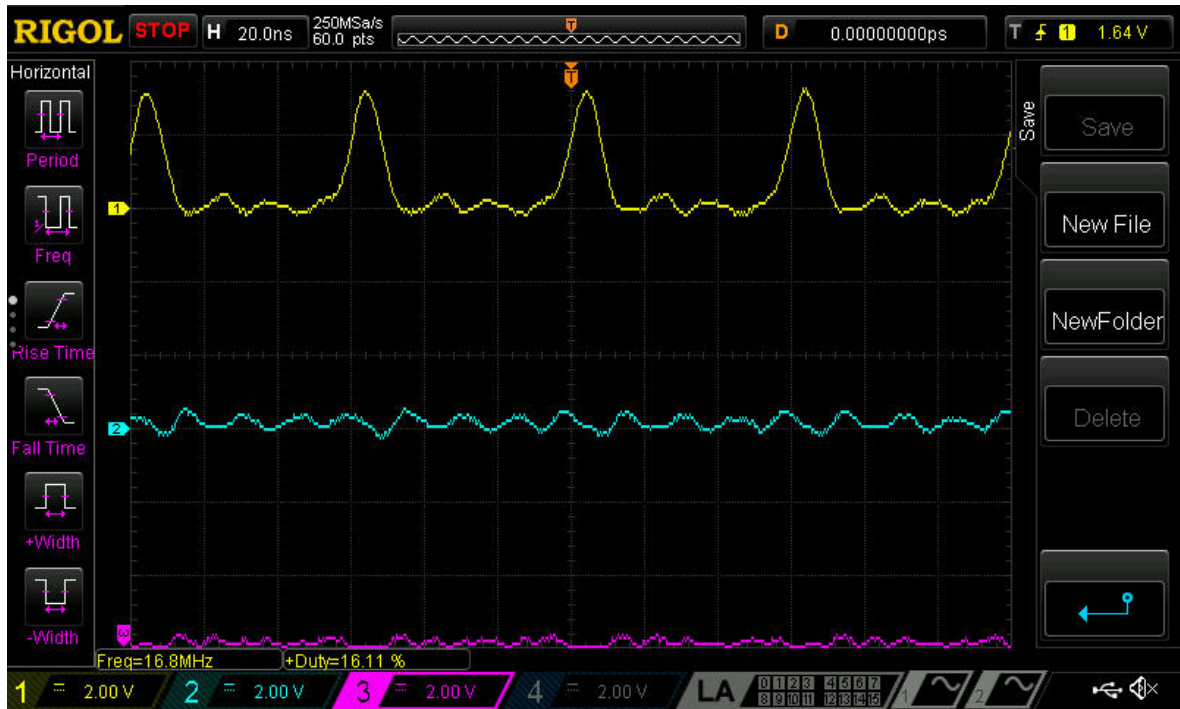
Figure 5

- 2. Period is 60 ns. Pulse width is 20 ns, DC = 33.3 % (incorrect functionality).

Currently there is no workaround for this issue. Filter block is good at filtering short spontaneous glitches. It is intended to be used in series connection before the delay cell to avoid its latching.

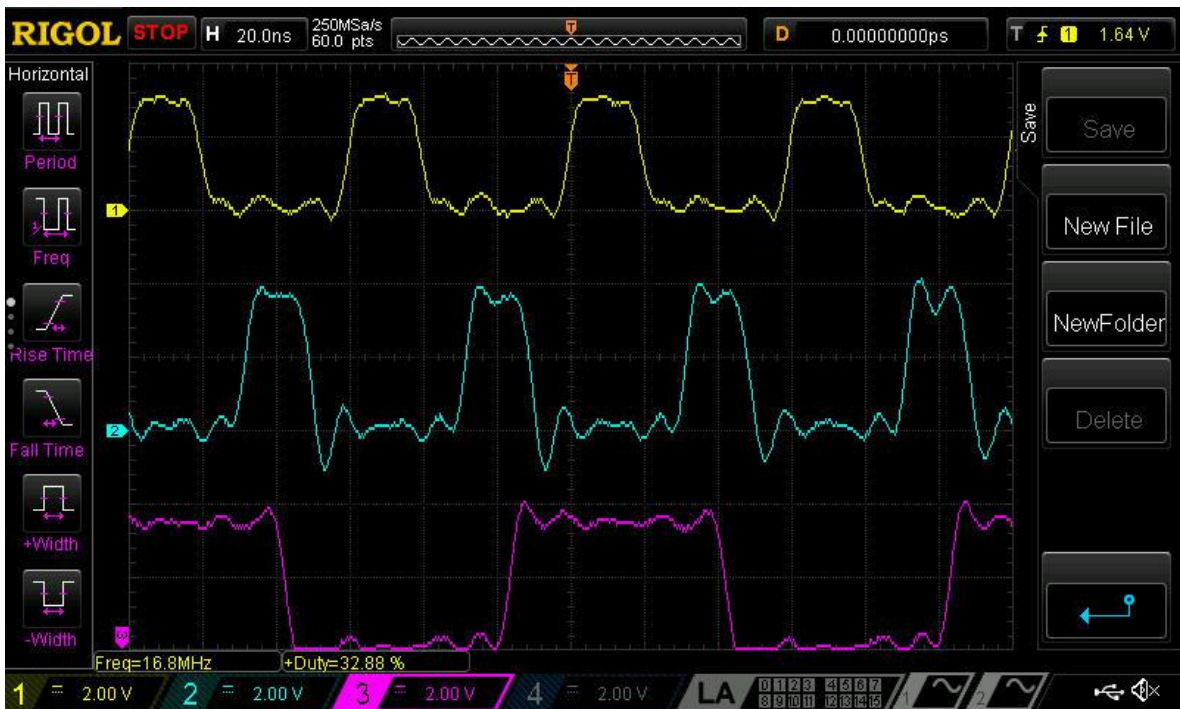
Figure 6

- Period is 60 ns. Pulse width is 30 ns, DC = 50 % (incorrect functionality).

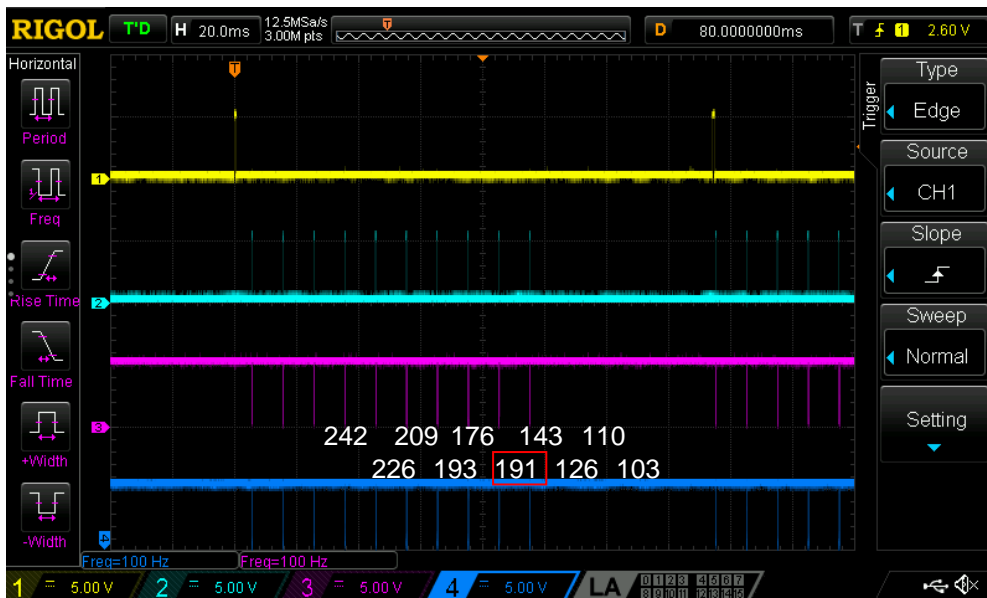
Asynchronous interaction between the CNT/DLY clock input and the I²C LATCH signal (generated by an I²C read command of the CNT/DLY block's count value) can result in an incorrect I²C data read. The CNT/DLY block will count accurately, but the count value transferred into the block's I²C read register might be loaded incompletely if the I²C LATCH signal and the clock input occur at about the same time.

The example data capture in Figure 9 shows ten periodic I²C reads of CNT2/DLY2 configured to count down at about 16 clocks per read. The sixth read sample erroneously shows a value greater than that of the fifth. The seventh sample reads as if the previous I²C error never occurred - the difference from the fifth sample (176) to the seventh (143) is 33 clocks or 16 clocks + 17 clocks as expected.

If the possibility of incorrect I²C data reads cannot be accommodated for by external software checks, one can guarantee proper operation by stopping the CNT/DLY block's clock during I²C reads through one of the following methods: by disabling the oscillator block, by reconfiguring the CNT/DLY block's clock source, or by gating an external clock using a LUT (Look Up Table) in the signal matrix. After disabling the CNT/DLY block's clock, the count registers can be read without error. Please note that this workaround will add the I²C read and processing time to the counter's overall clock period.

The best workaround depends on the resource constraints of the application. If the oscillator block does not clock other logic elements within the design, a matrix output can be used to manually power down the oscillators for the I²C read. When the CNT/DLY block's clock source is routed internally from the oscillator block, I²C commands can temporarily reconfigure the CNT/DLY block's clock source registers to select "Ext. CLK. (From Matrix)". This action will disable the clock by connecting it to ground. If the CNT/DLY block is clocked from the signal matrix, a LUT can be used to gate the clock during the I²C read.

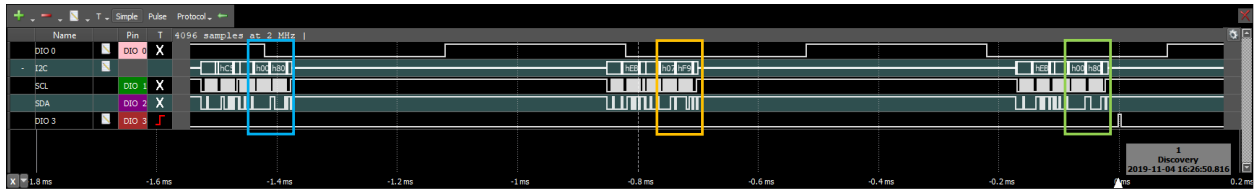
Figure 12. Counter Behavior

For the following condition, the Counter Data register contents are unexpectedly loaded into the counter’s DFF chain. This behavior occurs when there is a falling edge on the counter block’s clock input during the data return

portion of the I²C read of the Counter Data registers. Figure 12 shows this falling edge boxed in light blue followed by two I²C reads of the Current Count Value registers.

As you can see by the MCU data log below, the Current Count Value gradually increases from 0xF904 to 0xF907 but is unexpectedly reset to 0x8000. Please note that the colored HEX values in the MCU Log correspond to the boxed I²C read commands shown in the waveform above. As previously described, this reset occurs because there is a falling edge on the counter’s clock input while the GreenPAK device is responding to the I²C read request to 0xC5 and 0xC6 (note that 0xC5/0xC6 are the Counter Data registers and 0xEB/0xEC are the Current Count Value registers for CNT0).

The reason that the counter is not set to 0x8000 on the I²C read immediately following the Counter Data query is because the counter requires two rising edges on its clock input to load the data from the Counter Data registers into the DFF chain. Note that all rising edges during T_{stop} will be gated internally by the “Stop and Restart” feature.

For systems that require I²C write access to the Counter Data registers while the counter is clocking, enable the “Stop and Restart Bit” (Case 2).

I²C Read of Counter Data: avoid reading Counter Data via I²C while the counter is being clocked.

Within the MCU, we recommend saving the Counter Data register configuration as a software variable so that the Counter Data register does not need to be read during counter operation.

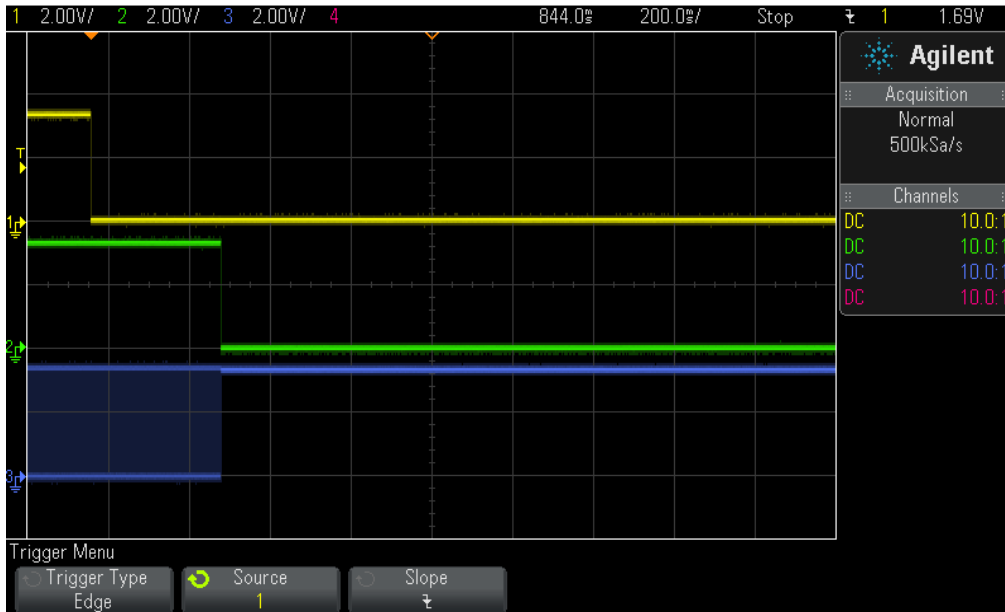
Figure 14

By toggling I2C_SDA low and then I2C_SCL low, the GreenPAK registers this as a start bit and latches all General Purpose Outputs such as PIN#17 (“OSC_OUT0”). In Figure 14, notice that PIN#17 (OSC_OUT0) stops toggling.

Disable IO Latching in programmed OTP. This register is I²C-write locked during normal operation and therefore should be disabled in configuration file.

Do not share I²C bus with other devices and make sure the I²C bus is not powered down while the GreenPAK is still powered through V_{DD}.

If the above cannot be satisfied, then consider using the SLG4658x devices, where this errata has been fixed.
