RENESAS TECHNICAL UPDATE

Product Category	Application Specific Standard Product		Document No.	TN-USB-A0005A/E	Rev.	1.00
Title	Notification for additional restriction on usage of SMBus Interface of USB Power Delivery Controller (R9A02G011, R9J02G012)		Information Category	Technical Notification		
Applicable Product	R9A02G011GNP#AC0, R9A02G011GBG#AC0, R9J02G012xxxGBG#AC0	Lot No.	Reference Document	R9A02G011 User's Manual (R19UH0102EJ0230) R9J02G012 User's Manual (R19UH0107EJ0230) R9A02G011/R9J02G012 Application Note (R19AN0062EJ0150)

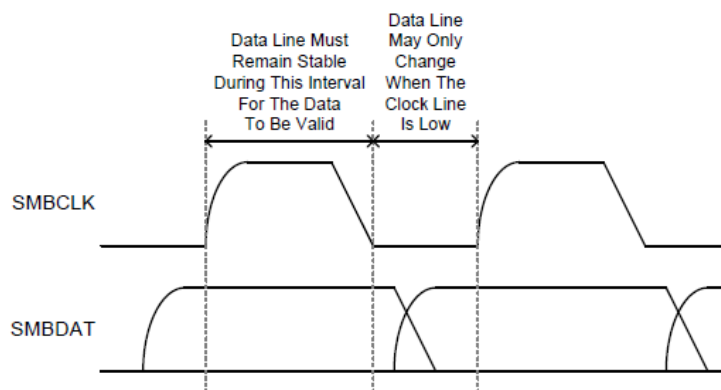
Note that the SMBus specification has timeout definition of SCL low period, but it is min. 25ms to max. 35ms. The I2C specification does not have such timeout so that SCL low can be infinite.

SMBus Data validity (System Management Bus (SMBus) Specification V3.2, Fig. 10)
