Abstract

The design of a daisy chain battery system, while fairly straightforward, has a number of design elements that can become obstacles to implementation. This case study provides a glimpse into the questions and responses in the development of one daisy chain system.

Introduction

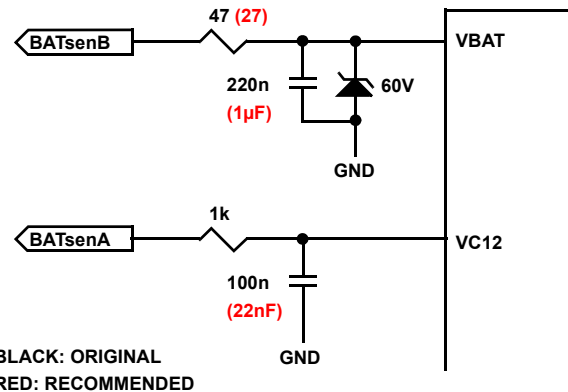
FIGURE 1. INITIAL VBAT CONNECTION

The VBAT input resistor was not damaged. Attached is a schematic of the VBAT connection.

Normally, we recommend a 27Ω resistor. While a 47Ω resistor may be OK, what happens is that the voltage at the VBAT pin drops when there is higher current, like during SPI or daisy chain communications. If the voltage drops too much, then there is not enough headroom on the front end analog circuits and there can be measurement errors. So, if the input resistor is not damaged then try a 27Ω resistor to see if this makes a difference.

If a smaller resistor value does not make a difference, then check that there is no large voltage differential across the VBAT series resistor. There should be a small drop in voltage (up to

about 80mV), however, if there is more than this, check the diode. If the diode is OK and there is still a voltage drop across the resistor, then the part may be damaged.

Another recommendation we make on the input filters is that the time constants on all inputs be the same (or about the same). In this case, the cell input time constant is about 16 times the VBAT time constant. If there are high voltage transients on the pack voltage, the differential time constants will result in high voltage differentials on the IC input pins. To minimize this, we recommend different filter values, as shown in RED in [Figure 1 on page 2](#).

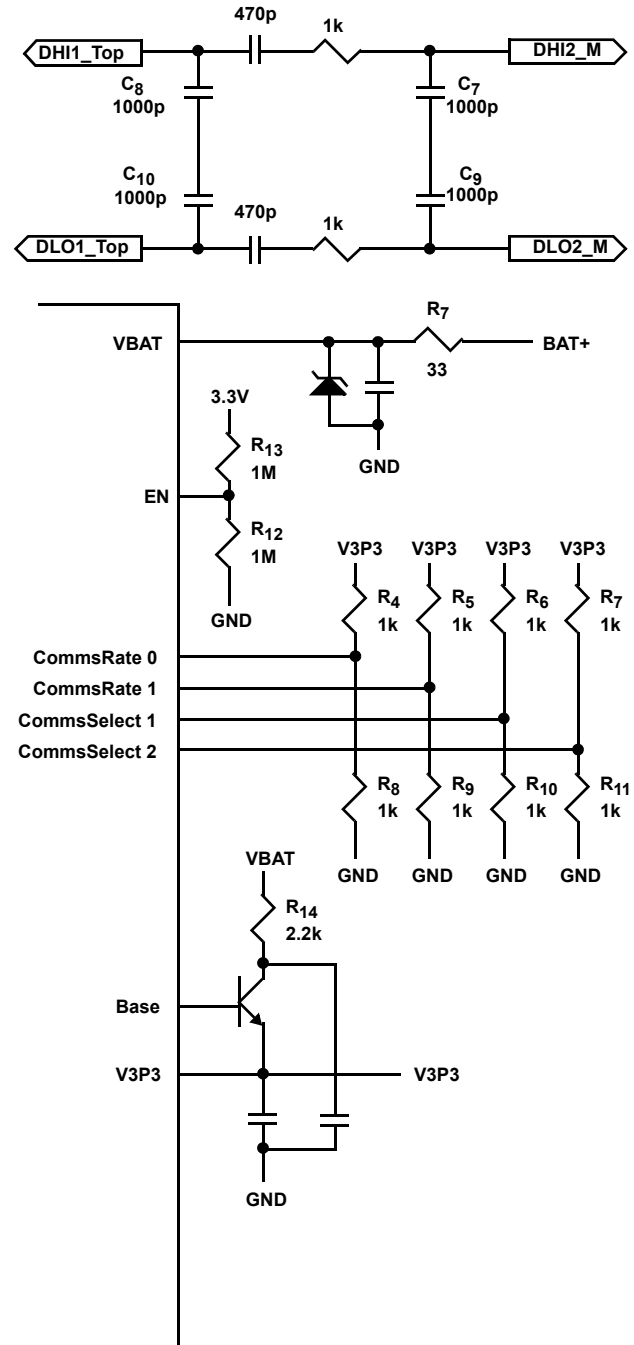
FIGURE 6. CUSTOMER ORIGINAL DAISY CHAIN CONTROL CONNECTIONS

Resistor R_{12} is not loaded and the Comms pull-up/pull-down resistors are loaded according to the configuration settings above. I measured the voltage across the resistor, R_7 , in the schematic. The master bottom device is currently reading 11.9mV (360 μ A) and the top device is currently reading 2.4mV (72 μ A). Neither of these currents are popping off the datasheet to tell me what is going on.

The first thing to notice on the schematic is that the center point of the capacitors C₈ and C₁₀ (and C₇ and C₉) should be at the respective IC GND (see [Figure 7](#)).

1. Resistor R₁₄ is probably too big. This will work OK for stand-alone, however, because of higher currents in the Daisy Chain mode, it might cause the 3.3V supply to drop out during communications. In our designs, we use a 100 Ω resistor.
2. On the V3P3 regulator, the collector resistor R₁₄ is shown to connect to VBAT. This should connect to BAT+, otherwise the V3P3 current will also flow through R₇, reducing the VBAT voltage.

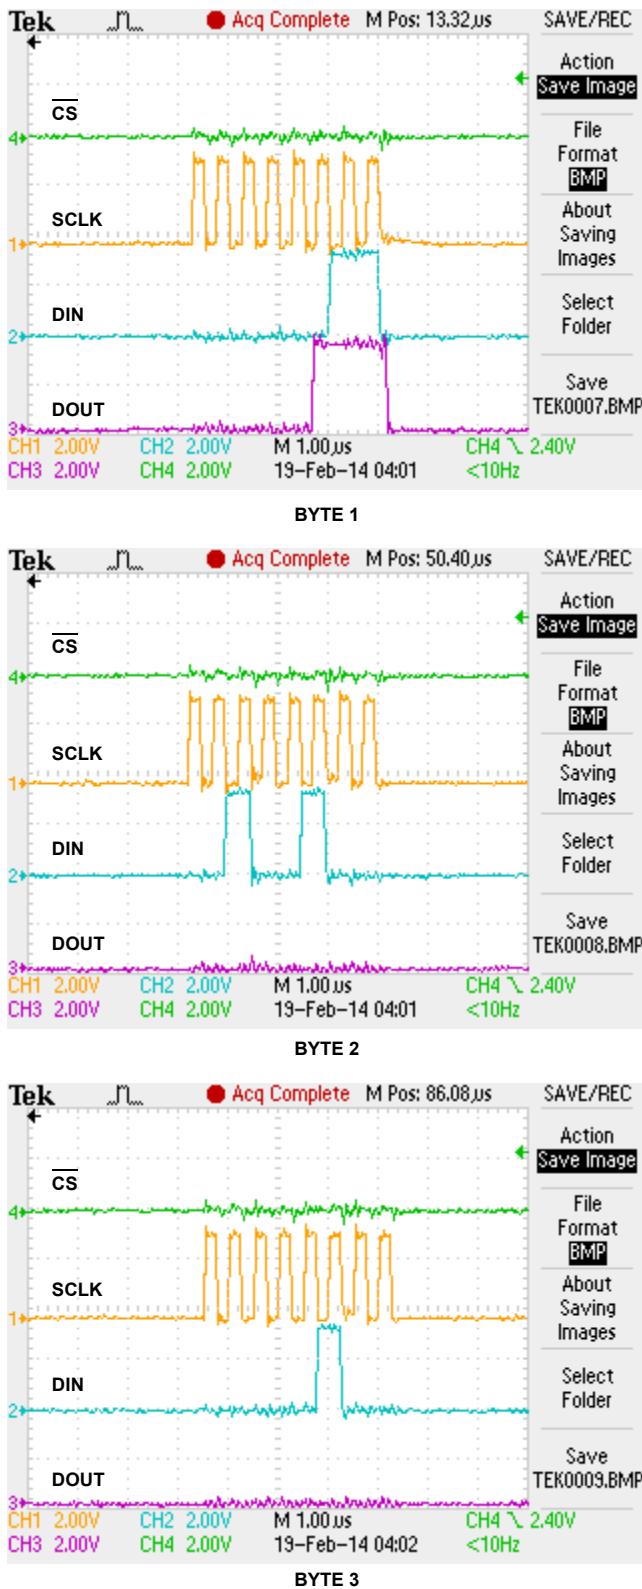
FIGURE 8. CUSTOMER REPORTED CORRECT STAND-ALONE COMMUNICATION

[Figure 8 on page 9](#) shows the SPI Identify command. The MISO data looks like 0x070000 but that's nothing valid to the best of my knowledge. If I send this command a few times in a row, I can get the MISO data to be 0x133800, which looks like a Comms Failure to me.

A: The fact that the upper device does not recognize the sleep/wake commands and there is no movement on the daisy chain lines means that there is something wrong with the daisy chain. *Nothing else matters until this can be cleared up.*

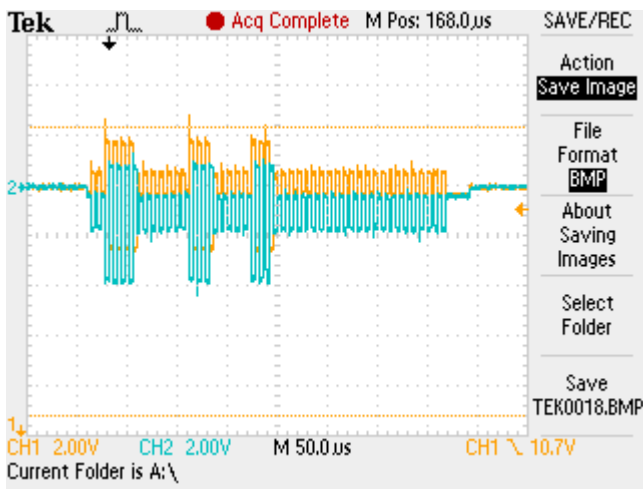
FIGURE 10. CUSTOMER DHI/DLO TRACES

So, that looks good. [Figure 10](#) is the scope waveform for the master/bottom device's DHI2 and DLO2 lines, which actually look correct now while the daisy chain interface isn't connected. DLO2 is blue and DHI2 is orange.

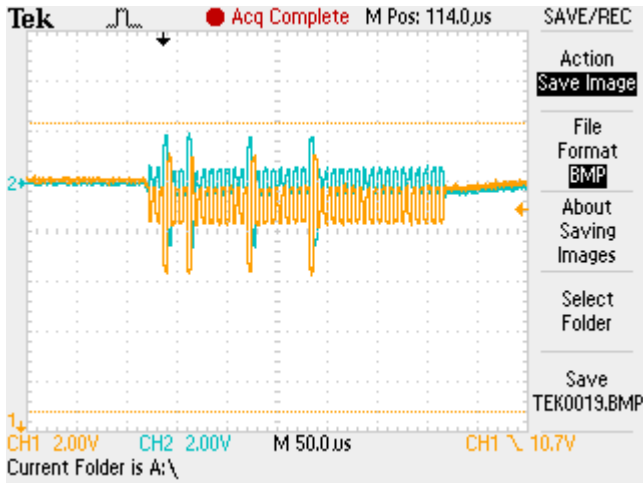
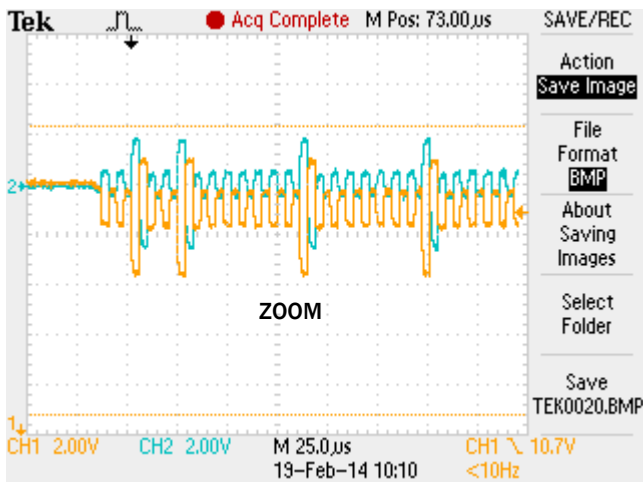
FIGURE 12. CUSTOMER DAISY WAVEFORMS AFTER CHANGES (GOOD)

Q: Wow, it's been a long day. I think I finally got it right, however, I won't be able to check if valid data is coming back down the stack until tomorrow. [Figure 12](#) are two waveforms showing my daisy chain communication. What I sent you last time was just the master/bottom side, since connecting them had the isolation issue I described. Once I fixed the isolation issue, I connected the 2-wire daisy chain interface and captured the attached waveforms.

A: This looks better.

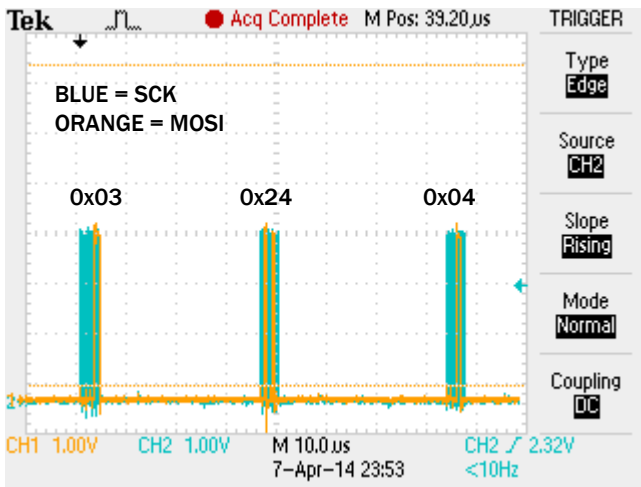
FIGURE 13. CUSTOMER BASE ID COMMAND (SPI)

The 'base id command' waveform (Figure 13) shows the transmission of 0x03 24 04 from the Host MCU to the bottom/master device, specifically, the timing between SPI bytes in the overall transmission of this command. The timing shows that this command meets the 100µs maximum requirement defined as the \overline{CS} high time (the time between bytes). Please let me know if you see any concerns with the timing of my command transmission.

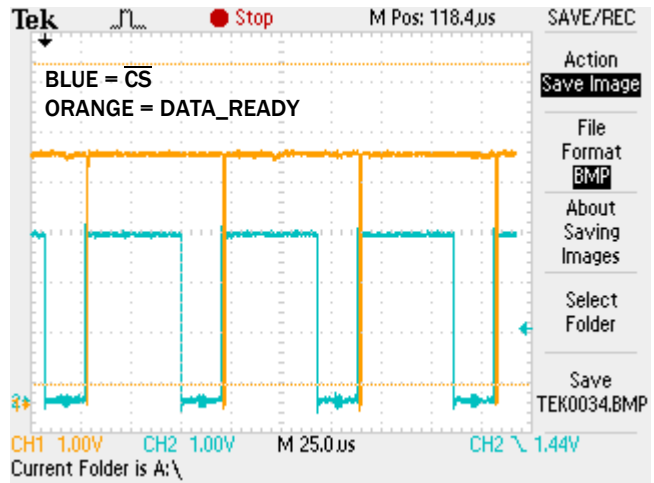
FIGURE 14. CUSTOMER DATA READY RESPONSE HANDLING TIMING

Also, the 'data_ready response handling' waveform (Figure 14), shows the timing on servicing the $\overline{DATA_READY}$ line. Please note that I have a level shifter that inverts $\overline{DATA_READY}$ from the ISL78600. As shown in the waveform, the $\overline{DATA_READY}$ signal goes HIGH when a byte is available in the ISL78600 buffer. The time that \overline{CS} is low is the time it takes for me to read a SPI byte (~25µs). At the completion of each read with the rising edge of \overline{CS} , you can see $\overline{DATA_READY}$ dip low briefly and return HIGH, indicating another byte is available. The time from the rising edge of $\overline{DATA_READY}$ to \overline{CS} going low again is the time it takes for me to respond to the $\overline{DATA_READY}$ signal (~45-50µs). Do you think this is too long?

I went through some timing diagrams from tests I did a while ago and found a scope shot of an identify sequence from our board. See [Figure 16](#). You can see that our response to data ready (the "0" trace) is much faster than yours and is about 3-4 μ s delay from falling edge of data ready to the start of SPI communication.

IMPORTANT: The host microcontroller must continue to feed the buffer with command bytes before all bytes have been clocked out on the Daisy Chain. If the Host MCU cannot keep the buffer full with proper command bytes, the Daisy Chain sends bad data to the devices on the Daisy Chain. This results in the Daisy Chain device receiving a command with a bad CRC and that device responds with a NAK.

Q: Thanks for the follow up on these issues I was experiencing. I have been using the daisy chain interface successfully since I sped up my host MCU clock rate and forced the \overline{CS} to SCLK time to be within the working range. I'm glad my frustrations here actually checked out with something on your end, because I spent a while scratching my head and was pretty wowed when I fixed the problem only by speeding up my MCU.
