# **RENESAS TECHNICAL UPDATE**

Product Category	MPU/MCU		Document No.	TN-RX*-A0279A/E	Rev.	1.00
Title	Errata Regarding Setting of the RCR4.RCKSEL Bit for the RX66N Group, RX72M Group, and RX72N Group MCUs		Information Category	Technical Notification		
Applicable Product	RX66N Group, RX72M Group, RX72N Group	Lot No.				
		All	Reference Document User's Manual: Hardware to products listed under Relate Documents on the last page		are for ap Related page	applicable

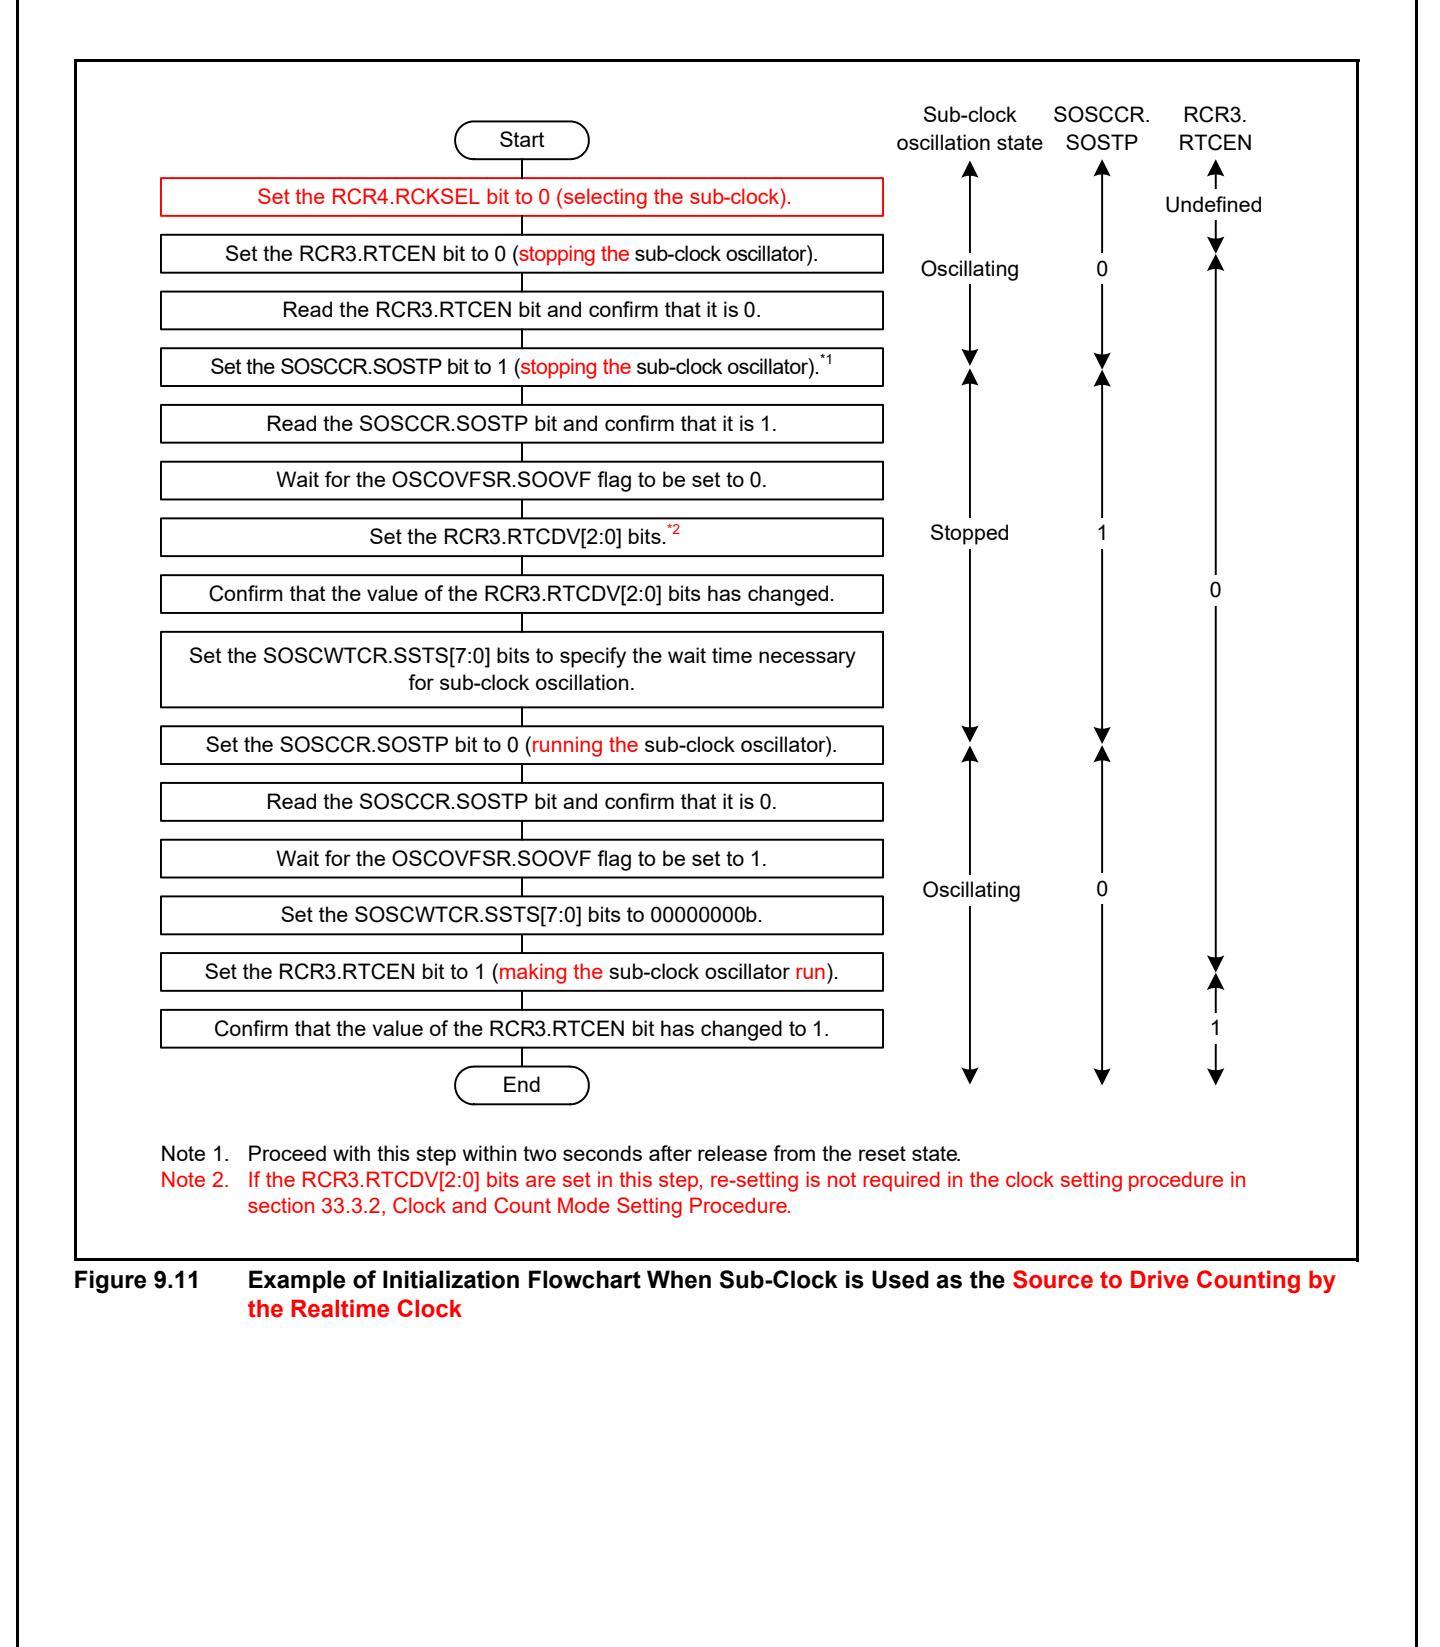
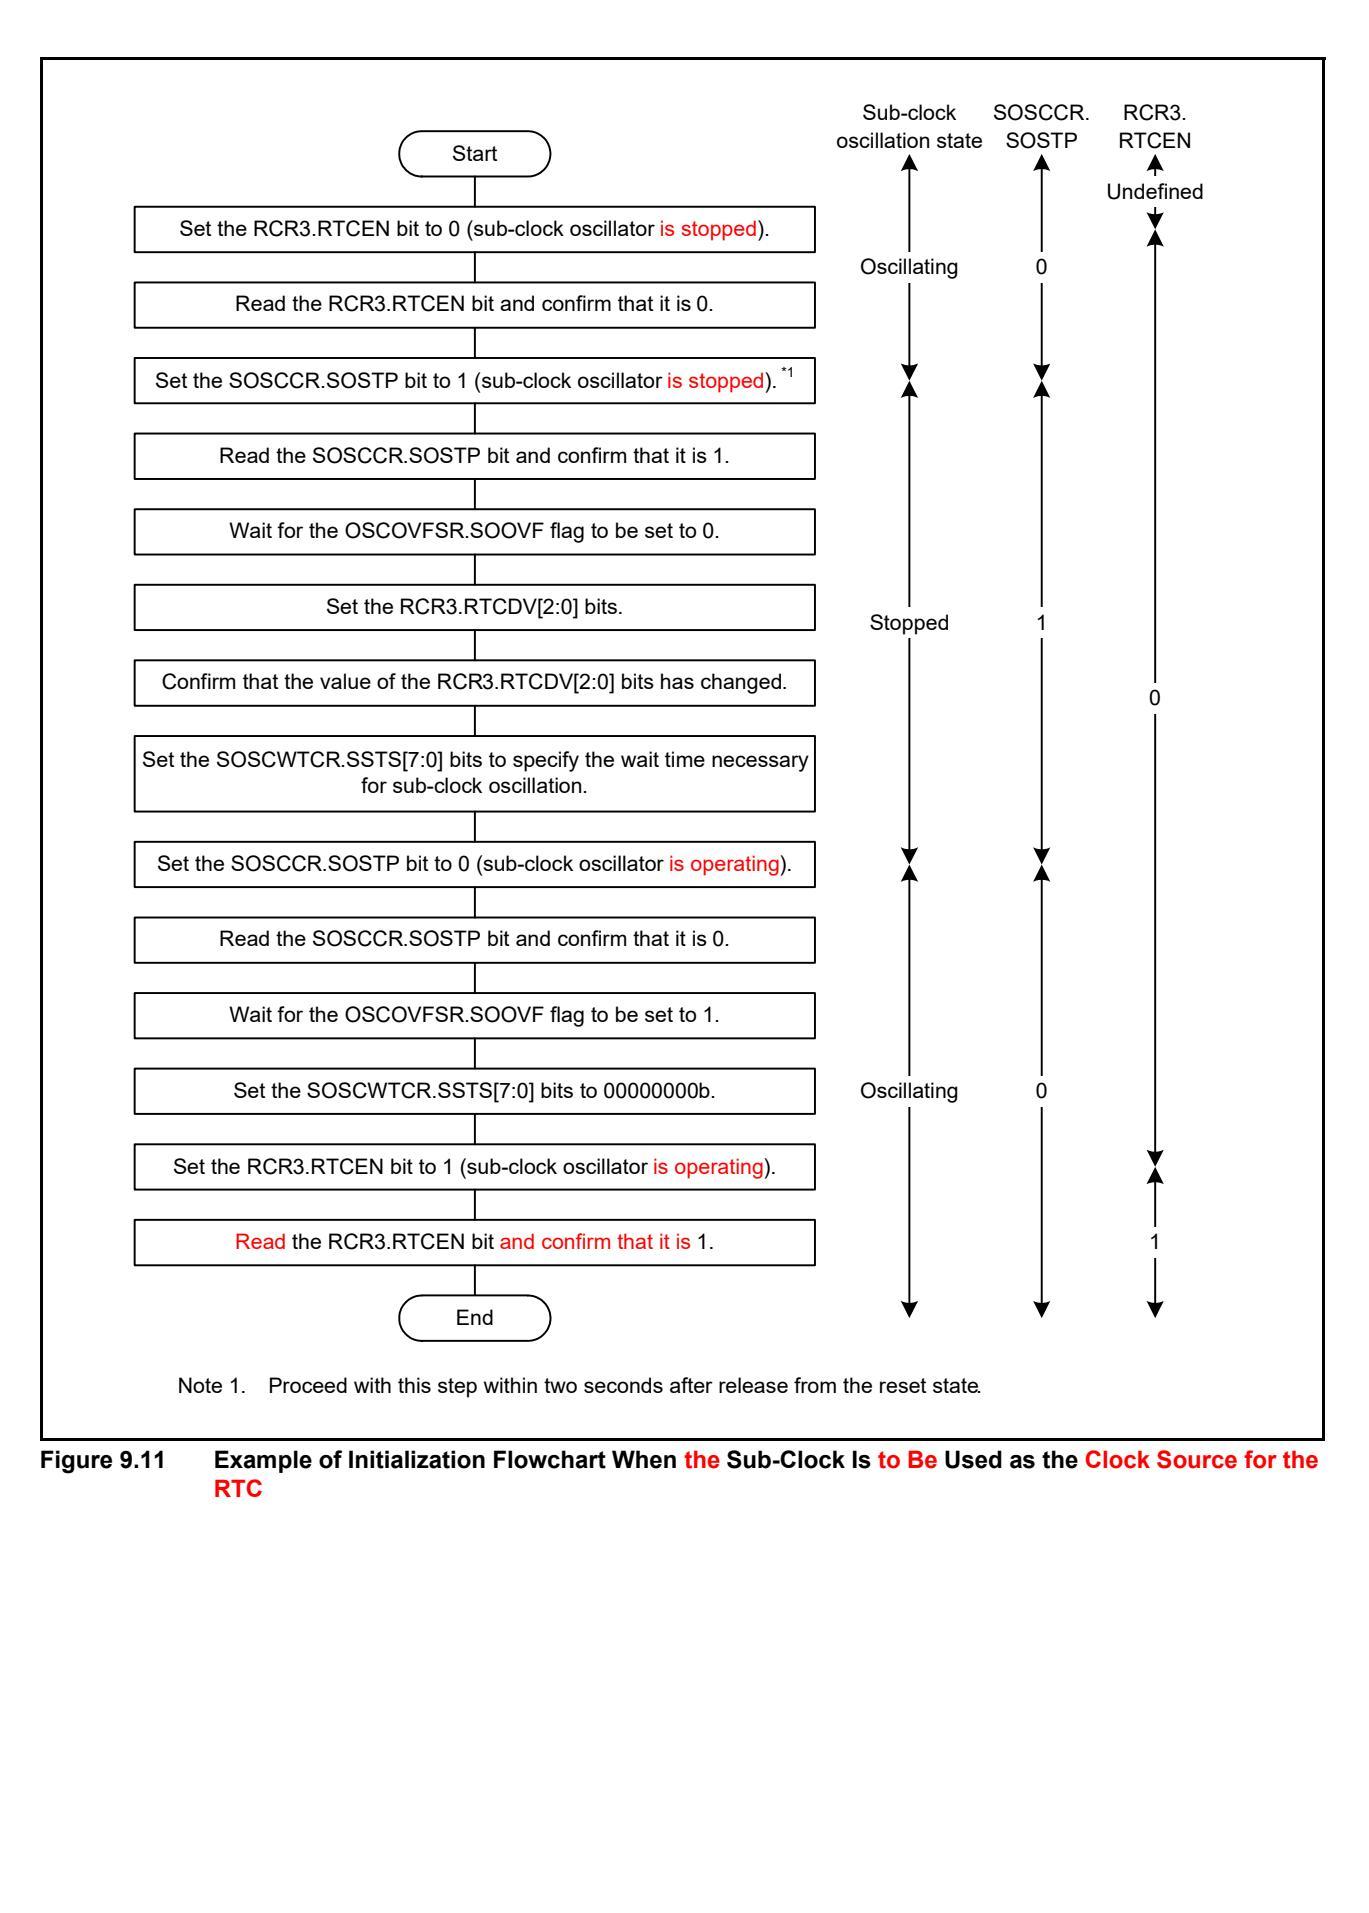
## • Page 367 of 3065

The following deletions are made in Figure 9.11, Example of Initialization Flowchart When Sub-Clock is Used as the Source to Drive Counting by the Realtime Clock.

- The RCR4.RCKSEL bit setting
- Note 2

The title of Figure 9.11 is also modified.

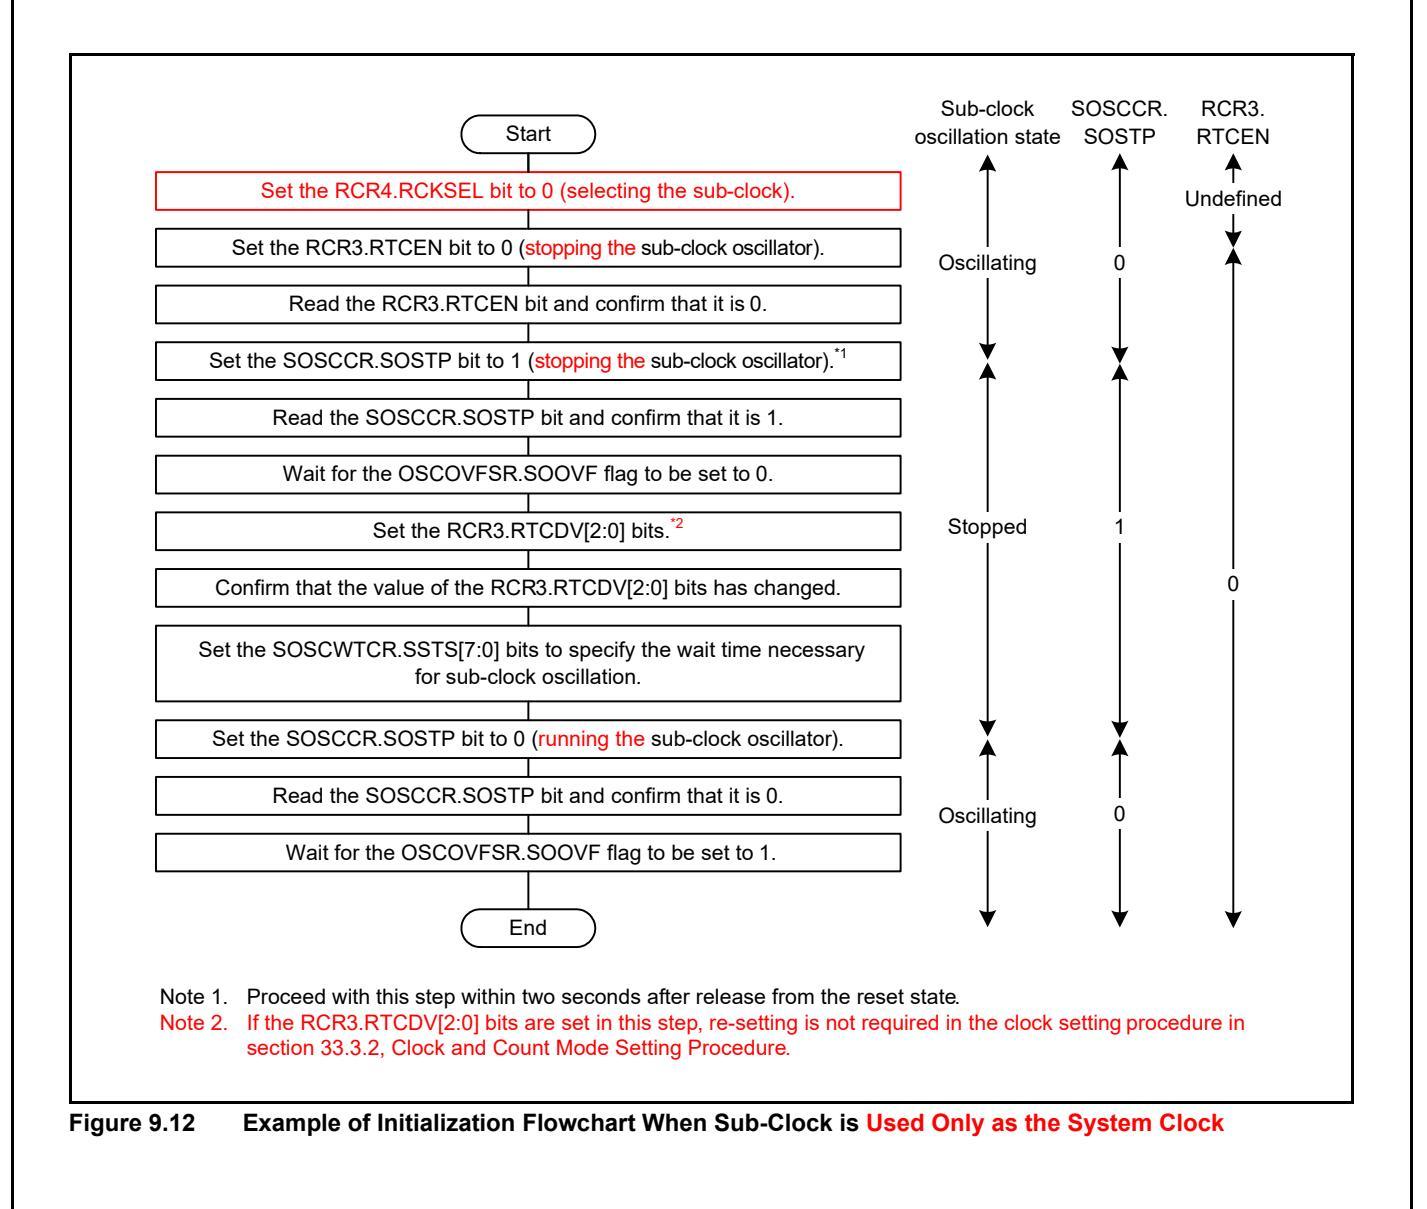
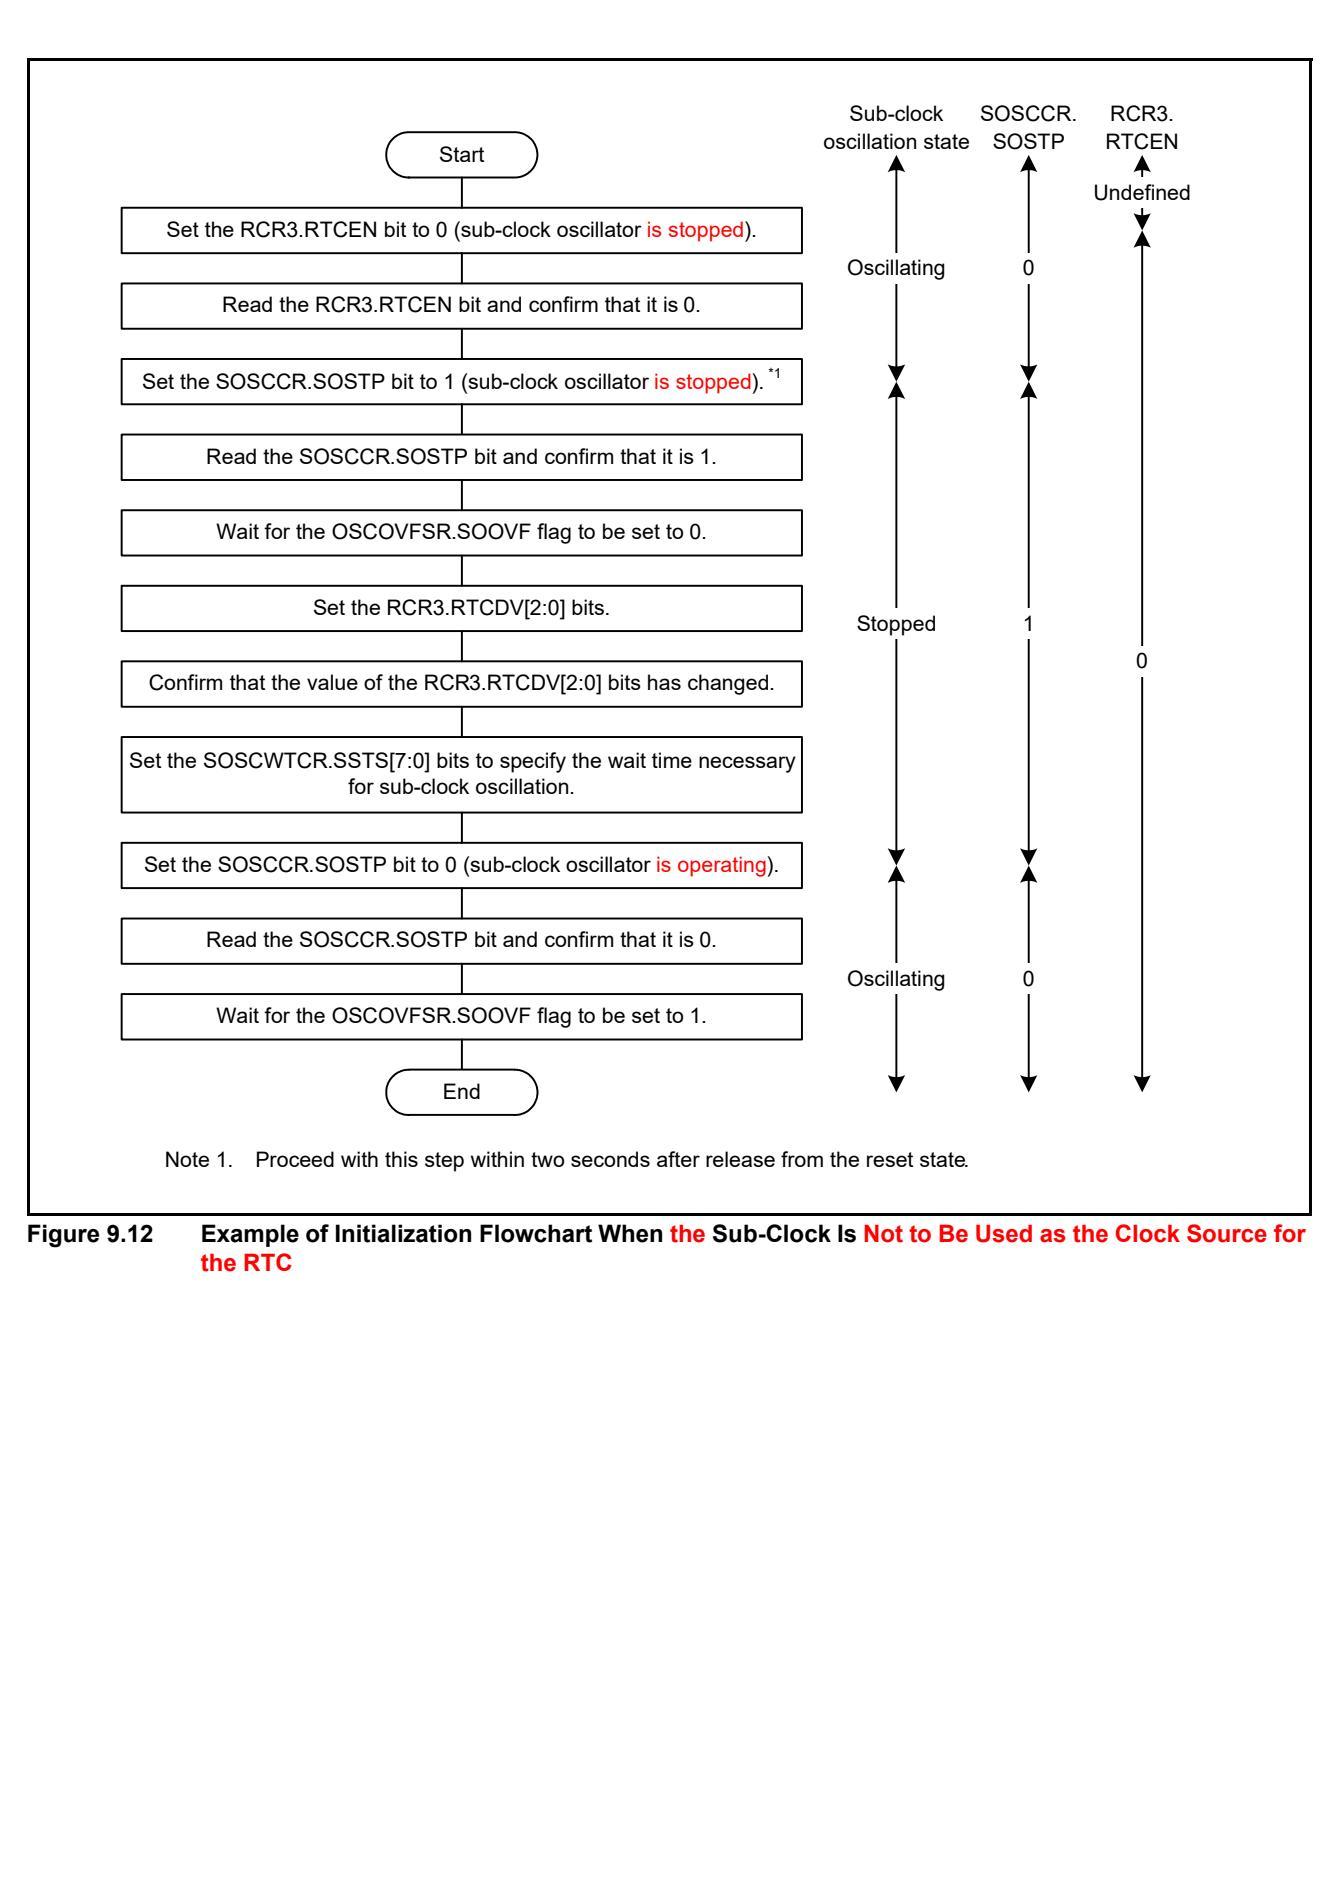
## • Page 368 of 3065

The following deletions are made in Figure 9.12, Example of Initialization Flowchart When Sub-Clock is Used Only as the System Clock.

• The RCR4.RCKSEL bit setting

• Note 2

The title of Figure 9.12 is also modified.

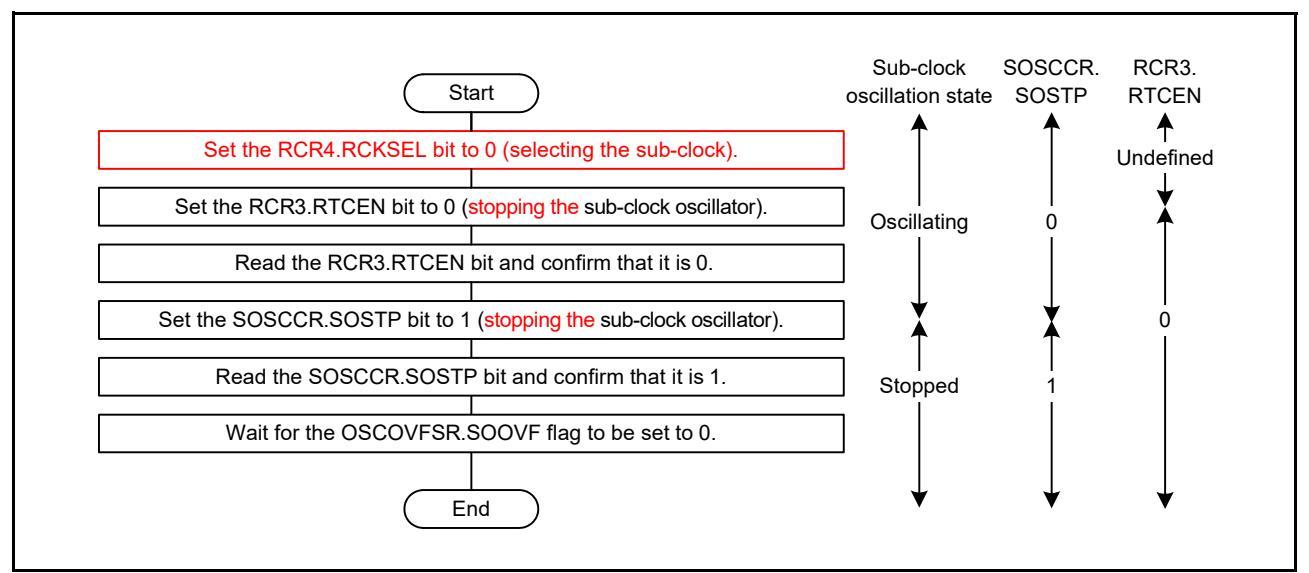
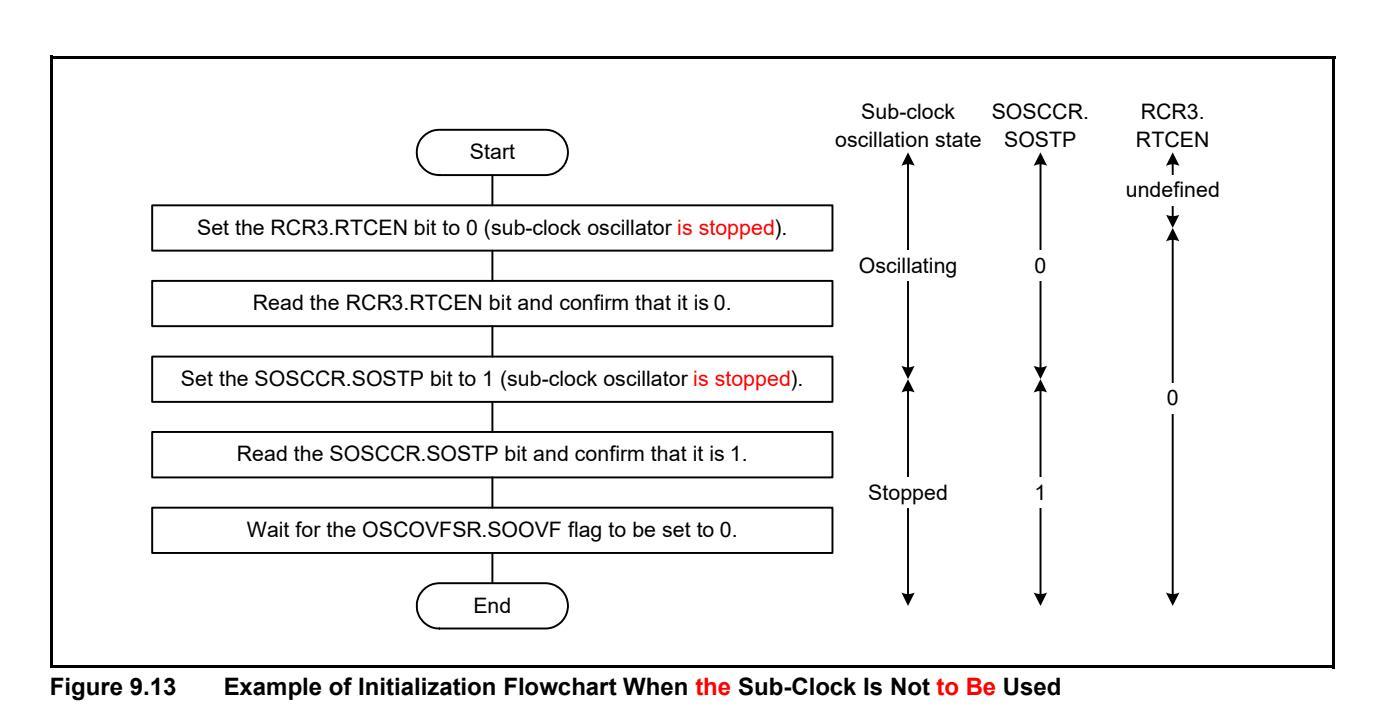
## • Page 369 of 3065

The following deletion is made in Figure 9.13, Example of Initialization Flowchart When Sub-Clock is Not Used.

• The RCR4.RCKSEL bit setting

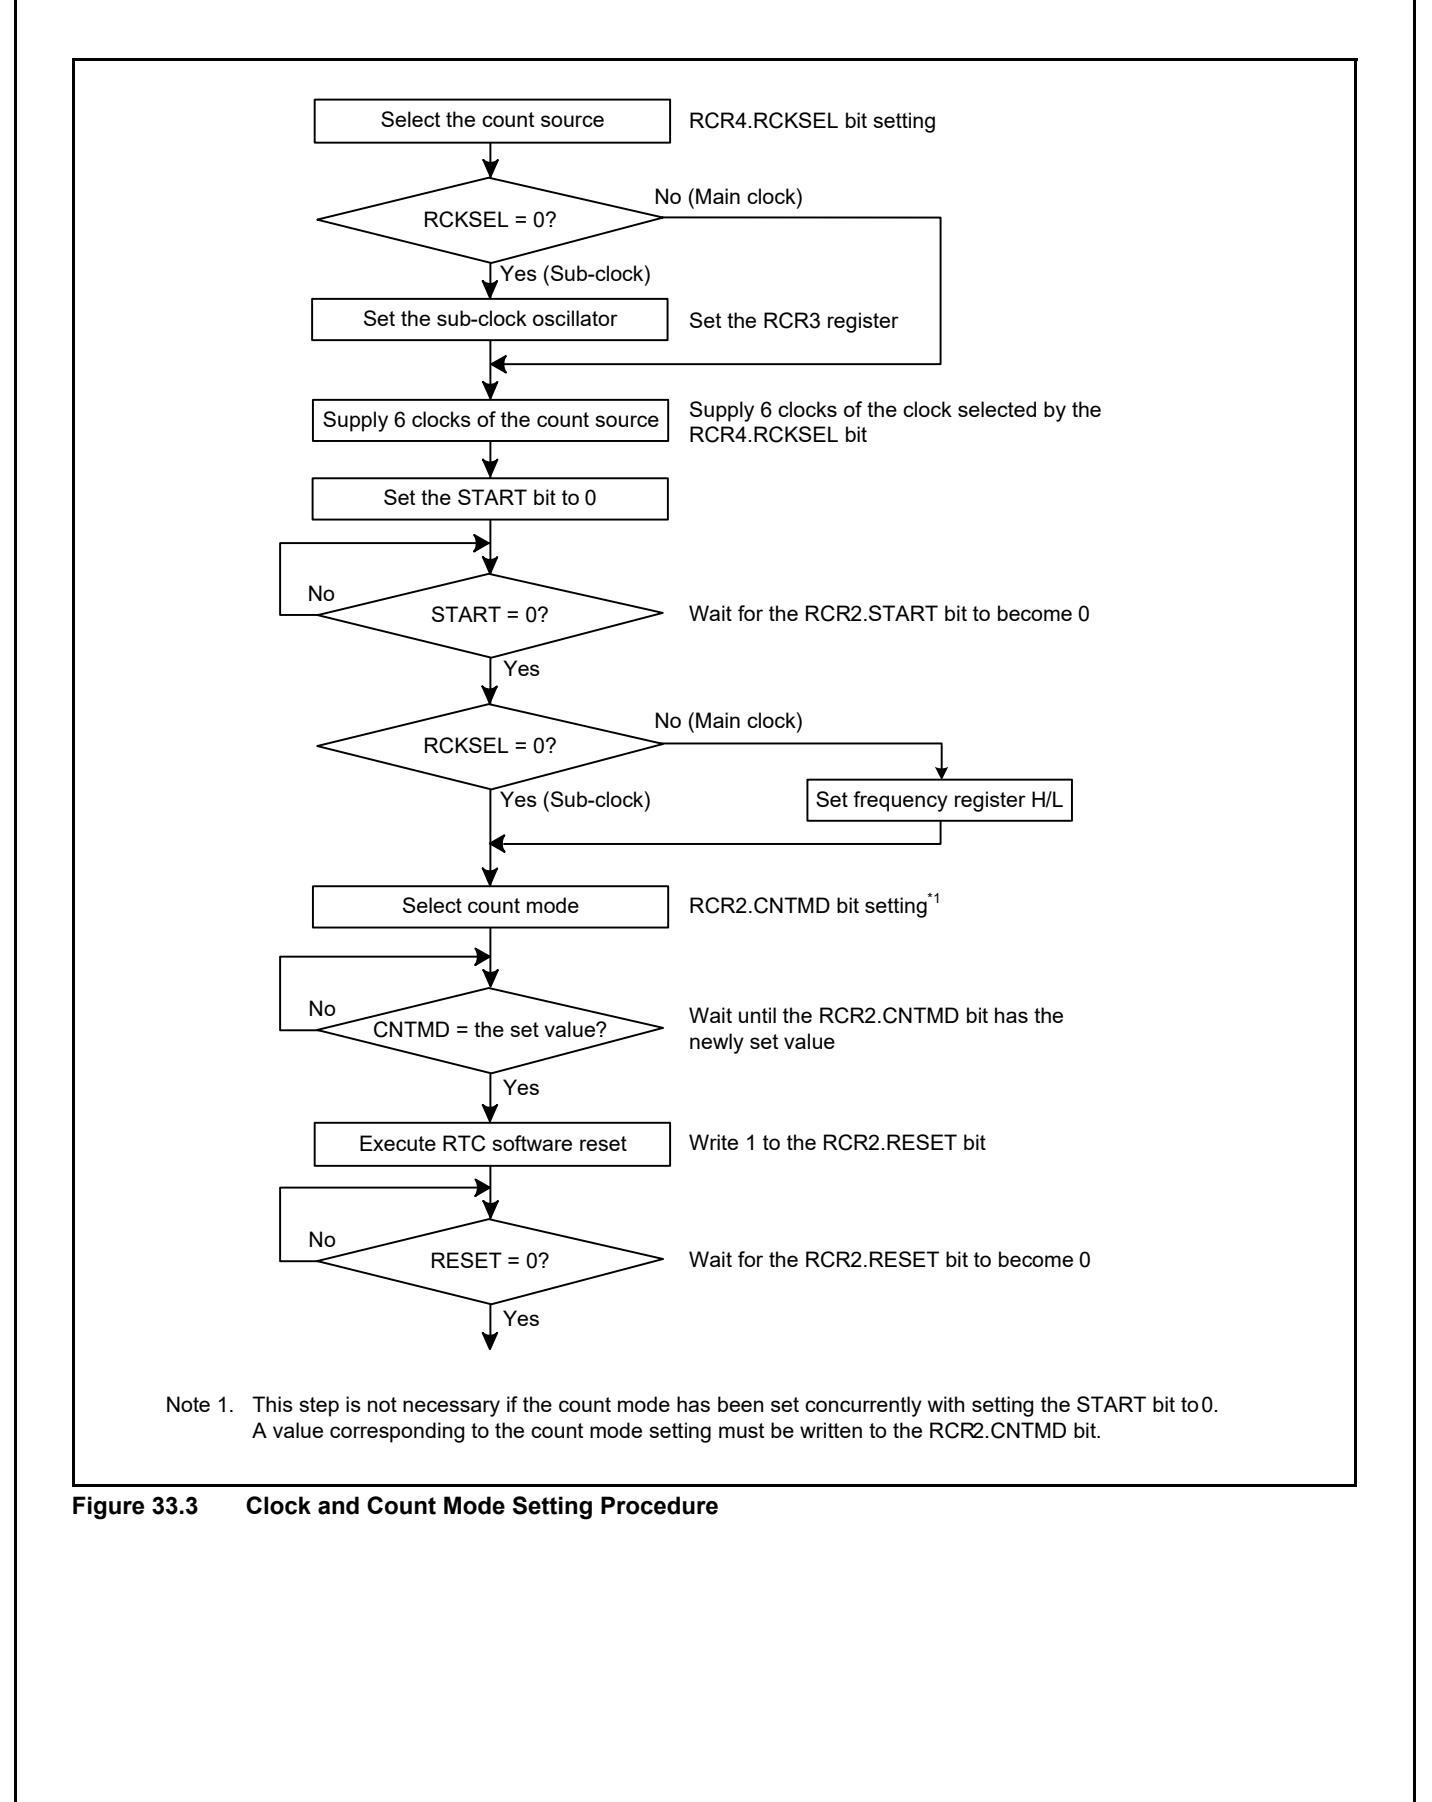
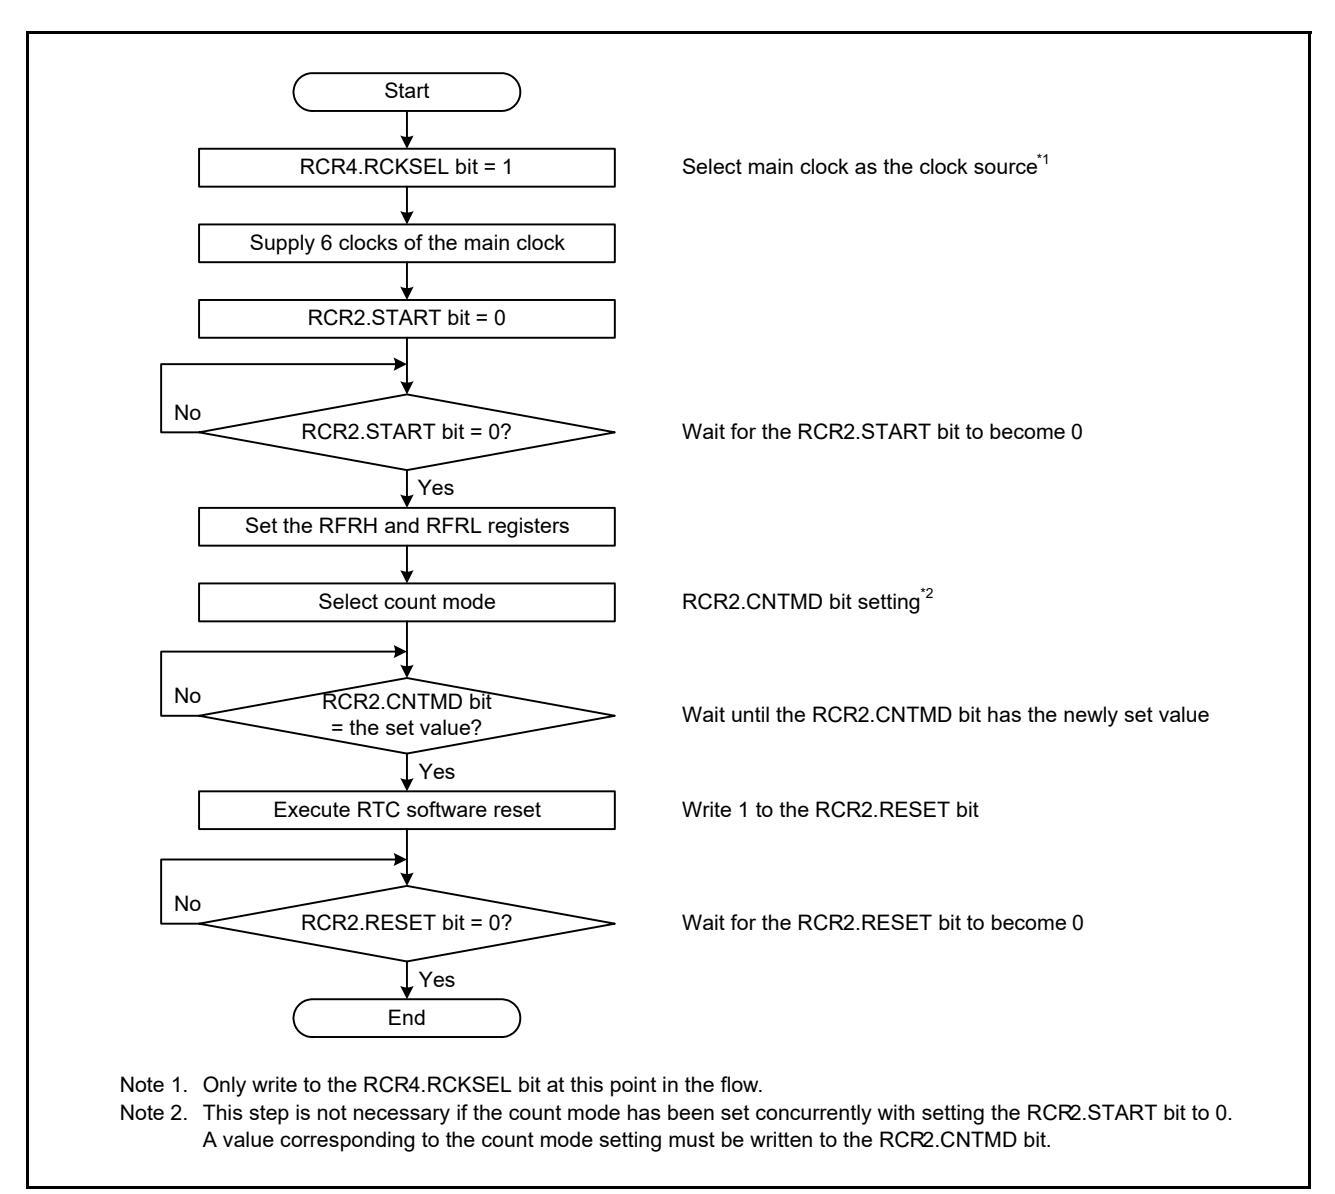
Figure 33.3 Clock and Count Mode Setting Procedure (When Using Main Clock)

Figure 33.3, Clock and Count Mode Setting Procedure, in section 33.3.2, Clock and Count Mode Setting Procedure, is separated into two flowcharts as follows to suit the clock that is in use.

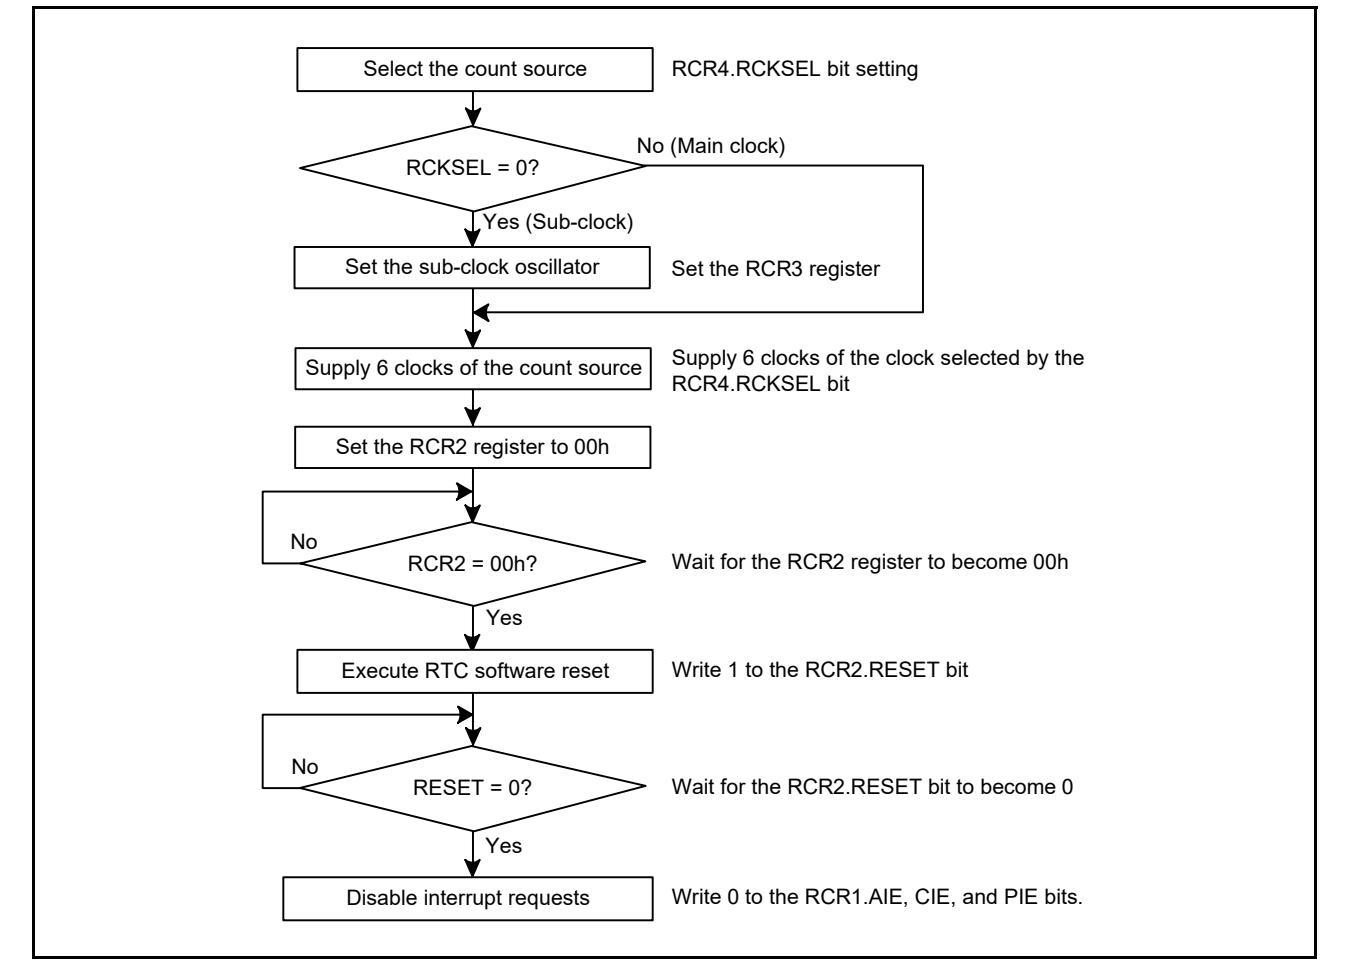
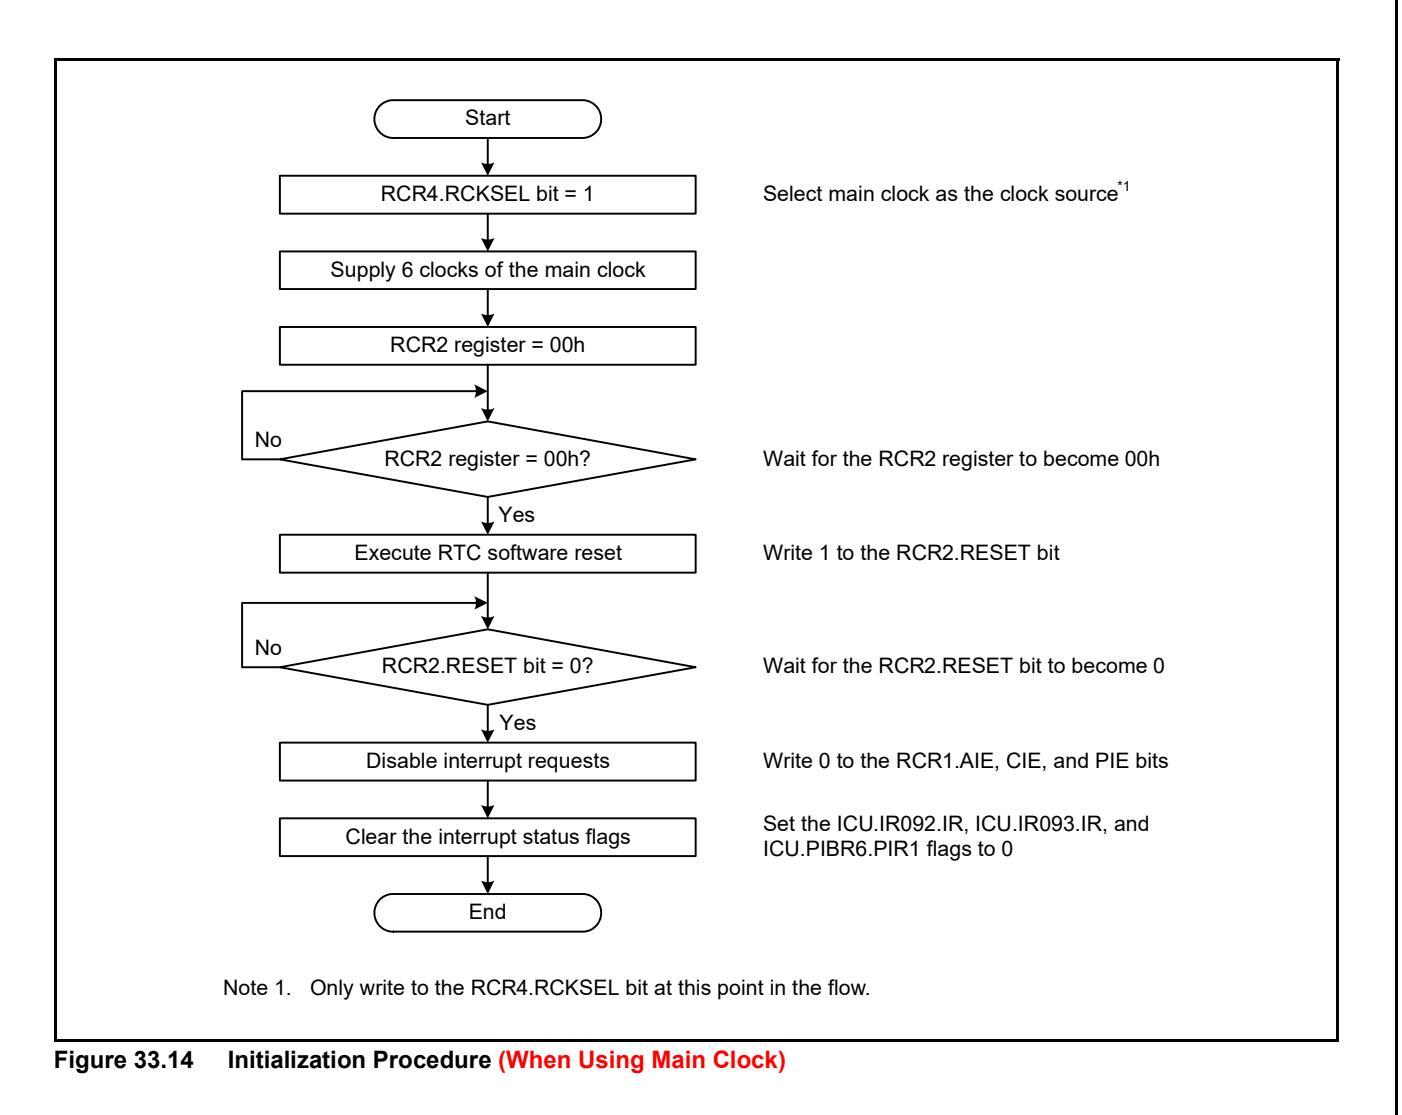
Figure 33.14 Initialization Procedure

Figure 33.14, Initialization Procedure, in section 33.6.7, Initialization Procedure When the Realtime Clock is Not to be Used, is separated into two flowcharts as follows to suit the clock that is in use. A step of clearing the interrupt status flags is also added to both flowcharts.
