[Notes]

R20TS0523EJ0100

# CS+ Code Generator for RX, e<sup>2</sup> studio Code Generator Plug-in, AP4 Coding Assistance Tool for RX

## Outline

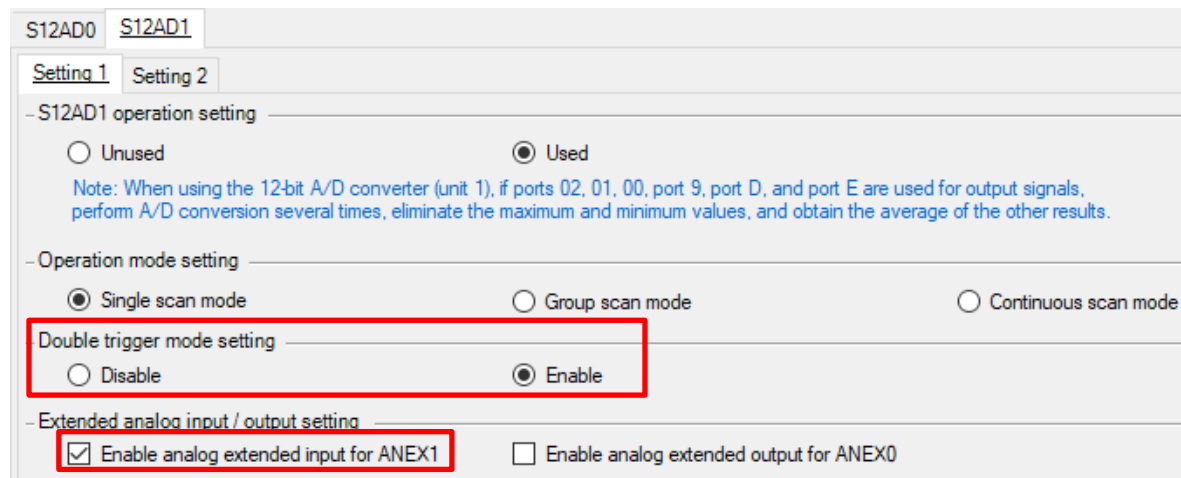
Error location

When using Double trigger mode on Single Scan Mode component of the 12-bit A/D converter, “Enable analog extended input for ANEX1” is still available for configuration even though it cannot be used simultaneously.

Do not select [Enable analog extended input for ANEX1] when using double trigger mode.
