## Environmental (IP-67) Test Report

Report Number: R18857

Renesas Electronics America  
2605 Trade Centre Avenue, Ste C  
Longmont, CO 80503  
United States

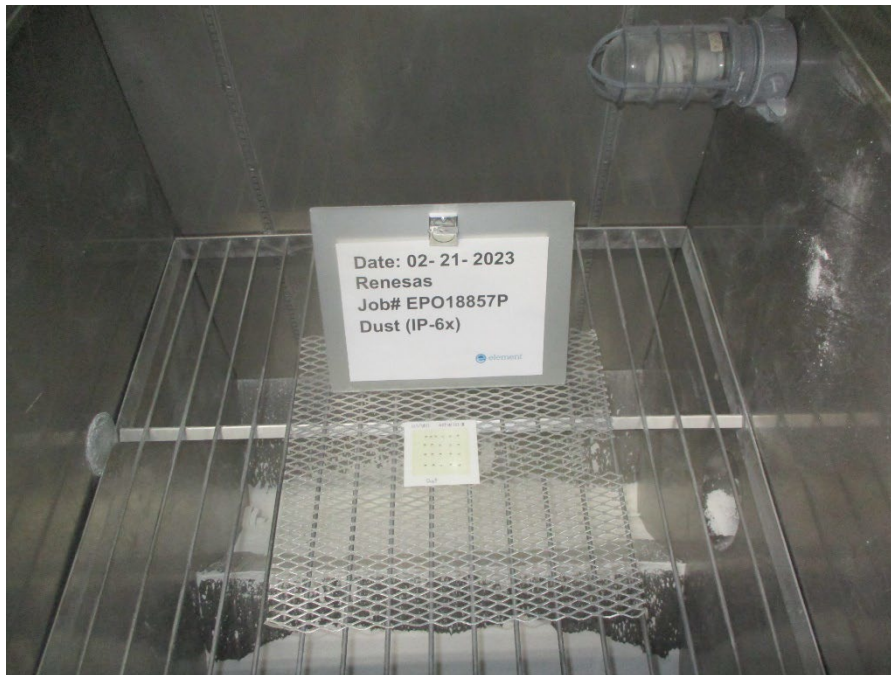
**Photo 1 – Samples setup**

- 4.2.1 The samples were set up in chamber 1224.
- 4.2.2 The samples were exposed to eight (8) hours in the dust environment.
- 4.2.3 Following exposure, the samples were brushed off and removed from the chamber.
- 4.2.4 Upon test completion, at ambient conditions, the samples were visually inspected, and then remained onsite for further testing.

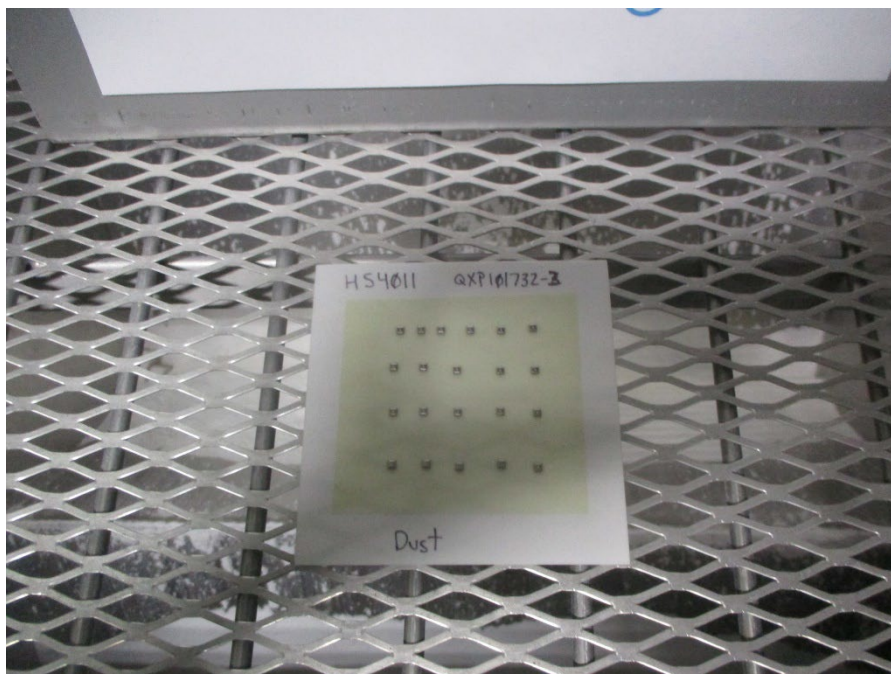
**Photo 2 – Samples setup**

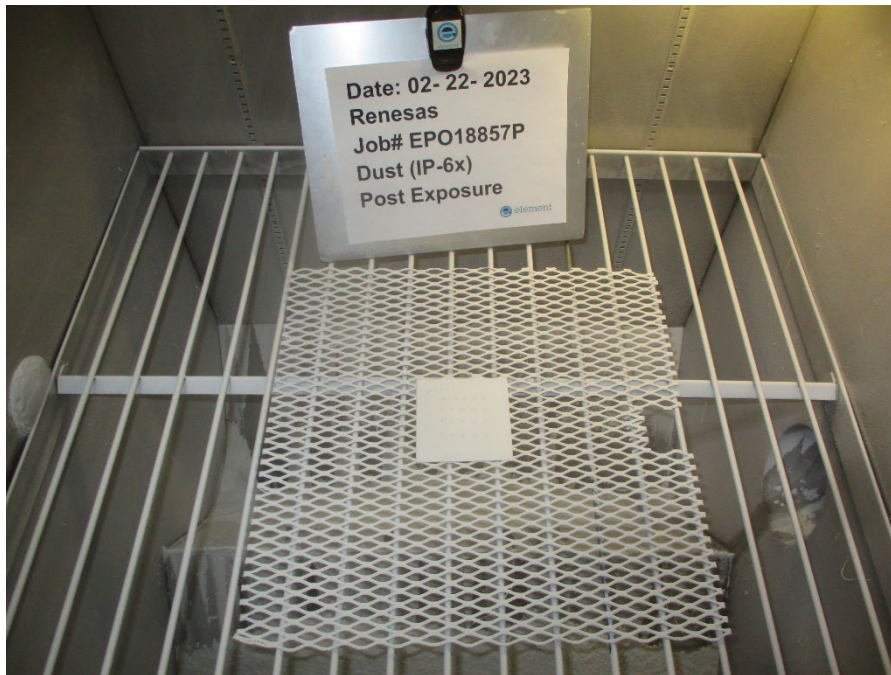
**Photo 3 – Samples post exposure**

- 4.3.1 Per IEC 60529: 2013, the protection is satisfactory if no deposit of dust is observable inside the enclosure at the end of the test.
- 4.3.2 No signs of dust ingress was observed within the samples.  
Per IEC 60529: 2013, the samples completed testing with a satisfactory result.

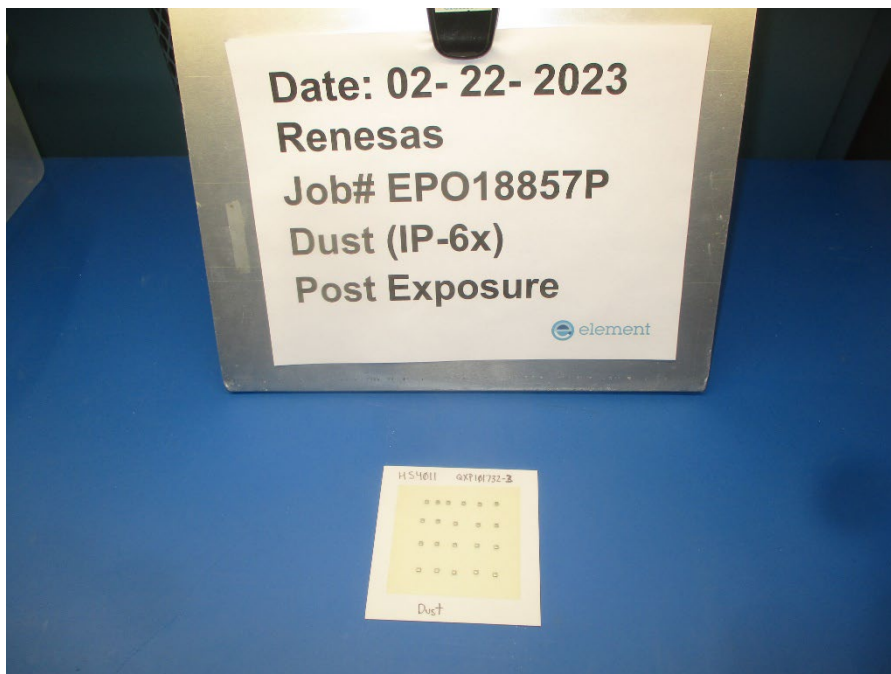
**Photo 4 – Samples post exposure**

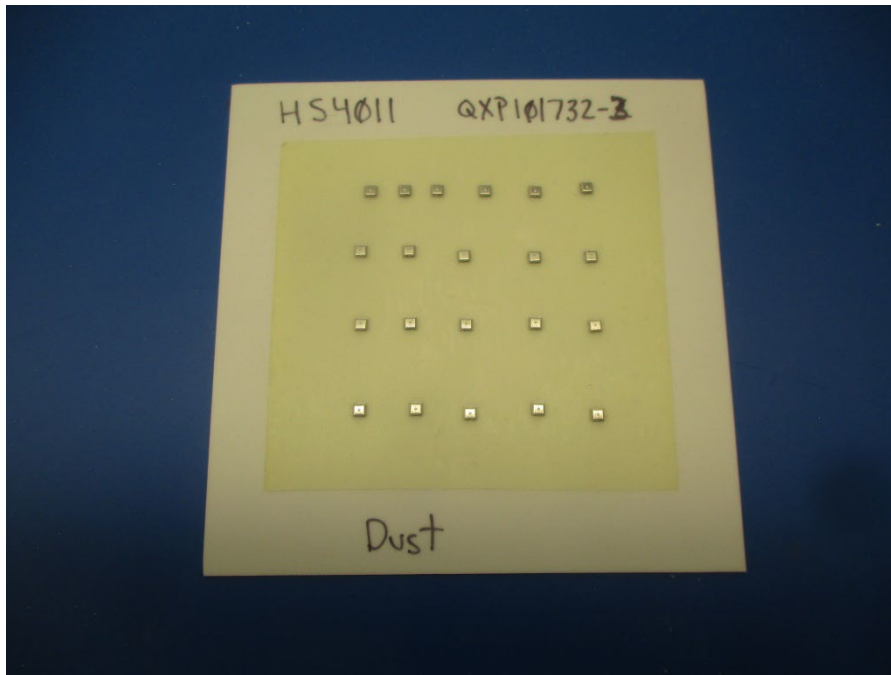
**Photo 5** – *Samples post exposure*

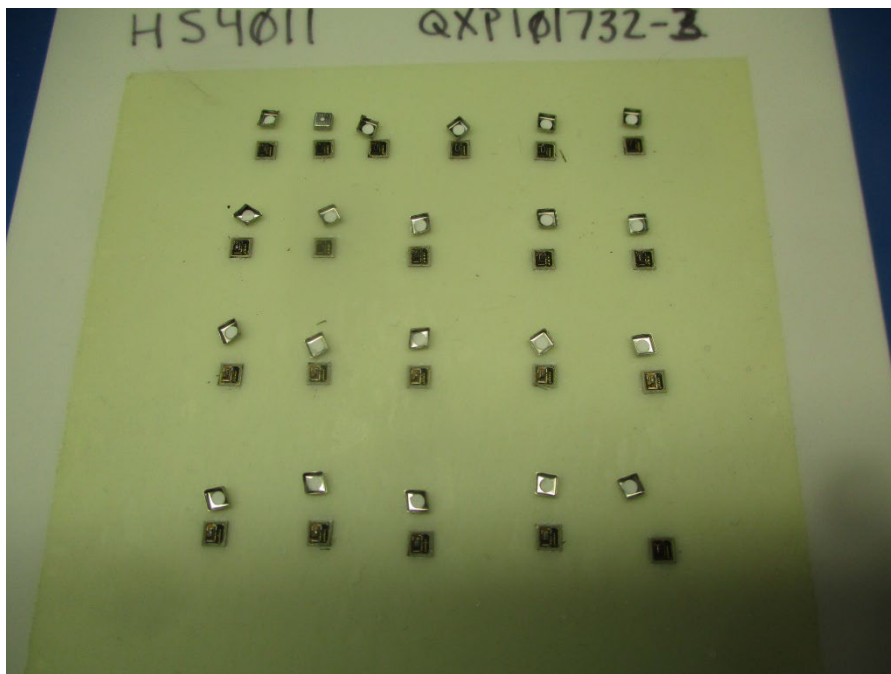
**Photo 6** – *Samples post exposure*

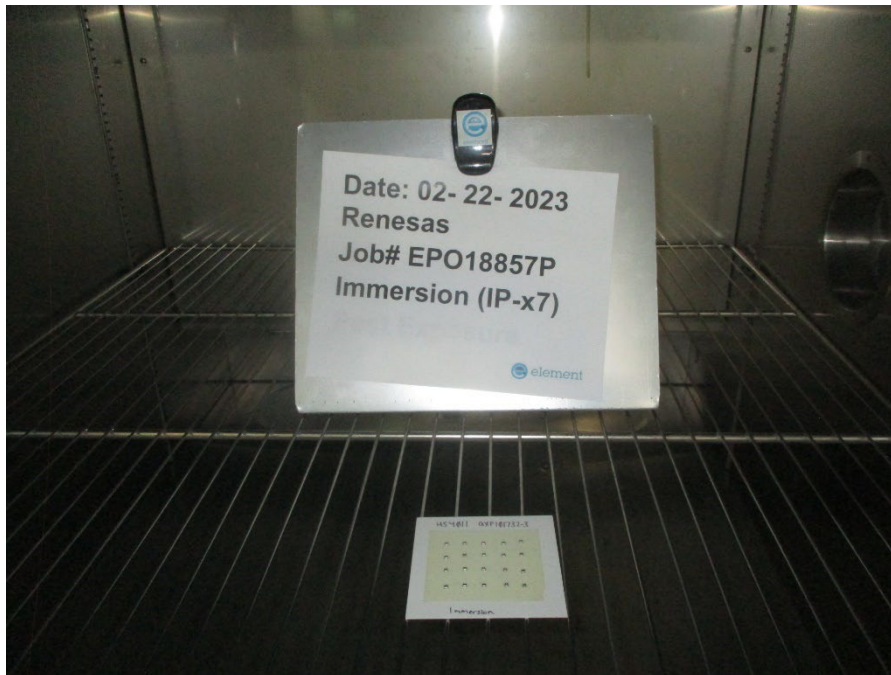
**Photo 7 – Test set up - Conditioning**

- 5.2.1 The samples were placed into the chamber to condition it to be within 5°K of the water temperature.
- 5.2.2 The samples were secured to a weight and placed into mesh bag for testing.
- 5.2.3 The immersion depth was set at 1 meter.
- 5.2.4 The samples were lowered into the tank and maintained at this 1-meter depth for 30 minutes.
- 5.2.5 The samples were removed and blotted dry with a towel.
- 5.2.6 Upon test completion, at ambient conditions, the samples were visually inspected, and then returned to customer for final analysis.

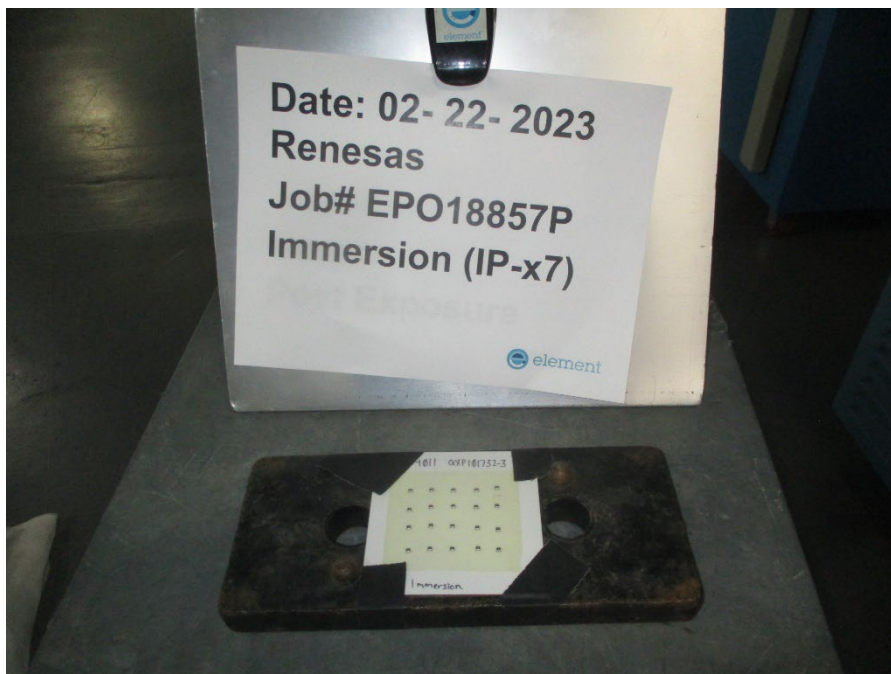
**Photo 8 – Samples setup**

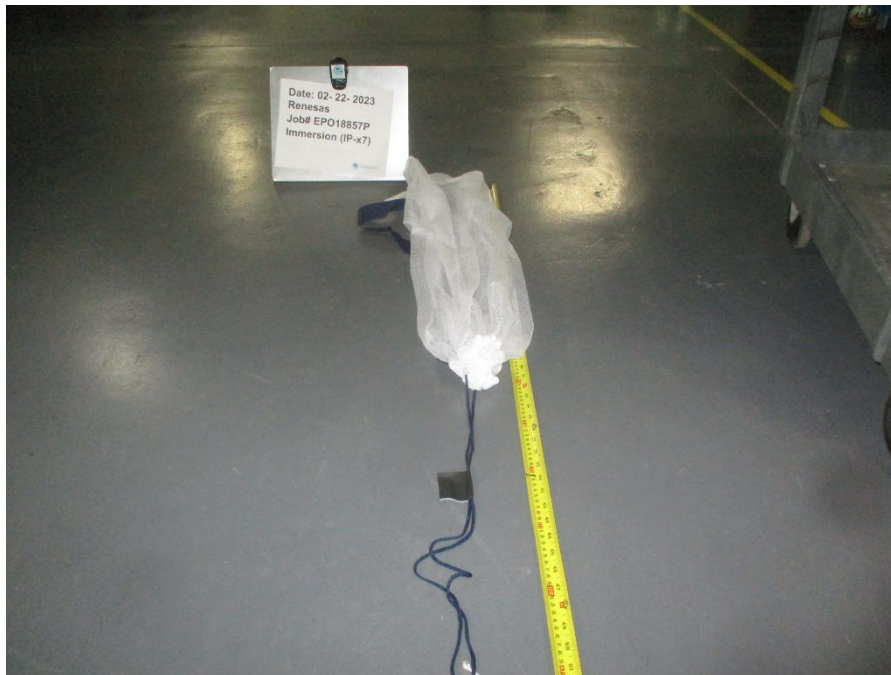
**Photo 9 – Test set up**

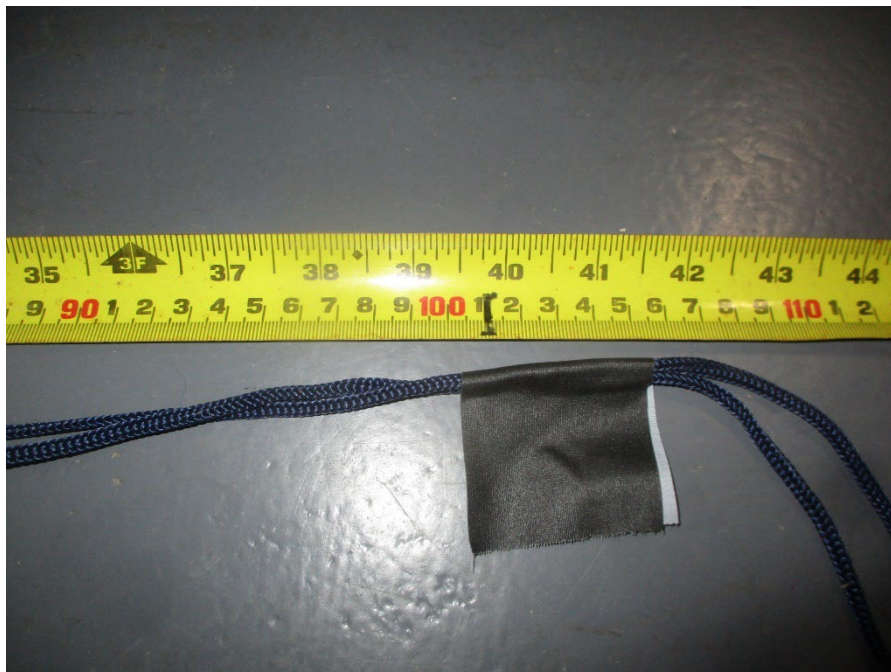
**Photo 10 – Depth verification 1 meter**

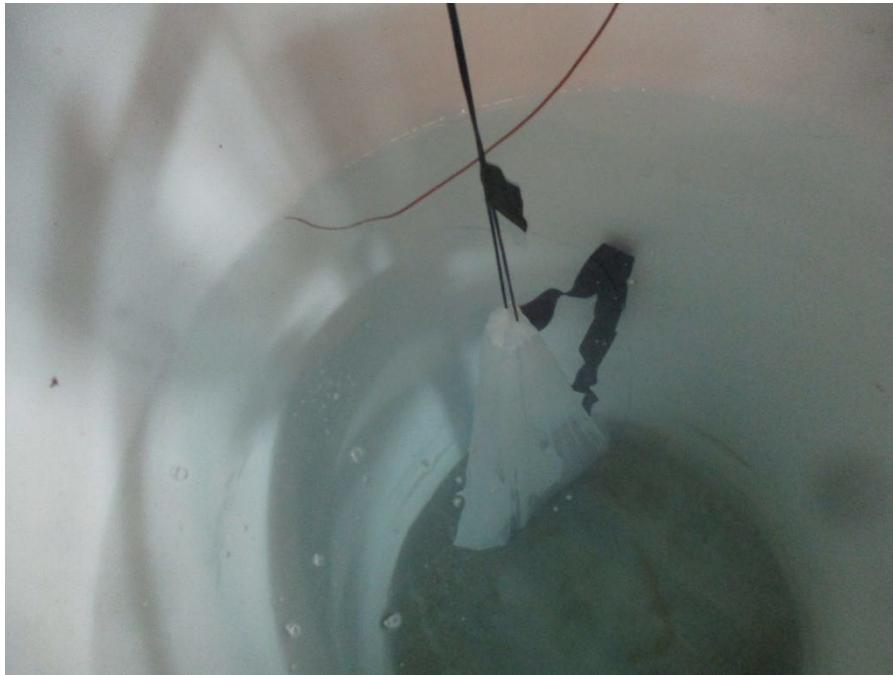
**Photo 11 – Samples setup**

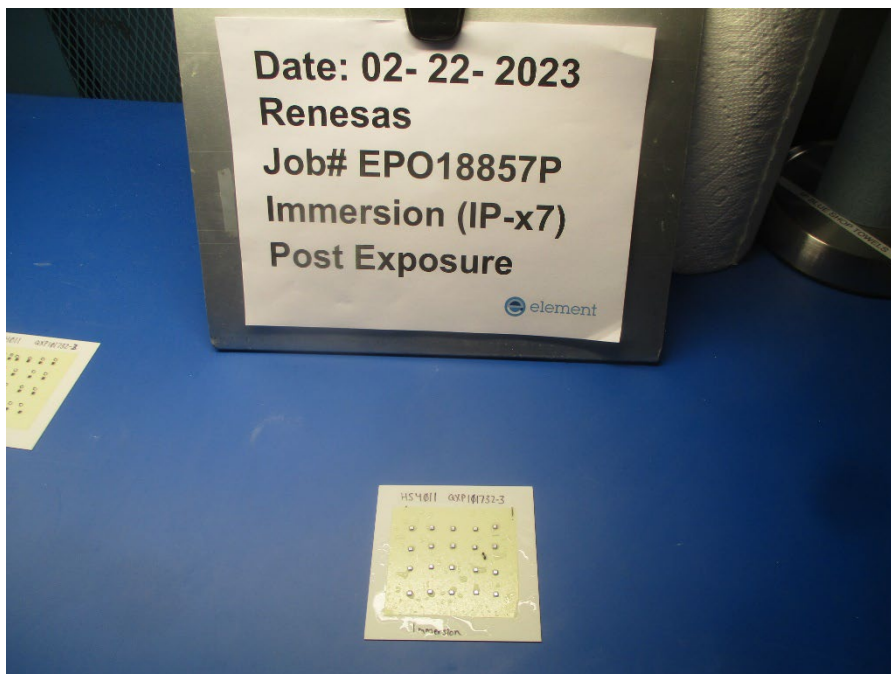
**Photo 12 – Samples post exposure**

- 5.3.1 Per IEC 60529 the passing criteria if any water has entered, it will not:
- 5.3.1.1 Be sufficient to interfere with the correct operation of the equipment or impair safety.
  - 5.3.1.2 Deposit on insulation parts where it could lead to tracking along the creepage distances.
  - 5.3.1.3 Reach live parts or windings not designed to operate when wet.
  - 5.3.1.4 Accumulate near the cable end or enter the cable if any.
- 5.3.2 No signs of water ingress were found.  
Per IEC 60529: 2013, the samples completed testing with a satisfactory result.

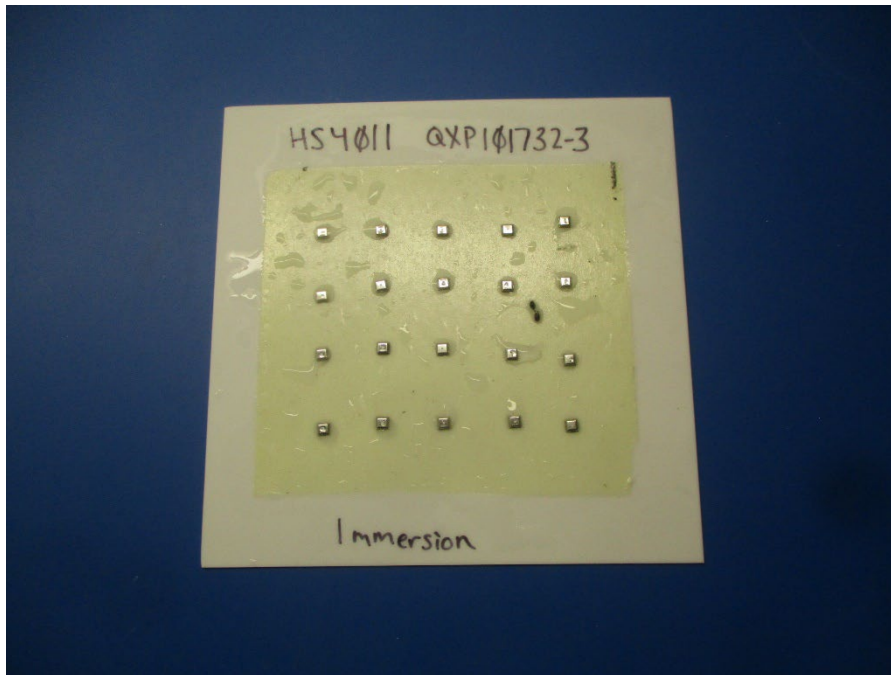
Photo 13 – Samples post exposure

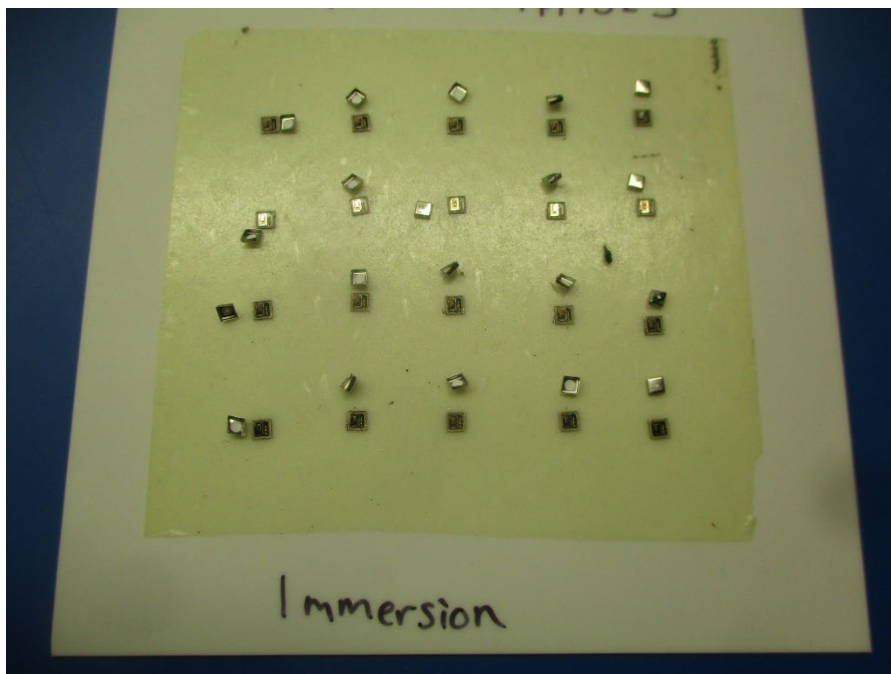
Photo 14 – Samples post exposure

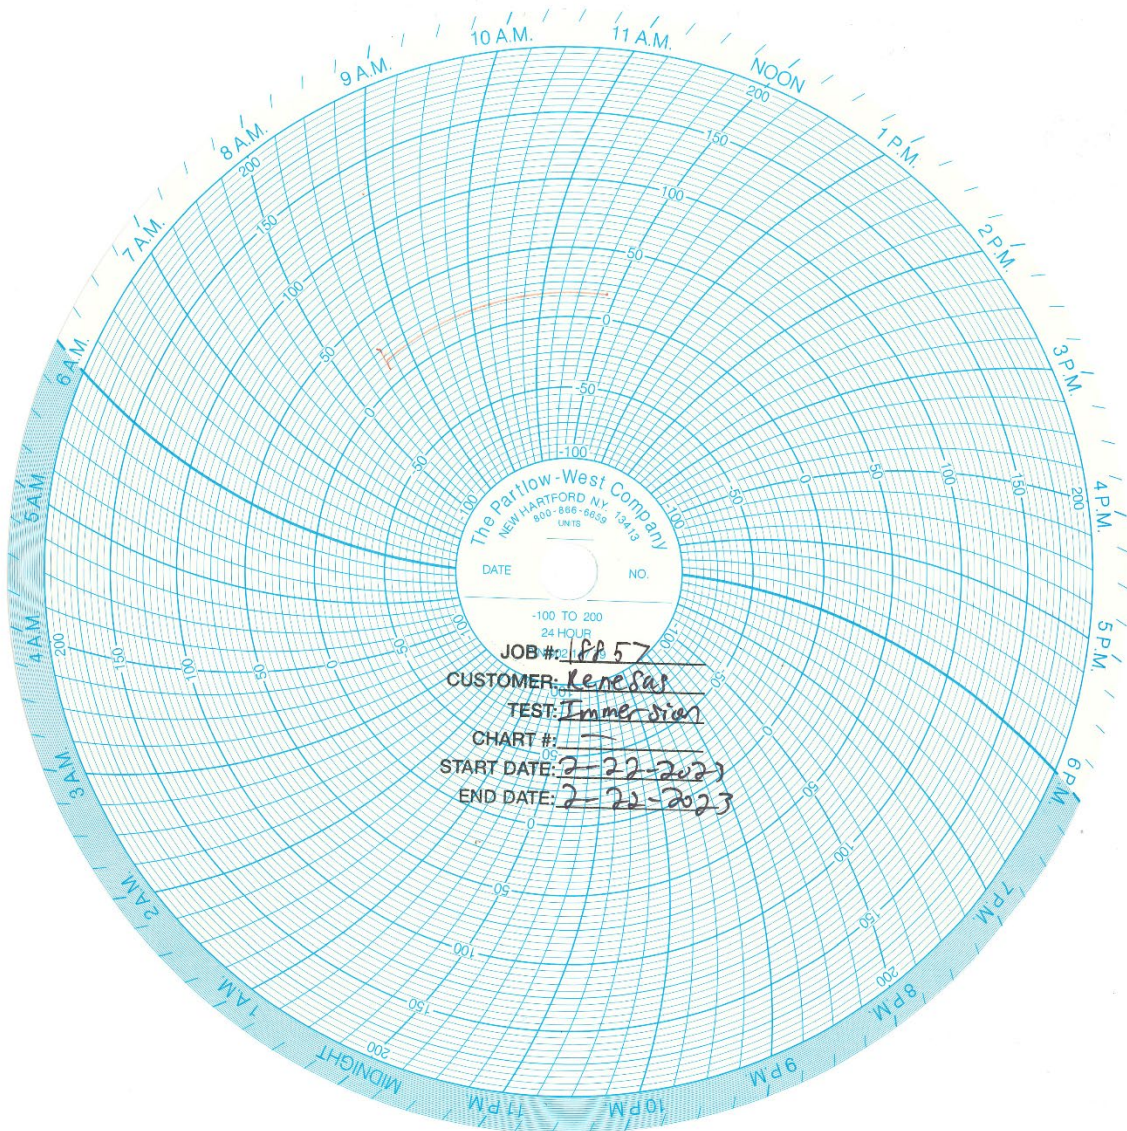
Figure 1 – Immersion Chart
