# Errata

## SLG46827-A

### CE-GP-007

*This document contains the known errata for SLG46827-A and the recommended workarounds.*

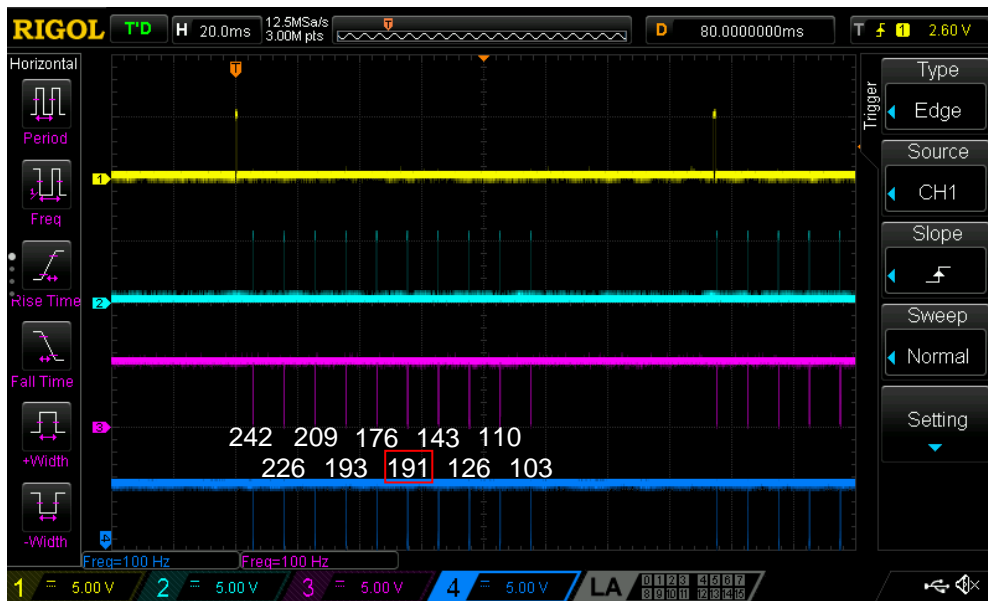
Figure 1: Example Data

Asynchronous interaction between the CNT/DLY clock input and the I<sup>2</sup>C latch signal (generated by an I<sup>2</sup>C read command of the CNT/DLY block's count value) can result in an incorrect I<sup>2</sup>C data read. The CNT/DLY block will count accurately, but the count value transferred into the block's I<sup>2</sup>C read register might be loaded incompletely if the I<sup>2</sup>C latch signal and the clock input occur at about the same time.

The example data capture below shows ten periodic I<sup>2</sup>C reads of CNT2/DLY2 configured to count down at about 16 clocks per read. The sixth read sample erroneously shows a value greater than that of the fifth. The seventh sample reads as if the previous I<sup>2</sup>C error never occurred - the difference from the fifth sample (176) to the seventh (143) is 33 clocks or 16 clocks + 17 clocks as expected.

Channel 1 (yellow/1<sup>st</sup> line) – PIN2 (CNT2/DLY2 Out)  
 Channel 2 (light blue/2<sup>nd</sup> line) – PIN1 (I<sup>2</sup>C Read Triggers)  
 Channel 3 (magenta /3<sup>rd</sup> line) – PIN8 (I<sup>2</sup>C SCL)  
 Channel 3 (dark blue /4<sup>th</sup> line) – PIN9 (I<sup>2</sup>C SDA)

If the possibility of incorrect I<sup>2</sup>C data reads can't be accommodated for by external software checks, one can guarantee proper operation by stopping the CNT/DLY block's clock during I<sup>2</sup>C reads through one of the following methods: by disabling the oscillator block, by reconfiguring the CNT/DLY block's clock source, or by gating an external clock using a LUT (Look Up Table) in the signal matrix. After disabling the CNT/DLY block's clock, the count registers can be read without error. Please note that this workaround will add the I<sup>2</sup>C read and processing time to the counter's overall clock period.

The best workaround depends on the resource constraints of the application. If the oscillator block doesn't clock other logic elements within the design, a matrix output can be used to manually power down the oscillators for the I<sup>2</sup>C read. When the CNT/DLY block's clock source is routed internally from the oscillator block, I<sup>2</sup>C commands can temporarily reconfigure the CNT/DLY block's clock source registers to select "Ext. CLK. (From Matrix)." This action will disable the clock by connecting it to ground. If the CNT/DLY block is clocked from the signal matrix, a LUT can be used to gate the clock during an I<sup>2</sup>C read.

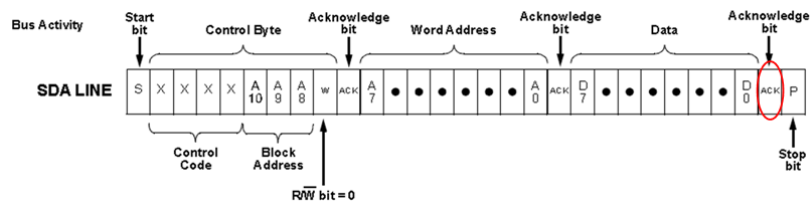
Figure 2: GreenPAK I<sup>2</sup>C Write Frame for Page Erase

To erase the NVM and the EEPROM, one must perform an I<sup>2</sup>C write to the "Page Erase Byte" located at 0xE3. The ACK bit which follows the "Data" portion of [Figure 2](#) won't comply with standard I<sup>2</sup>C specifications. Please see the ACK bit circled in RED below.

No workaround is required for the GreenPAK device as the NVM and EEPROM erase operations will execute properly. For verification, one can perform an I<sup>2</sup>C read of the erased pages. Excluding protected pages, all erased NVM and EEPROM registers should be cleared.

Adjust the MCU’s I<sup>2</sup>C firmware to catch and ignore a “NACK” from the GreenPAK device when the “Page Erase Byte” is addressed. In light of the additional STOP and START conditions, the behavior of other I<sup>2</sup>C slaves on the same bus should be evaluated.

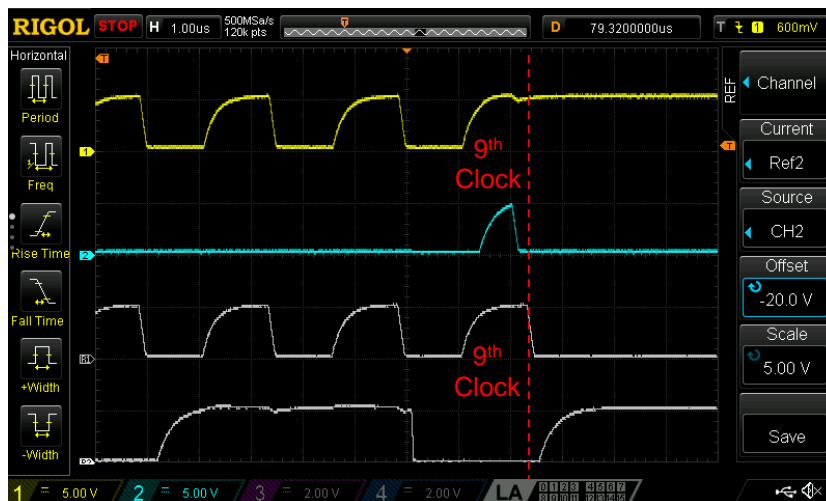
Figure 3: Non-I<sup>2</sup>C Compliant Behavior Oscilloscope

The following waveform compares the regular I<sup>2</sup>C ACK behavior (Ref 1 - SCL and Ref 2 - SDA) with the non-compliant ACK behavior (Channel 1 - SCL and Channel 2 - SDA) generated by an I<sup>2</sup>C write to the “Page Erase Byte.” During the 9<sup>th</sup> clock cycle, the SLG46827-A does not adhere to the “data hold time” specification by releasing SDA (Channel 2) before the falling edge of the clock pulse on SCL (Channel 1).

Channel 1 (yellow/1<sup>st</sup> line) – SCL ~ Non-I<sup>2</sup>C Compliant ACK Behavior (After Data byte)  
 Channel 2 (light blue/2<sup>nd</sup> line) – SDA ~ Non-I<sup>2</sup>C Compliant ACK Behavior (After Data byte)  
 Ref 1 (grey/3<sup>rd</sup> line) – SCL ~ Regular I<sup>2</sup>C ACK behavior (Before Data byte) – (5 V/div)  
 Ref 2 (grey/4<sup>th</sup> line) – SDA ~ Regular I<sup>2</sup>C ACK behavior (Before Data byte) – (5 V/div)

On a system level, other I<sup>2</sup>C devices might interpret this non-compliant ACK as an additional STOP and START condition. By definition, a START condition occurs when SCL is HIGH and SDA transitions from HIGH to LOW. A STOP condition occurs when SCL is HIGH and SDA goes from LOW to HIGH. After the 9<sup>th</sup> clock cycle, the MCU should generate the final STOP condition to indicate the end of transmission to all I<sup>2</sup>C slaves on the bus.

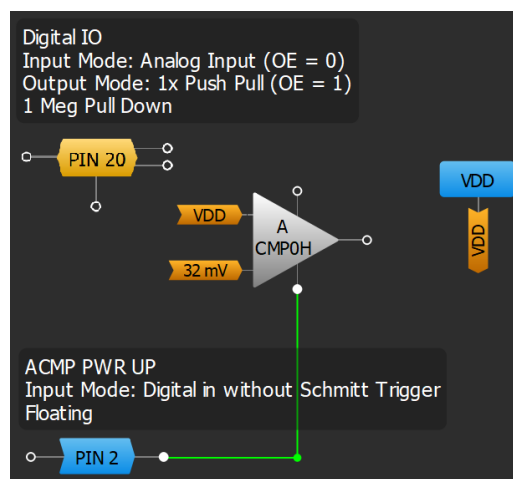
**Figure 4: GreenPAK Input Structure Test Schematic**

Figure 4 shows the GreenPAK configured with IO14 as a Digital IO with a 1 MΩ pull-down resistor. Since the OE pin is connected to 0 V, this pin is acting as an “Analog IO.” As seen in Table 2, IO14 and V<sub>DD</sub> are both input options for ACMP0H. In this example, IO0 is being used as a digital input to enable and disable the ACMP.

There is no workaround for this behavior. With this in mind, the IOs should not be used as digital IOs (with "Input mode" set to Analog input) or as digital outputs (with "Output mode" set to 1/2/4x 3-State Output) if the respective ACMP is enabled and connected to another input source.

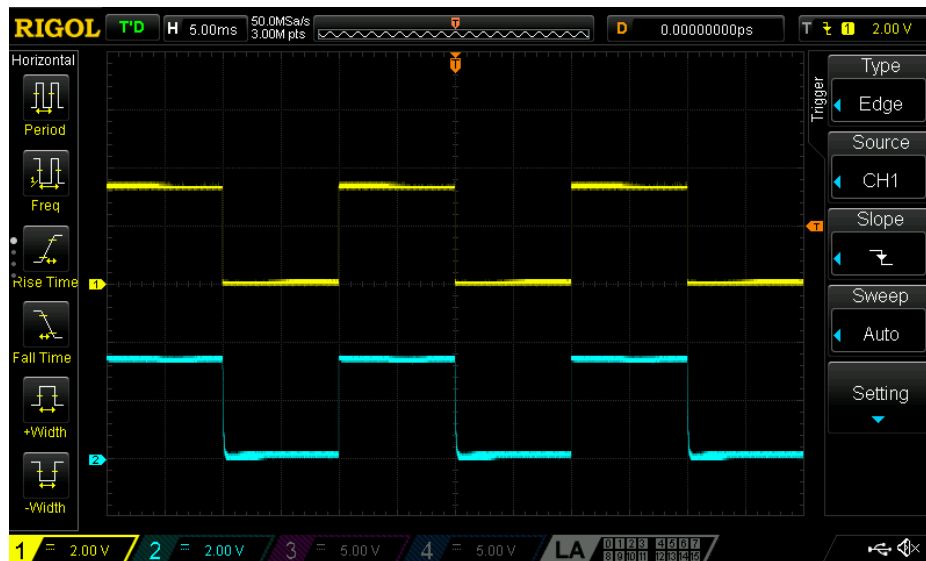
Figure 5: ACMP Input Structure Behavior

Figure 5 shows that IO14 in analog input mode is pulled HIGH by the V<sub>DD</sub> signal whenever the ACMP is enabled despite having an internal pull-down resistor. This behavior is caused by an internal connection between V<sub>DD</sub> and IO14. Similar behavior can be reproduced when one ACMP’s IN+ port is connected to another ACMP’s IN+ port.

CH1 (Yellow): ACMP PWR UP (IO0)

CH3 (Light Blue): Digital IO w/ Analog Input Mode Configuration (IO14)

If an ACMP is disabled, the IO associated with that ACMP will operate as expected under any configuration. Please reference [Table 2](#) for more information regarding which IOs are associated with which ACMPs.

When the ACMPs are enabled, it is possible to inadvertently connect multiple ACMP sources together through the input structure. This is possible when the ACMP input is connected to a source other than its analog IO and that IO's input mode is set to "Analog IO".

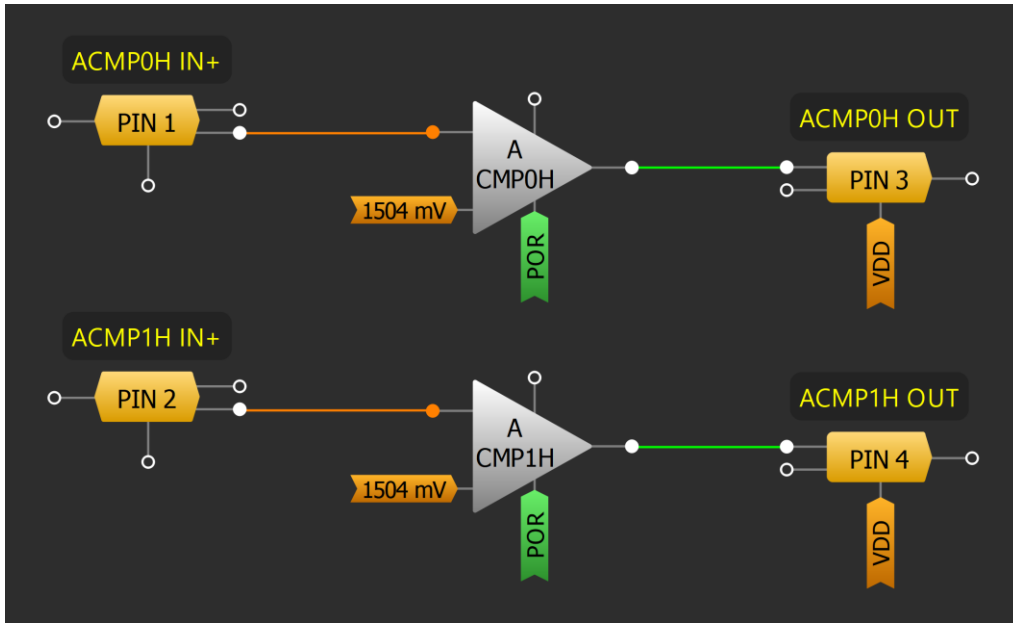
Figure 6: Testing Design

If using ACMPxH with 32 mV hysteresis, ACMPxH output could be glitching when ACMPxH positive input (IN+) is close to the negative input (IN-). It can happen when  $V_{DD} = 4.0$  V or higher and  $V_{ref}$  ranges from 0.832 V to 1.024 V, and 1.312 V to 1.44 V.

1. Use the deglitch filter connected to the ACMPxH output.
2. Avoid conditions described in paragraph 3.4.2.

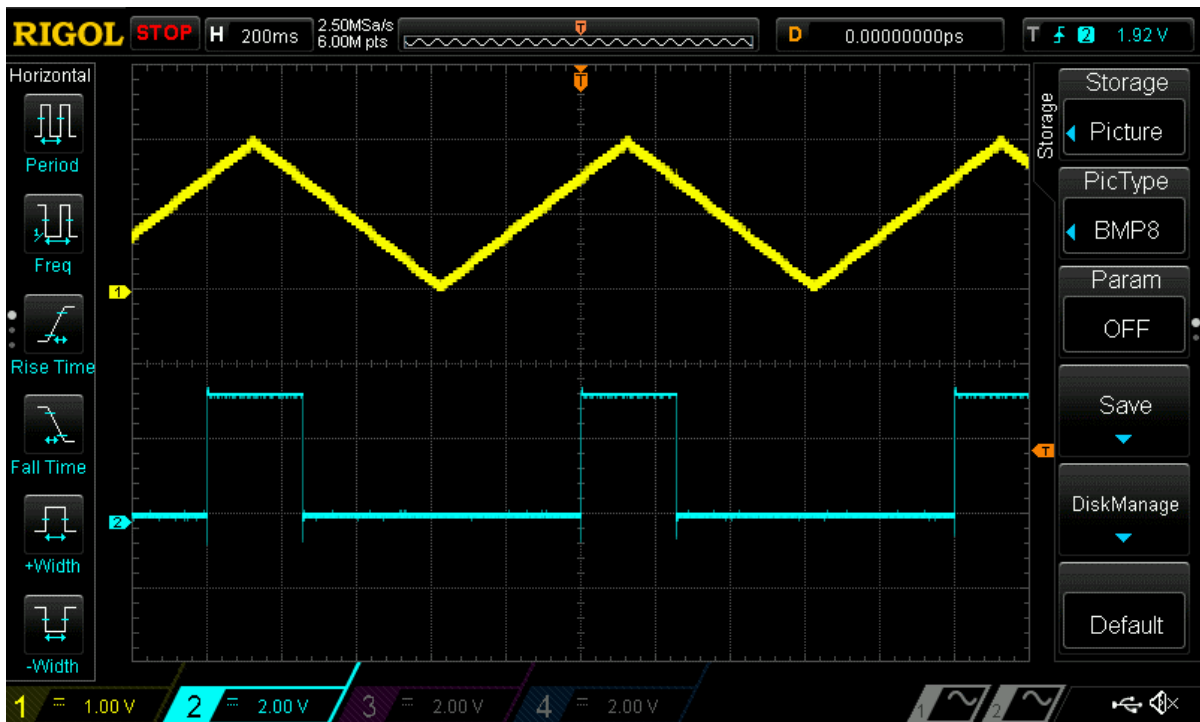
Figure 7: ACMP Output during Glitching

Channel (yellow/top line) - PIN#1 (ACMP0H IN+)

Channel (light blue/top line) - PIN#3 (ACMP0H OUT)

1. Waveform at Vref = 1504 mV, hysteresis is equal to 32 mV.

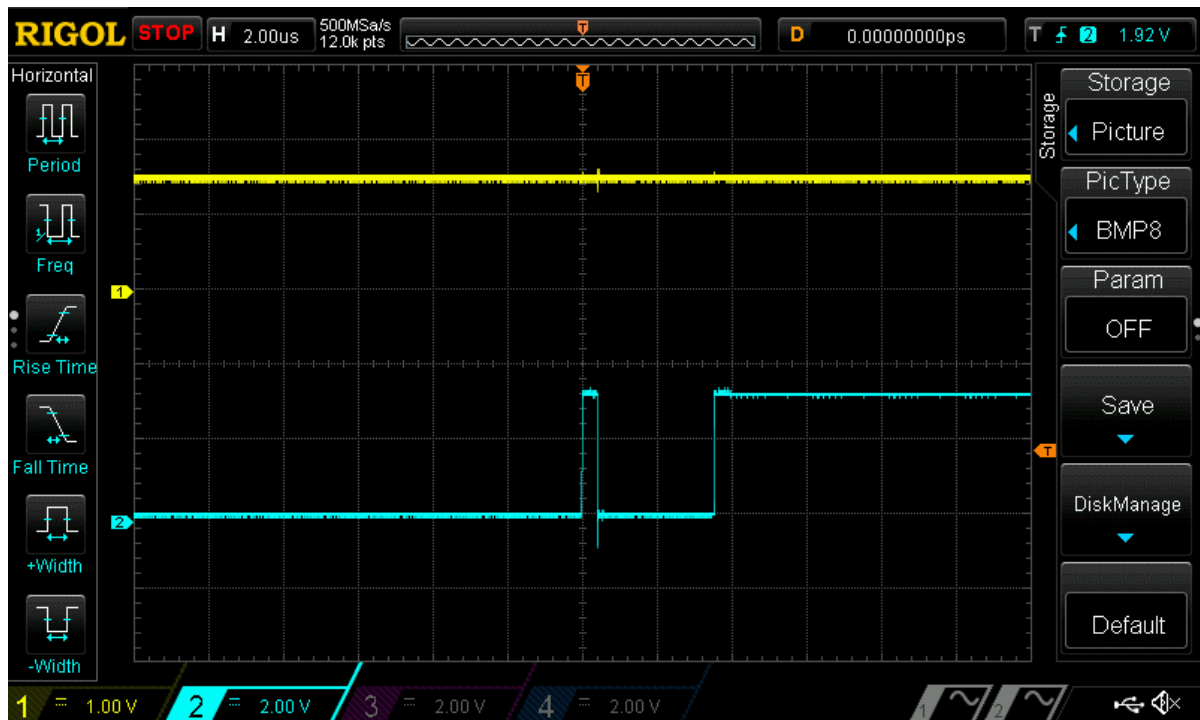
Figure 8: Zoomed ACMP Output during Glitching

2. Waveform at Vref = 1504 mV, hysteresis is equal to 32 mV (zoomed rising edge).

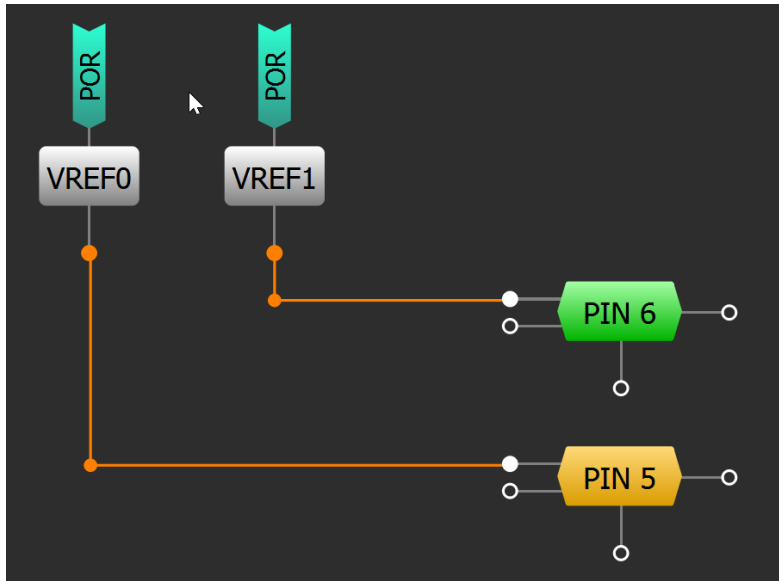
Figure 9: Testing Design

If using Vref output in the range of 32 mV to 192 mV connected to the analog input/output PIN, the Vref accuracy is very low due to the built-in buffer's offset.

There is no workaround.
