SLG47525/28 Errata Note

This document contains the known errata for SLG47525/28 and the recommended workarounds.

<b>Package(s)</b>	14-pin STQFN (SLG47525): 2.0 mm x 2.2 mm x 0.55 mm, 0.4 mm pitch
	20-pin STQFN (SLG47528): 2.0 mm x 3.0 mm x 0.55 mm, 0.4 mm pitch

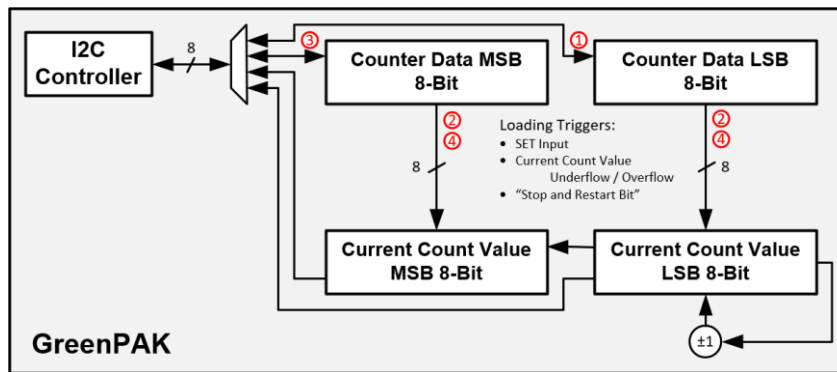
Figure 11. 16-Bit I<sup>2</sup>C Counter Block Diagram

As previously mentioned, the 16-bit value is loaded from the I<sup>2</sup>C buffers to the Counter Data registers in 8-bit chunks. Right at time “1”, the LSB byte (0x01) is loaded into the Counter Data registers. This makes the Counter Data value temporarily equal to 0x0001. At time “2” between the internal I<sup>2</sup>C load signals, the counter receives a rising edge on its clock input. This causes the Current Count Value to underflow and to be loaded with the Counter Data value which is 0x0001. At time “3”, the MSB byte (0x01) is loaded into the Counter Data registers setting the Counter Data value to 0x0101. At time “4”, the Current Count Value underflows again and is set to the Counter Data value of 0x0101.

This behavior results in two output pulses on OUT when only one pulse is expected. Observing this behavior depends upon the asynchronous timing between the counter’s clock and an I<sup>2</sup>C write command to the Counter Data registers. For some applications, the extra pulse on OUT can be ignored and the counter will self-correct after underflowing, overflowing, or being SET/RESET through the GreenPAK connection matrix.
