# RENESAS TECHNICAL UPDATE

| Product Category | MPU/MCU | | Document No. | TN-RH8-B0567B/E | Rev. | 2.00 |
| Title | RH850 G3M stuck Issue | | Information Category | Technical Notification | | |

We confirmed that the G3M CPU gets stuck while running a certain program code.

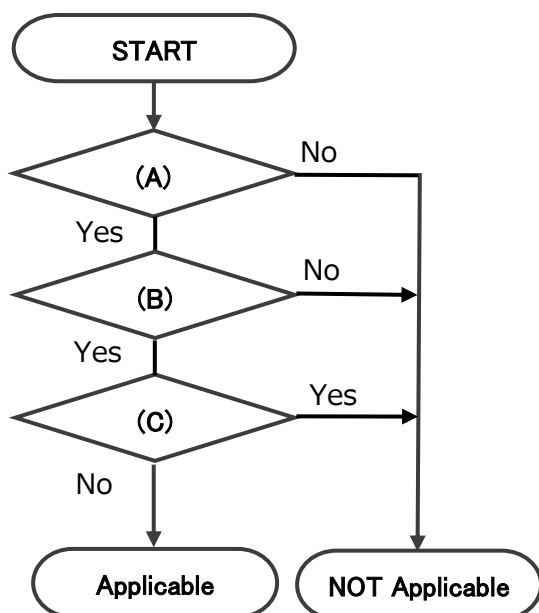
#### 3.1 Single-core product

| | Content |
|---|---|
| (A) | Is the product applicable (●) in the table below? |
| (B) | Were applicable parts detected by the checker tool? |
| (C) | Can you say that all detected applicable parts were mistakenly detected? |

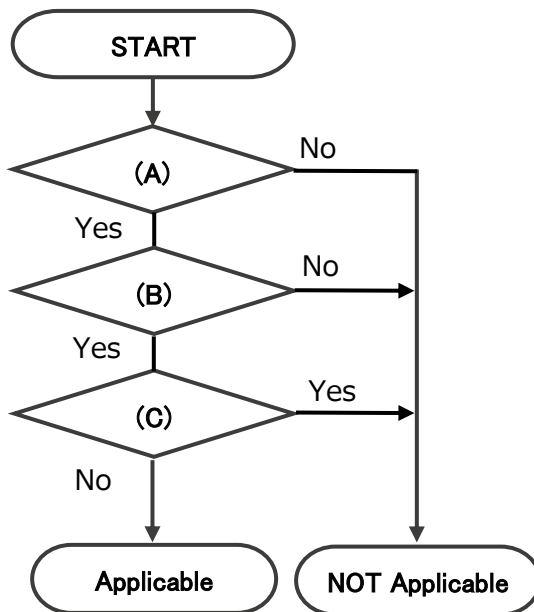
### 3.2 Multi-core product, CPU1 and CPU2 access the same Bank of Code Flash

| | Content |
|---|---|
| (A) | Is the product applicable (●) in the table below? |
| (B) | Were applicable parts detected by the checker tool? |
| (C) | Can you say that all detected applicable parts were mistakenly detected? |

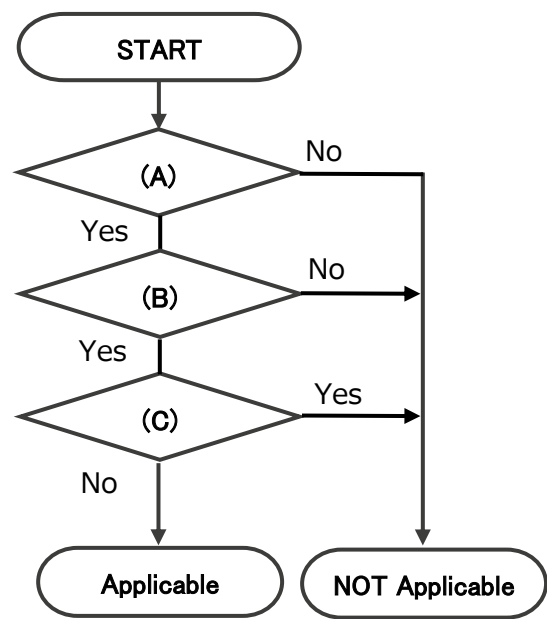
3.3 Multi-core product,   CPU1 and CPU2 access the different Bank of Code Flash

| | Content |
|---|---|
| (A) | Is the product applicable (●) in the table below? |
