Errata

SLG46517

CE-GP-001

This document contains the known errata for SLG46517 and the recommended workarounds.

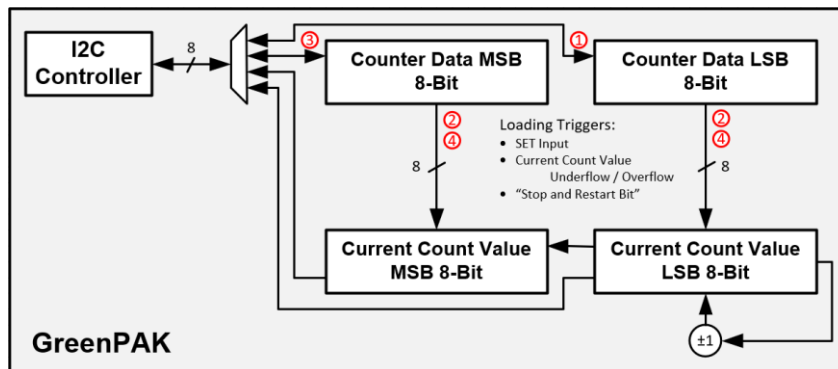
Figure 11: 16-Bit I2C Counter Block Diagram

As previously mentioned, the 16-bit value is loaded from the I2C buffers to the Counter Data registers in 8-bit chunks. Right at time “1”, the LSB byte (0x01) is loaded into the Counter Data registers. This makes the Counter Data value temporarily equal to 0x0001. At time “2” between the internal I2C load signals, the counter receives a rising edge on its clock input. This causes the Current Count Value to underflow and to be loaded with the Counter Data value which is 0x0001. At time “3”, the MSB byte (0x01) is loaded into the Counter Data registers setting the Counter Data value to 0x0101. At time “4”, the Current Count Value underflows again and is set to the Counter Data value of 0x0101.

This behavior results in two output pulses on OUT when only one pulse is expected. Observing this behavior depends upon the asynchronous timing between the counter’s clock and the I2C write command to the Counter Data registers. For some applications, the extra pulse on OUT can be ignored and the counter will self-correct after underflowing, overflowing, or being SET/RESET through the GreenPAK connection matrix.
