ISSUE 1: FILTER Cell does not Filter Out Repetitive Glitches

SLG46585

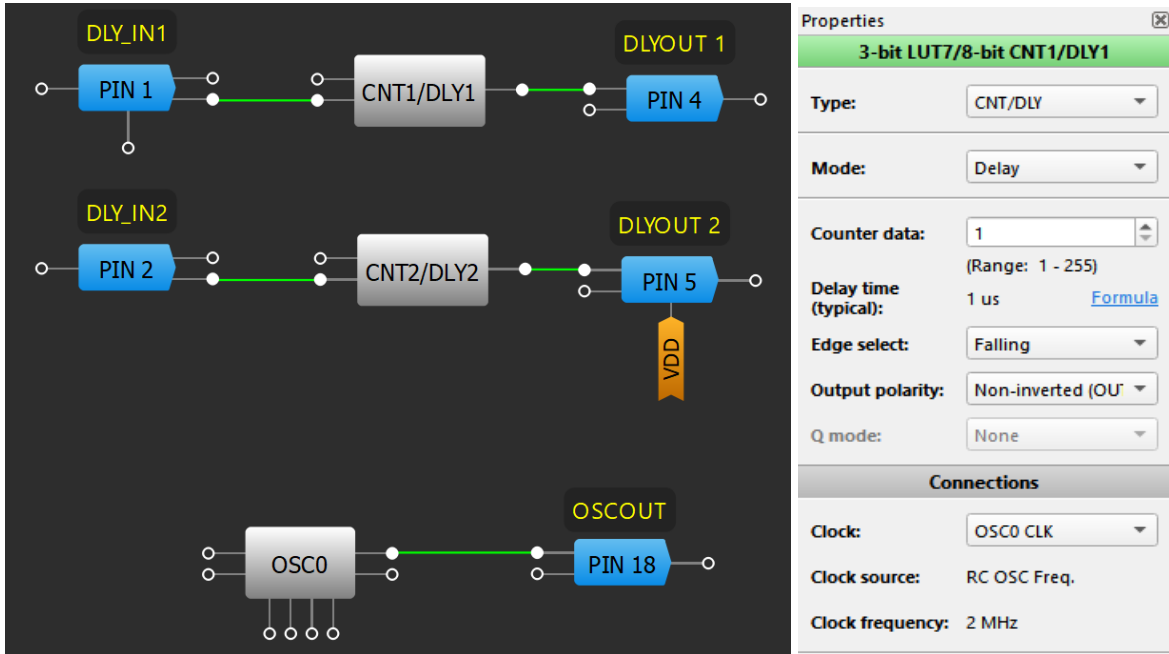
Figure 2: Test Circuit

The error is difficult to capture as the timing must be exact within ns, and short (ns) pulses are difficult to generate glitch precise enough to induce the problem. GPIO naturally filter out ns pulses, so for purposes of errata capture, two simultaneous falling-edge DLY circuits (as shown in [Figure 2](#)) were used. By lining up two delays precisely at a particular timing relationship, we can use the internal Auto Power On (OR logic) to generate the glitch pattern necessary to cause the error.

1. Use signal conditioning circuits to prevent glitch on DLY inputs < 200 ns. Examples:
 - a. ACMP with Hysteresis
 - b. External RC in front of Digital Input with Schmitt Trigger
 - c. Filter cell.
2. Set OSC power mode to Force Power On mode instead of Auto Power On.
3. Use different oscillator, such as 25 MHz Ring OSC, which does not have Auto Power On issue.
