SLG47525/28 Errata Note

This document contains the known errata for SLG47525/28 and the recommended workarounds.

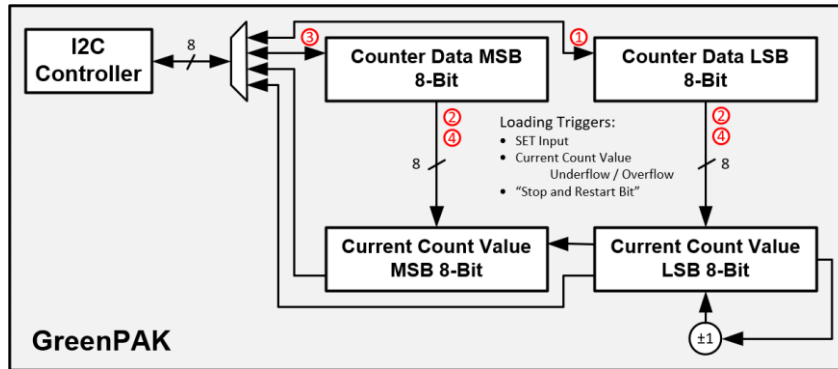
Figure 11. 16-Bit I²C Counter Block Diagram

As previously mentioned, the 16-bit value is loaded from the I²C buffers to the Counter Data registers in 8-bit chunks. Right at time “1”, the LSB byte (0x01) is loaded into the Counter Data registers. This makes the Counter Data value temporarily equal to 0x0001. At time “2” between the internal I²C load signals, the counter receives a rising edge on its clock input. This causes the Current Count Value to underflow and to be loaded with the Counter Data value which is 0x0001. At time “3”, the MSB byte (0x01) is loaded into the Counter Data registers setting the Counter Data value to 0x0101. At time “4”, the Current Count Value underflows again and is set to the Counter Data value of 0x0101.

This behavior results in two output pulses on OUT when only one pulse is expected. Observing this behavior depends upon the asynchronous timing between the counter’s clock and an I²C write command to the Counter Data registers. For some applications, the extra pulse on OUT can be ignored and the counter will self-correct after underflowing, overflowing, or being SET/RESET through the GreenPAK connection matrix.
