Errata

SLG46824

CE-GP-016

This document contains the known errata for SLG46824 and the recommended workarounds.

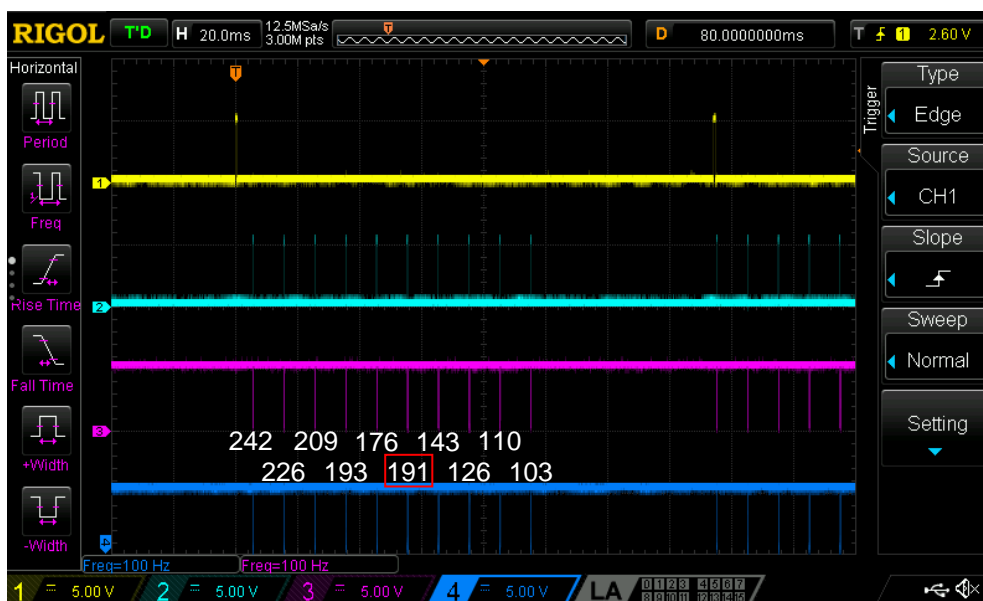
Figure 1: Example Data

Asynchronous interaction between the CNT/DLY clock input and the I^{2}C latch signal (generated by an I^{2}C read command of the CNT/DLY block's count value) can result in an incorrect I^{2}C data read. The CNT/DLY block will count accurately, but the count value transferred into the block's I^{2}C read register might be loaded incompletely if the I^{2}C latch signal and the clock input occur at about the same time.

The example data capture below shows ten periodic I^{2}C reads of CNT2/DLY2 configured to count down at about 16 clocks per read. The sixth read sample erroneously shows a value greater than that of the fifth. The seventh sample reads as if the previous I^{2}C error never occurred - the difference from the fifth sample (176) to the seventh (143) is 33 clocks or 16 clocks + 17 clocks as expected.

If the possibility of incorrect I^{2}C data reads can't be accommodated for by external software checks, one can guarantee proper operation by stopping the CNT/DLY block's clock during I^{2}C reads through one of the following methods: by disabling the oscillator block, by reconfiguring the CNT/DLY block's clock source, or by gating an external clock using a LUT (Look Up Table) in the signal matrix. After disabling the CNT/DLY block's clock, the count registers can be read without error. Please note that this workaround will add the I^{2}C read and processing time to the counter's overall clock period.

The best workaround depends on the resource constraints of the application. If the oscillator block doesn't clock other logic elements within the design, a matrix output can be used to manually power down the oscillators for the I^{2}C read. When the CNT/DLY block's clock source is routed internally from the oscillator block, I^{2}C commands can temporarily reconfigure the CNT/DLY block's clock source registers to select "Ext. CLK. (From Matrix)." This action will disable the clock by connecting it to ground. If the CNT/DLY block is clocked from the signal matrix, the LUT can be used to gate the clock during the I2C read.

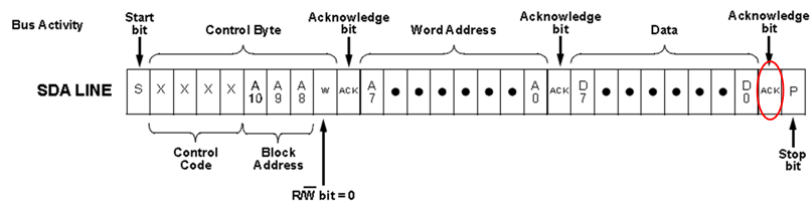
Figure 2: GreenPAK I²C Write Frame for Page Erase

To erase the NVM and the EEPROM, one must perform an I^{2}C write to the "Page Erase Byte" located at 0xE3. The ACK bit which follows the "Data" portion of Figure 2 won't comply with standard I^{2}C specifications. Please see the ACK bit circled in RED below.

No workaround is required for the GreenPAK device as the NVM and EEPROM erase operations will execute properly. For verification, one can perform an I²C read of the erased pages. Excluding protected pages, all erased NVM and EEPROM registers should be cleared.

Adjust the MCU's I²C firmware to catch and ignore a "NACK" from the GreenPAK device when the "Page Erase Byte" is addressed. In light of the additional STOP and START conditions, the behavior of other I²C slaves on the same bus should be evaluated.

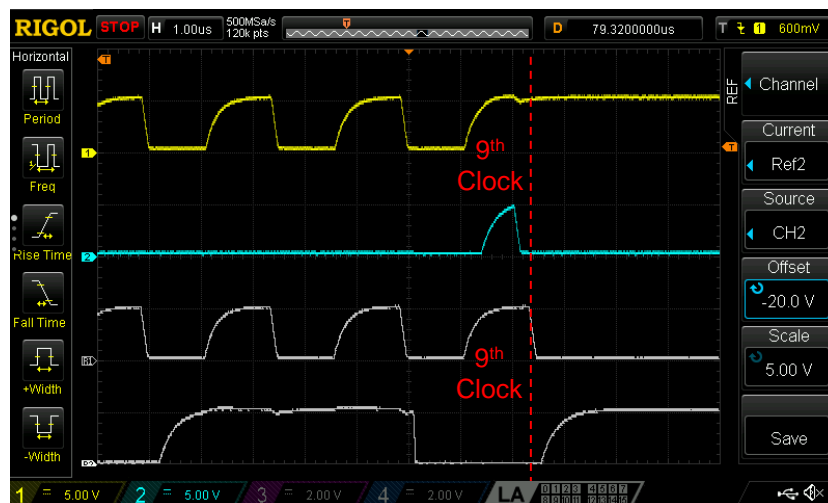
Figure 3: Non-I²C Compliant Behavior Oscillogram

The following waveform compares the regular I²C ACK behavior (Ref 1 - SCL and Ref 2 - SDA) with the non-compliant ACK behavior (Channel 1 - SCL and Channel 2 - SDA) generated by an I²C write to the "Page Erase Byte." During the 9th clock cycle, the SLG46824 does not adhere to the "data hold time" specification by releasing SDA (Channel 2) before the falling edge of the clock pulse on SCL (Channel 1).

Note 1   It should be noted that the NVM and EEPROM erases will execute properly inside the GreenPAK device despite a potential I²C NACK. In addition, this behavior only applies to the "Page Erase Byte." All other I²C writes won't exhibit this behavior.

On a system level, other I²C devices might interpret this non-compliant ACK as an additional STOP and START condition. By definition, a START condition occurs when SCL is HIGH and SDA transitions from HIGH to LOW. A STOP condition occurs when SCL is HIGH and SDA goes from LOW to HIGH. After the 9th clock cycle, the MCU should generate the final STOP condition to indicate the end of transmission to all I²C slaves on the bus.

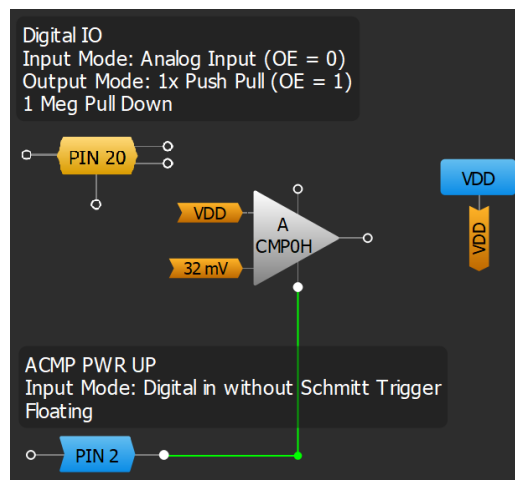
Figure 4: GreenPAK Input Structure Test Schematic

Figure 4 shows the GreenPAK configured with IO14 as a Digital IO with a 1 MΩ pull-down resistor. Since the OE pin is connected to 0 V, this pin is acting as an "Analog IO." As seen in Table 2, IO14 and V_{DD} are both input options for ACMP0H. In this example, IO0 is being used as a digital input to enable and disable the ACMP.

There is no workaround for this behavior. With this in mind, the IOs should not be used as digital IOs (with "Input mode" set to Analog input) or as digital outputs (with "Output mode" set to 1/2/4x 3-State Output) if the respective ACMP is enabled and connected to another input source.

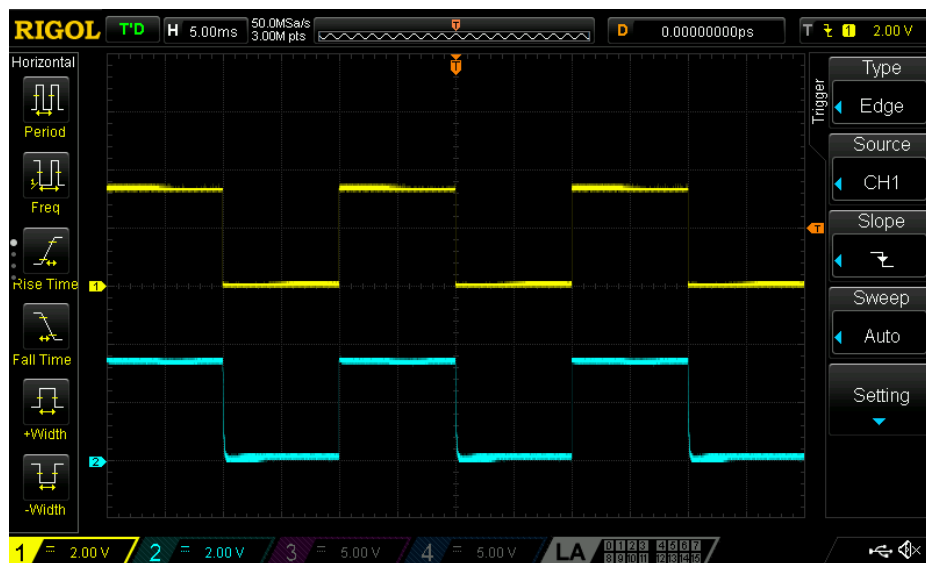
Figure 5: ACMP Input Structure Behavior

Figure 5 shows that IO14 in analog input mode is pulled HIGH by the V_{DD} signal whenever the ACMP is enabled despite having an internal pull down resistor. This behavior is caused by an internal connection between V_{DD} and IO14. Similar behavior can be reproduced when one ACMP's IN+ port is connected to another ACMP's IN+ port.

If an ACMP is disabled, the IO associated with that ACMP will operate as expected under any configuration. Please reference Table 2 for more information regarding which IOs are associated with which ACMPs.

When the ACMPs are enabled, it is possible to inadvertently connect multiple ACMP sources together through the input structure. This is possible when the ACMP input is connected to a source other than its analog IO and that IO's input mode is set to "Analog IO".

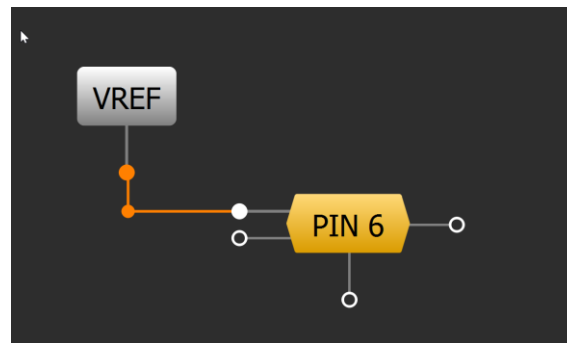
Figure 6: Testing Design

If using Vref output in the range of 32 mV to 192 mV connected to the analog input/output PIN, the Vref accuracy is very low due to the built-in buffer's offset.

There is no workaround.
