# Standard Boot Firmware for R9A02G021 RISC-V MCUs

This application note describes the communication protocol, command set, and usage of the boot firmware provided with Renesas R9A02G021 RISC-V MCUs.

R9A02G021 RISC-V MCUs

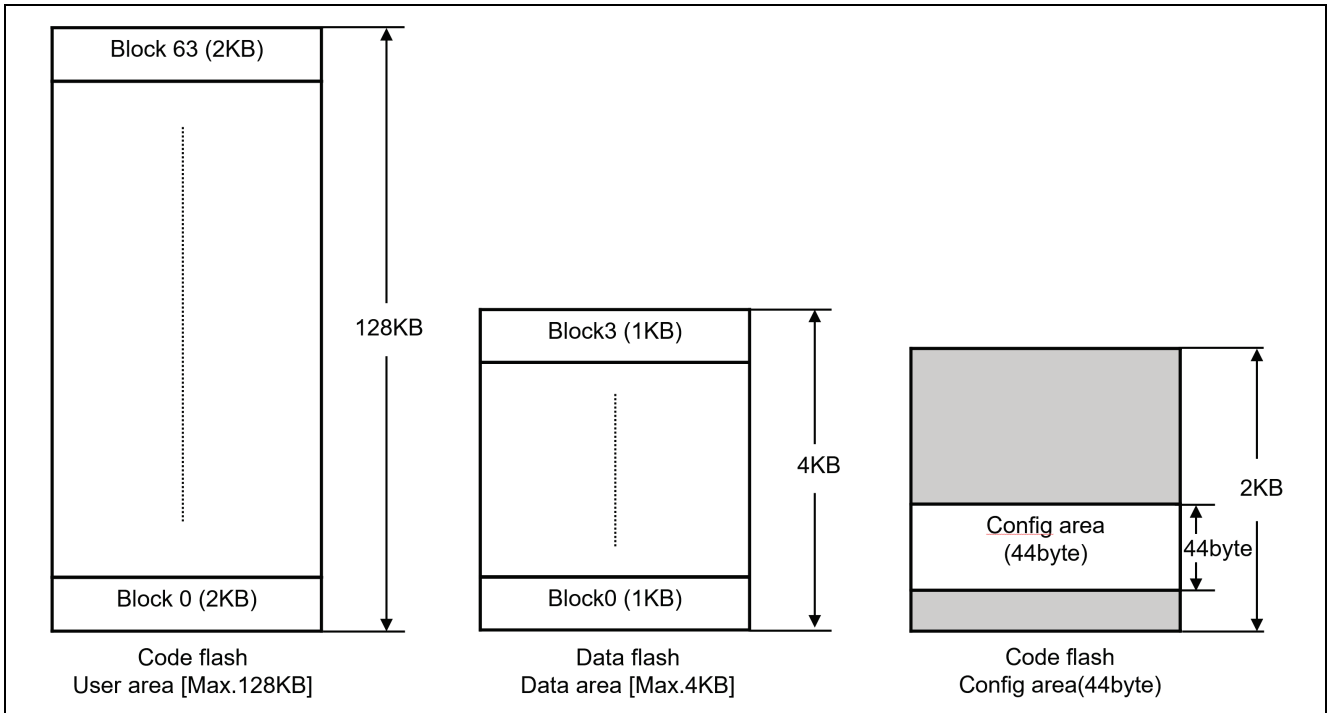
Figure 1. Flash Memory Structure Example 1

The boot firmware rewrites and reads the User area, Data area, and Config area according to commands given by the user.

Figure 1 shows an example of flash memory structure. Memory structure differs from device to device.

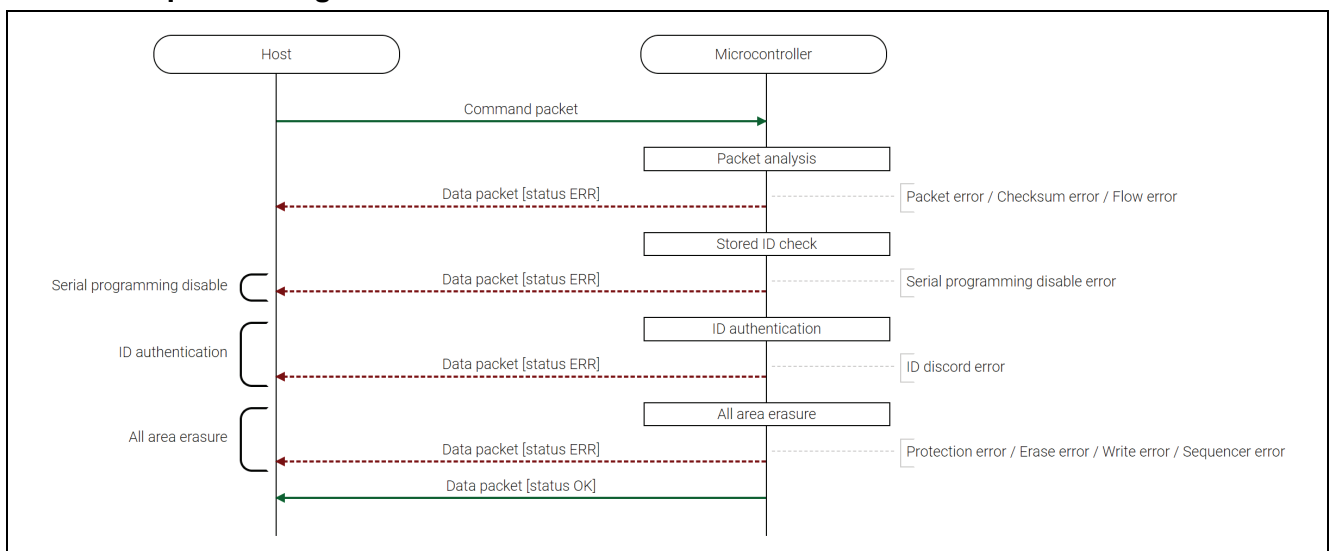
Figure 15. Authentication Command Sequence Diagram

Condition	Processing
Stored ID[127:126] = 0xb (x means Don't care)	Serial programming disable -> Enter an infinite loop
Stored ID[127:126] = 10b	ID authentication when ID mismatch -> Enter an infinite loop when ID match -> Transition to "Command acceptable phase"
Stored ID[127:126] = 11b	
received ID != "ALeRASE"	All area erasure when FAPR = 0 -> Enter an infinite loop when Error occurred -> Enter an infinite loop when Successful erasure -> Transition to "Command acceptable phase"
received ID = "ALeRASE"

- Boot firmware execute ID code authentication when at least one of the following conditions are met.
  - Bit 126 of the ID code stored in the device is 0b.
  - Bit 126 of the ID code stored in the device is 1b but received IDC is not "ALeRASE".
- When ID code authentication fails, boot firmware send "ID discord error" and finishes command processing.  
Boot firmware does not accept any commands nor response for the commands after sending this error.  
\* Flash memory status does not change before command reception.
- When ID code authentication passes, boot firmware send "OK" and finishes command processing.  
Then boot firmware transits to Command acceptable phase and wait for the next command.  
\* Flash memory status does not change before command reception.

- If the above error does not occur, boot firmware execute all erasure.
- When all erasure fails, boot firmware receives a data packet and returns "Erase error", "Write error" or "Sequencer error" and finishes command processing.  
Boot firmware does not accept any commands nor response for the commands after sending this error.  
\* Refer to Status code for conditions of the errors.  
\* Flash memory area are undefined.

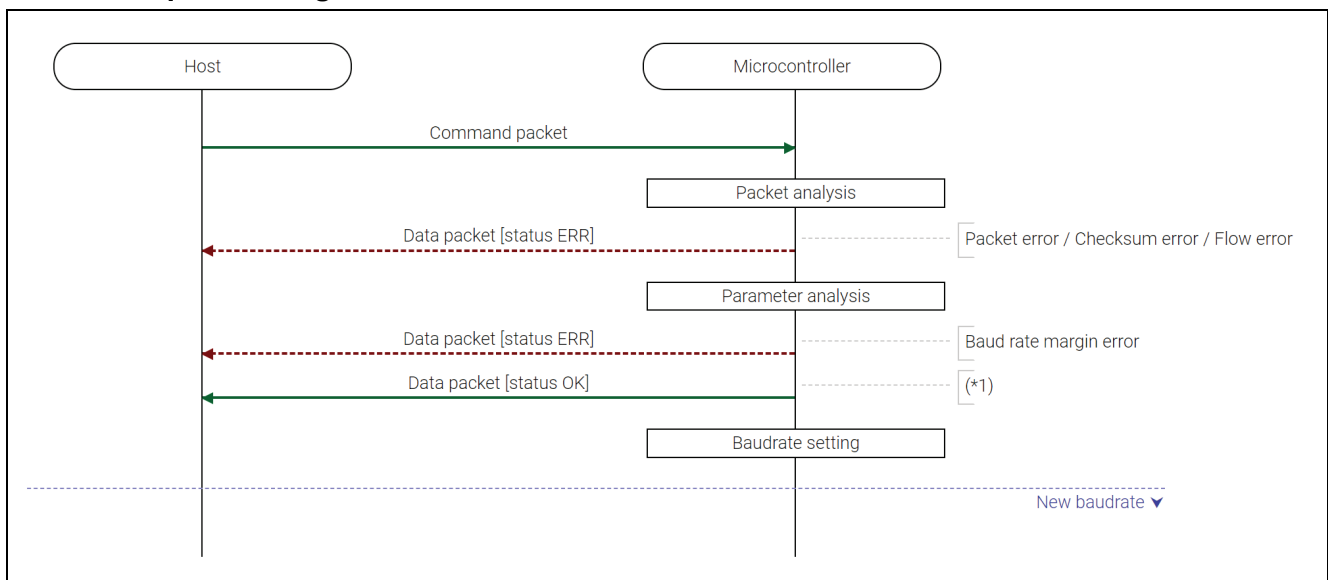
Figure 16. Baud Rate Command Sequence Diagram

\*1: After this packet receiving, next command packet shall wait tBRT for keeping the baudrate setting time.

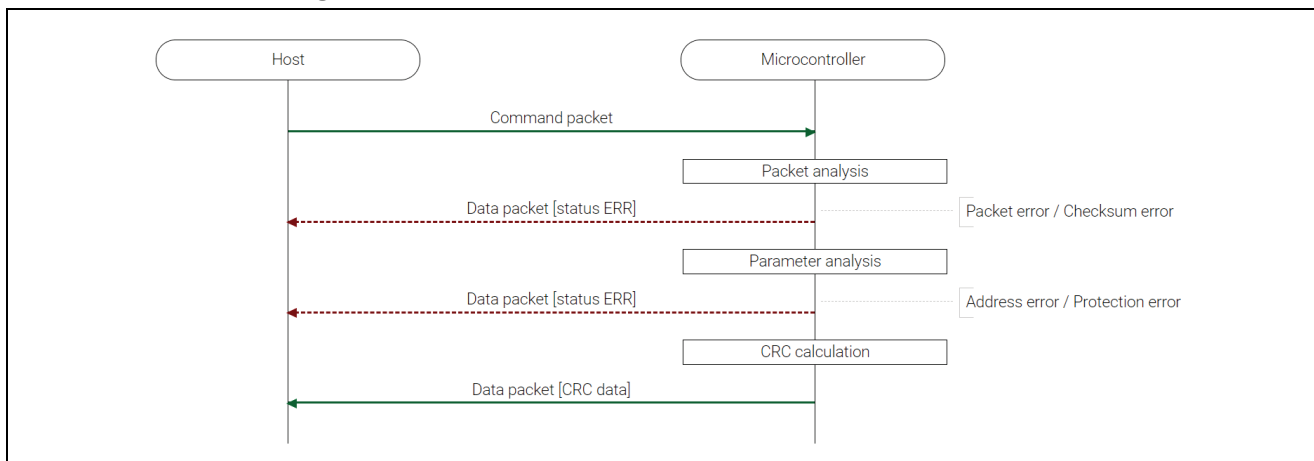
Figure 19. CRC Command Sequence Diagram

<b>Name</b>	CRC-32-IEEE-802.3
<b>Default value</b>	FFFFFFFFh
<b>Shift direction</b>	Left shift
<b>Polynomial representations</b>	(MSB first) 04C11DB7h

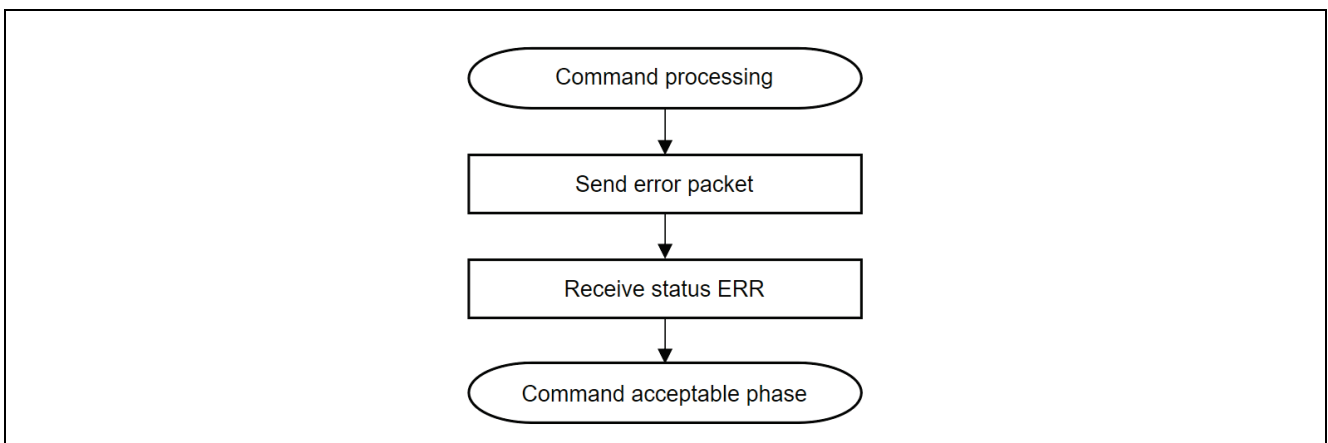
Figure 25. Command Cancel

For commands that continuously send and receive packets, you can end the command by intentionally sending an error packet and return to the command acceptable phase.

For example, error packets to end the command.
