# Renesas RA Family

## Standard Boot Firmware for the RA family MCUs Based on Arm® Cortex®-M33

This document describes the Standard Boot Firmware Specifications for RA family MCUs flash memory based on Arm Cortex-M33 flash memory. Make sure you understand the target devices and FPSYS / FACI specifications before reading this document. We do not guarantee the operation of any usage not described in this document.

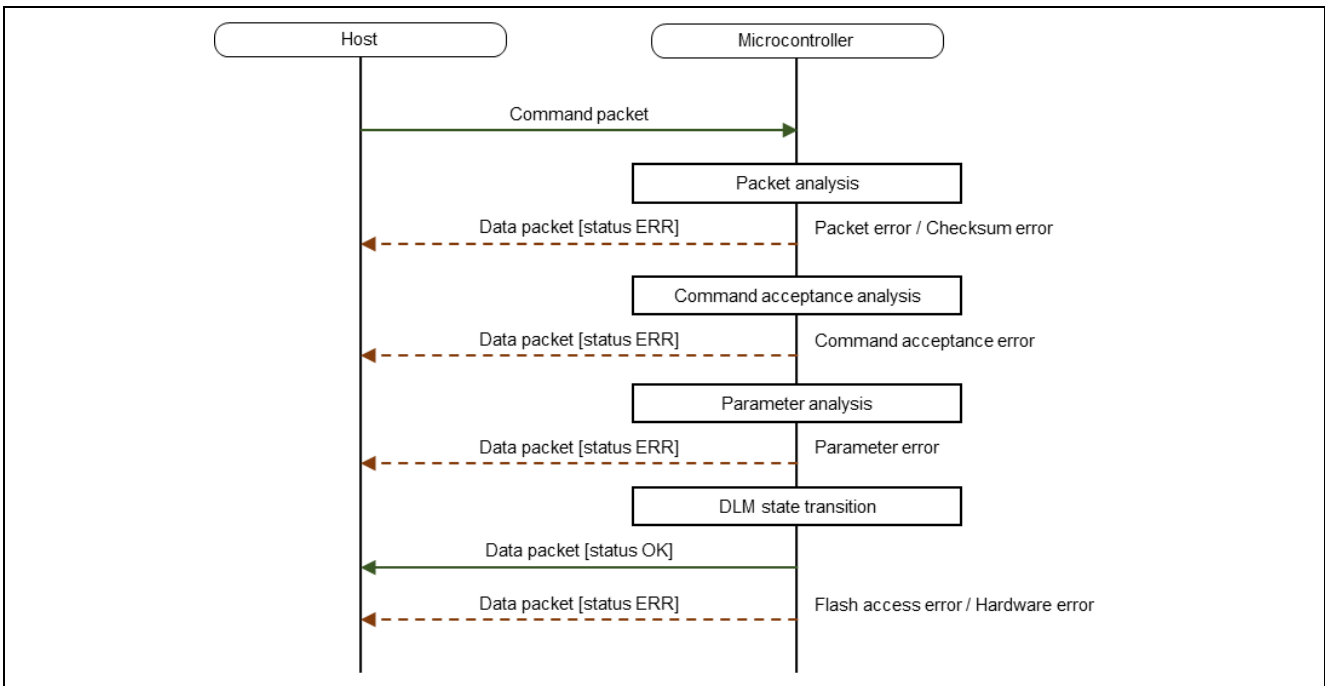
#### 6.2.1 Sequence diagram

This command transitions the DLM state without authentication. The boot firmware is hung when the DLM state transitions to LCK\_BOOT.

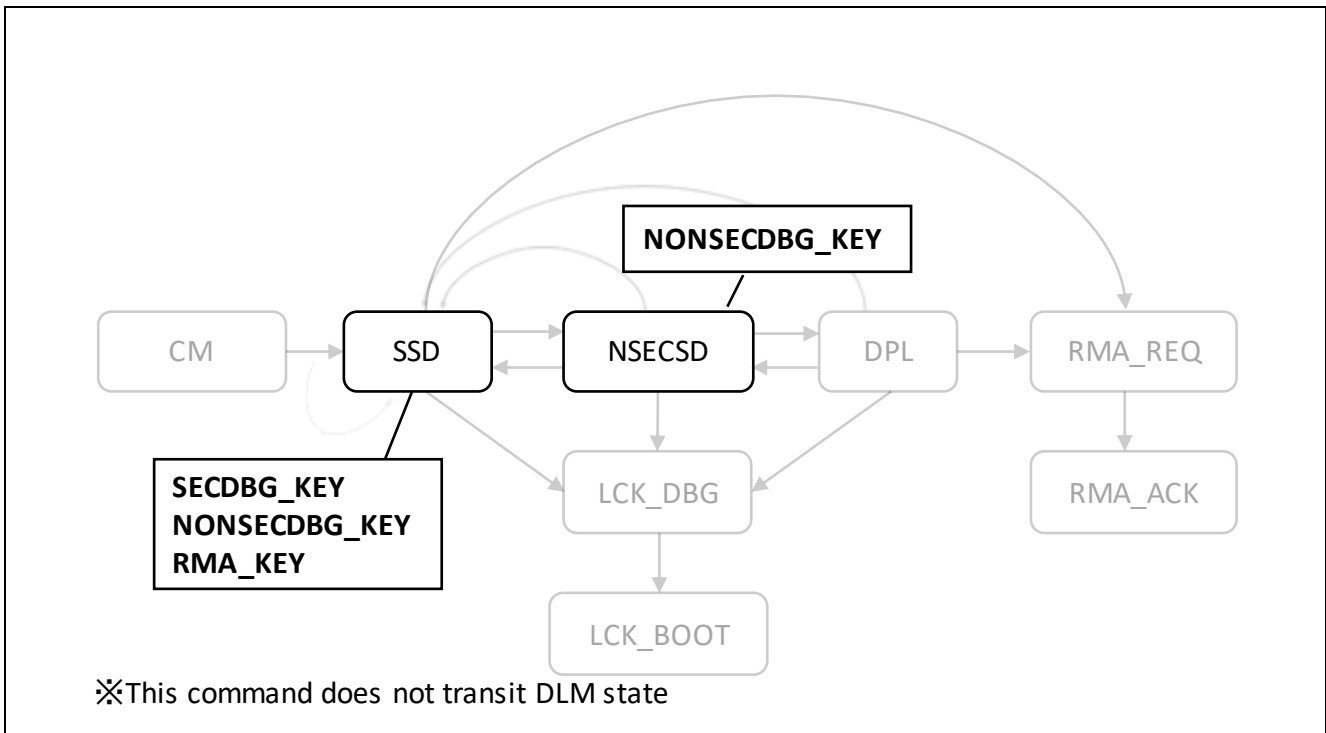
The following table shows the DLM state that can be set for Key type.

Key type	DLM state
SECDBG_KEY	SSD
NONSECDBG_KEY	SSD, NSECSD
RMA_KEY	SSD
