New features in 3.0:

Important workarounds useful to know when using 3.0:

Improvements and Fixed issues in 3.0.1.7

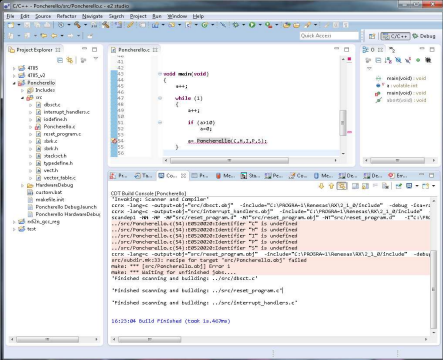
Component	Description
Application	Previous version of e2 studio was based on the Juno Eclipse version. This update moves the Eclipse version to Kepler SR1.
Application	<p>CDT component updated to 8.3. For an update on what is new in 8.3 of CDT please check this: http://wiki.eclipse.org/CDT/User/NewIn83</p>
Application	<p>Various updates made to the previous CDT integration to improve application functionality.</p> <ul style="list-style-type: none"> Project generation when using a folder that contains multi-byte characters is now fixed. When an error occurs in the linker and the user fixes it and rebuilds it is now removed from the problems tab. Build console error and warnings are colour coded and you can also jump to the relevant source window when double clicked.

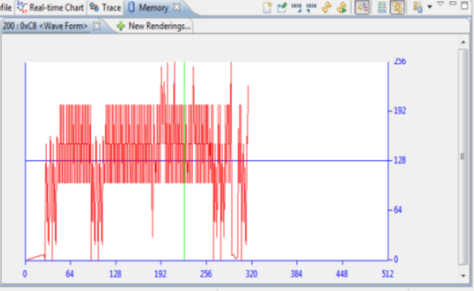
<ul style="list-style-type: none"> Memory fill made more prominent. Improved memory import performance from the memory plugin.
Memory plugin	<p>Waveform memory rendering added to memory plugin.</p>

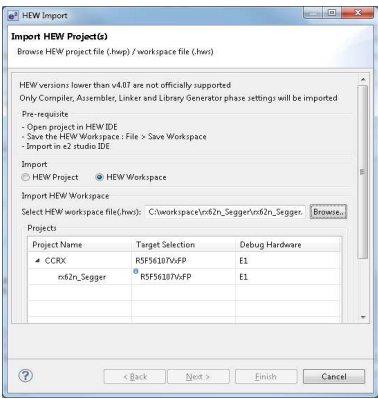
Application	<p>HEW workspace import is now supported.</p>

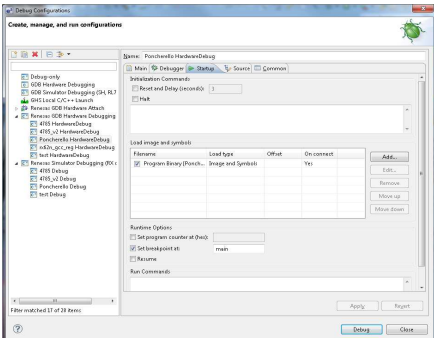
RX	RX64M is supported.
RH850	<p>Improvements made to RH850:</p> <ul style="list-style-type: none"> - RH850 debugging also now supports the profile view. - The RH850 GDB now supports Python scripting correctly.
RL78	On-chip trace now supported for RL78/F13 and F14.
RL78	RL78 EZ Emulator supported.
Application	<p>Multiple download module support added.</p>

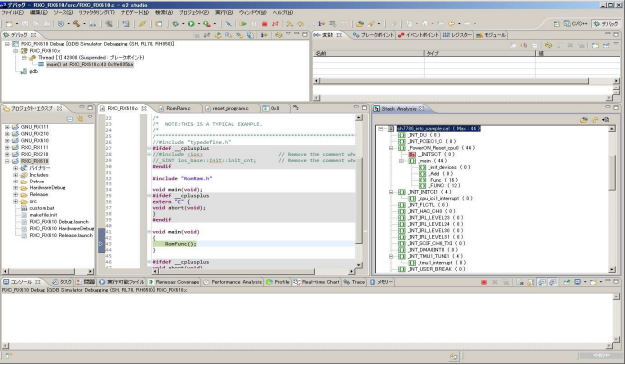
Static Analysis Plugin	<p>Stack Analysis plugin added. (Similar to Call Walker in HEW/CubeSuite+)</p>

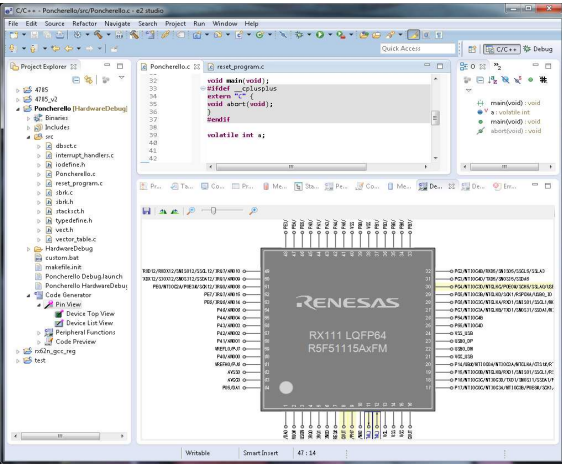
Visual Expressions	Additional controls added to the Visual Expressions plugin. Including meter, vertical slider, horizontal slider and thermometer.
RX Debug Configuration	RX Hot Plug support
Code Generator	Improved support for RX111 and RX64M. Code Generator can now save settings to .csv file.
Code Generator	Improved code generator support for more devices along with Pin View support.
